Draft Basic Assessment Report

Umbila Emoyeni Borrow Pit Application,

GCS Project Number: 23-0766

BASIC ASSESSMENT REPORT And ENVIRONMENTAL MANAGEMENT PROGRAMME REPORT

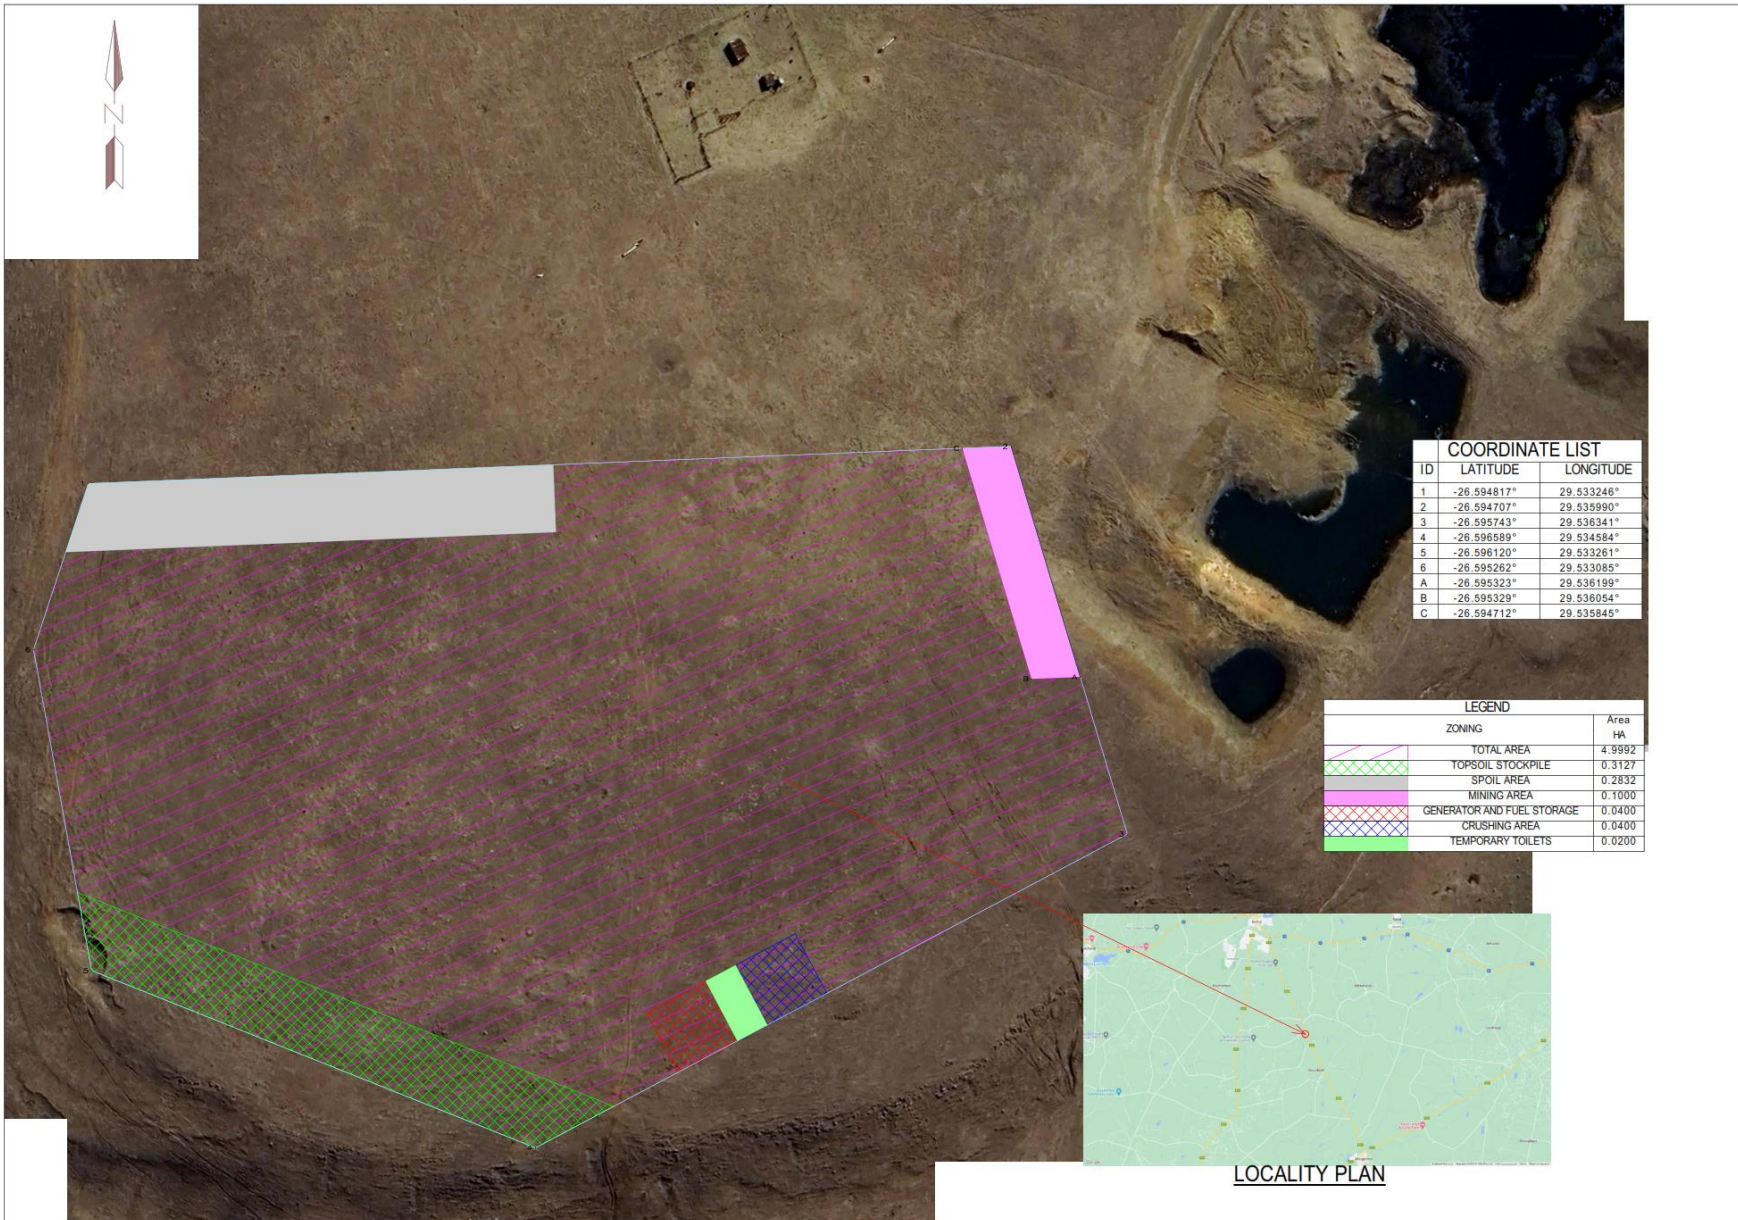
Figure 3-3: Site Layout Plan.

- The borrow pit;
- Topsoil stockpile area;
- Generator and fuel storage area;
- Crushing area;
- Spoils area.

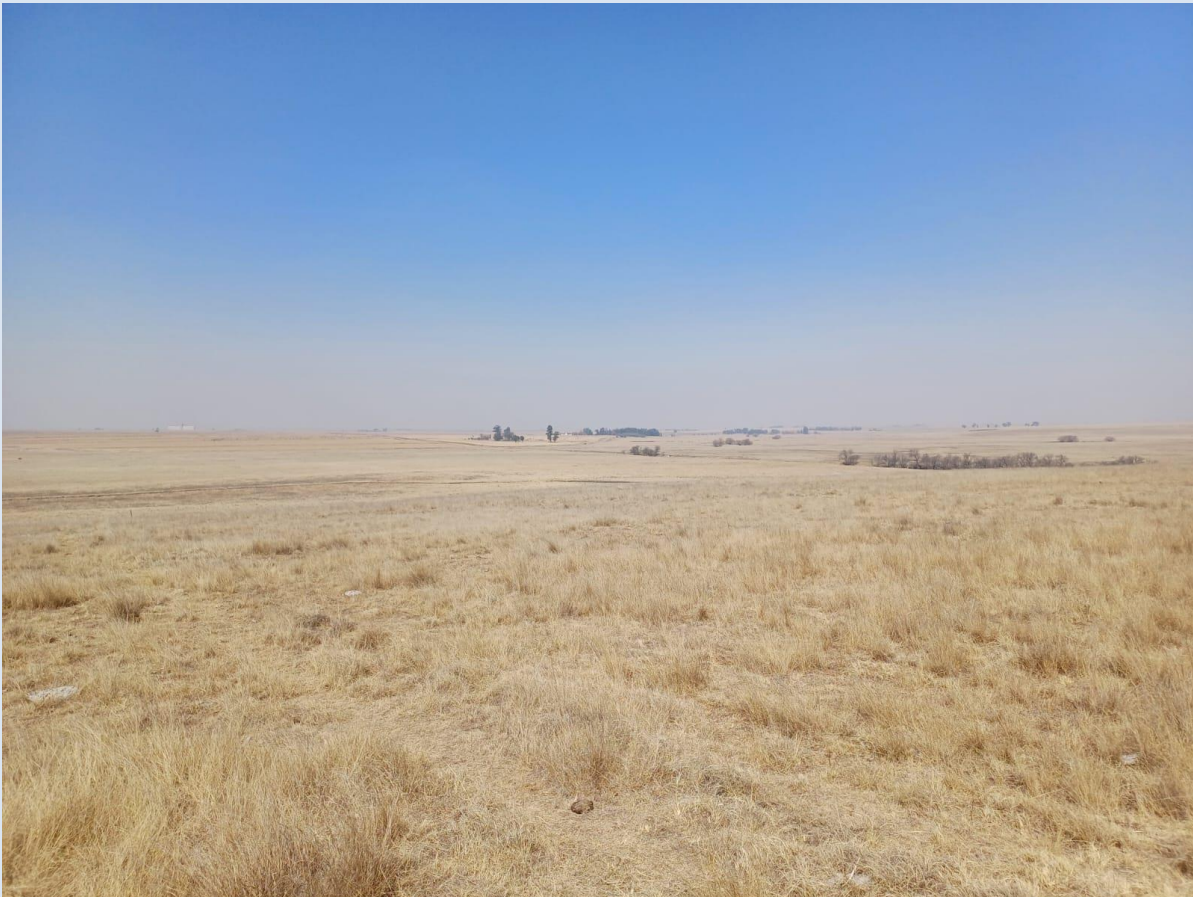
Figure 3-7: Photograph of the current environment at the proposed borrow pit location. (Taken 21 August 2024)

The area where the borrow pit is proposed is currently grassland that the farmer uses for cattle grazing. There are steep ridges towards the south and west of the borrow pit and towards the northeast of the pit there is remnants of a previous borrow pit that is currently being used as a watering area for the cattle. There are two worker houses located about 100m from the borrow pit and the farmhouse is situated approximately 350m from the site.

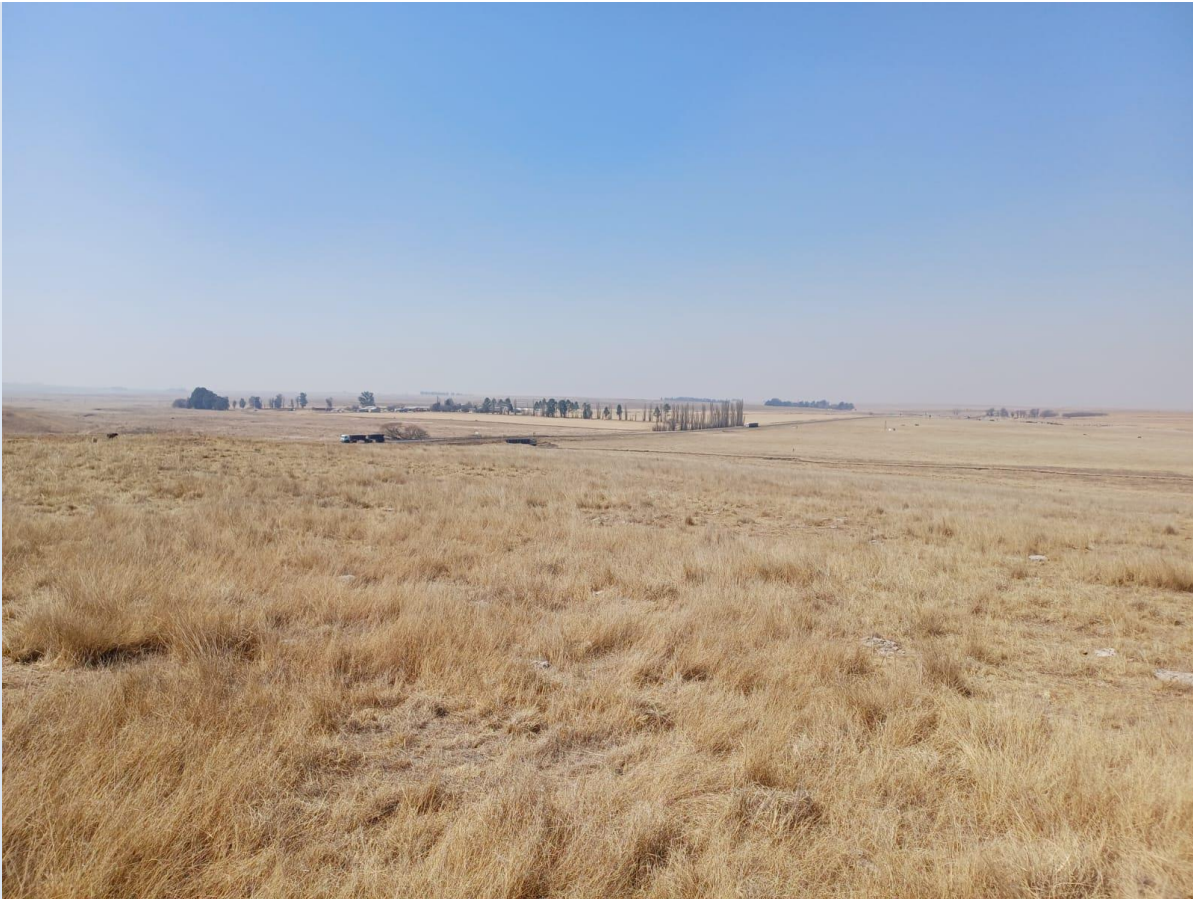
Figure 3-8: Photograph of the current environment at the proposed borrow pit location with the trucks on the R35 visible from the location. (Taken 21 August 2024)

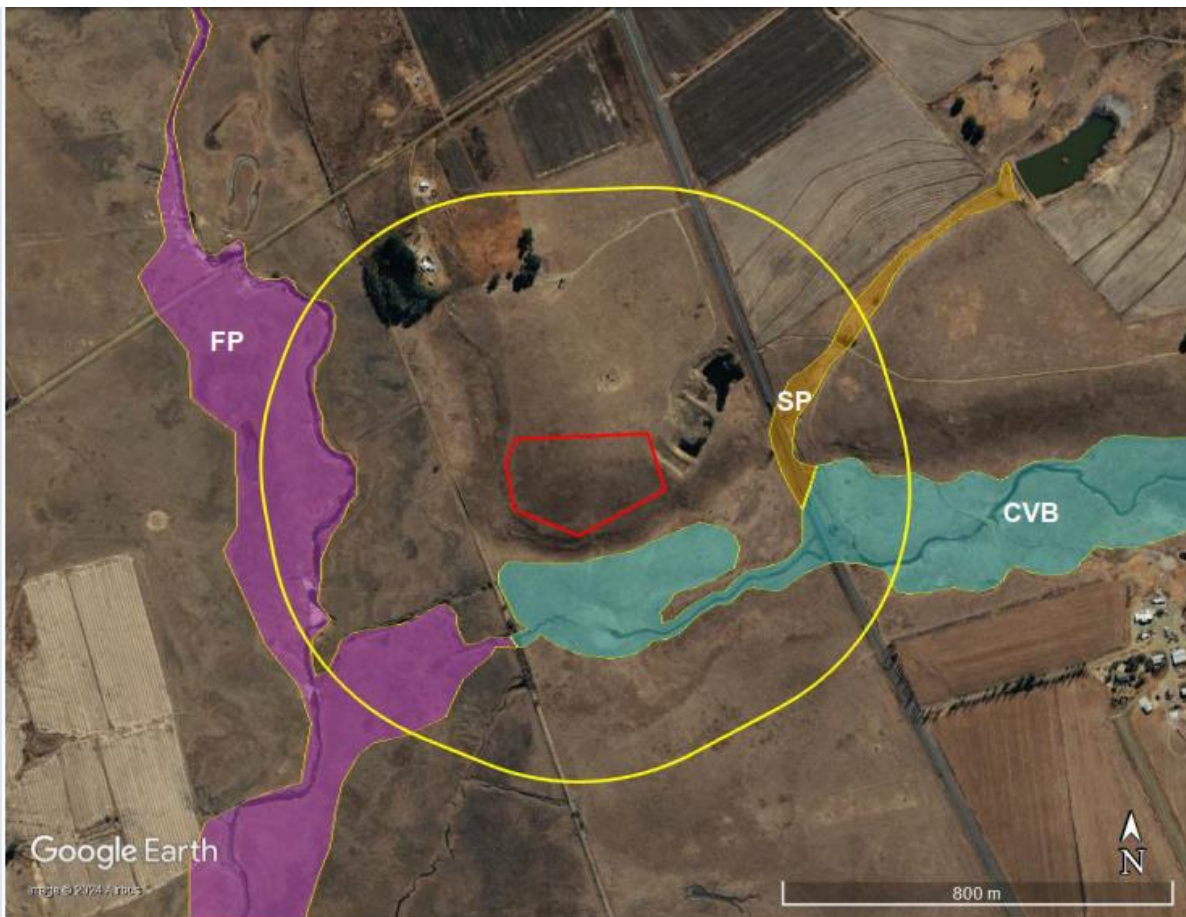
FP = Flood Plain; CVB = Channelled Valley Bottom; SP = Seep

The site assessment confirmed the absence of any natural wetland features within the boundaries of the project site. Furthermore, it identified three wetland features, one a Floodplain wetland (FP) associated with the Kwaggalaagte River, one a Channelled Valley Bottom wetland (CVB) associated with the Heilvleispruit and a Seep wetland (SP) within a 500m radius of the project site. The location of these features are indicated in Figure 3-10.

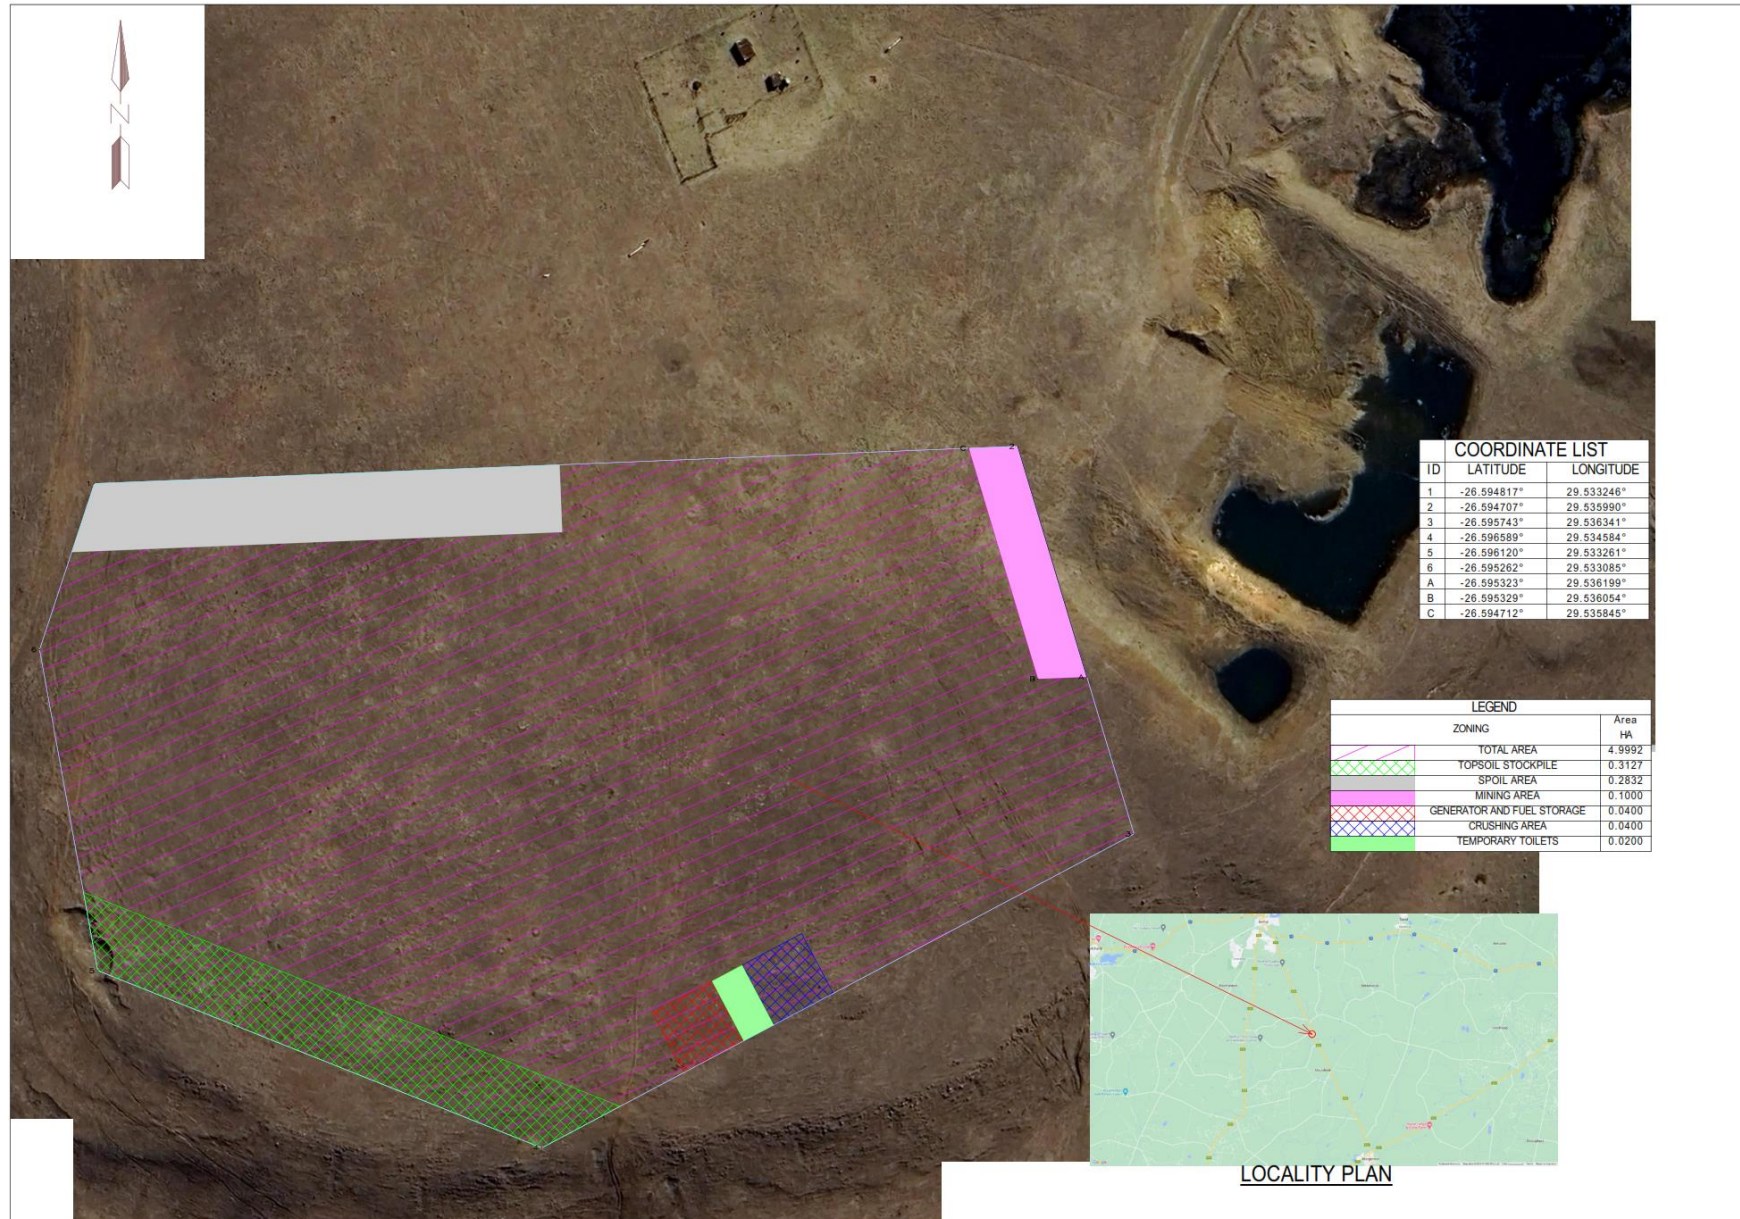
Figure 2-2: Layout Area of the Umbila Emoyeni Borrow Pit Project.

The extent of the study site is provided in Figure 2-2 with the corner point coordinates provided in Table 2-1.

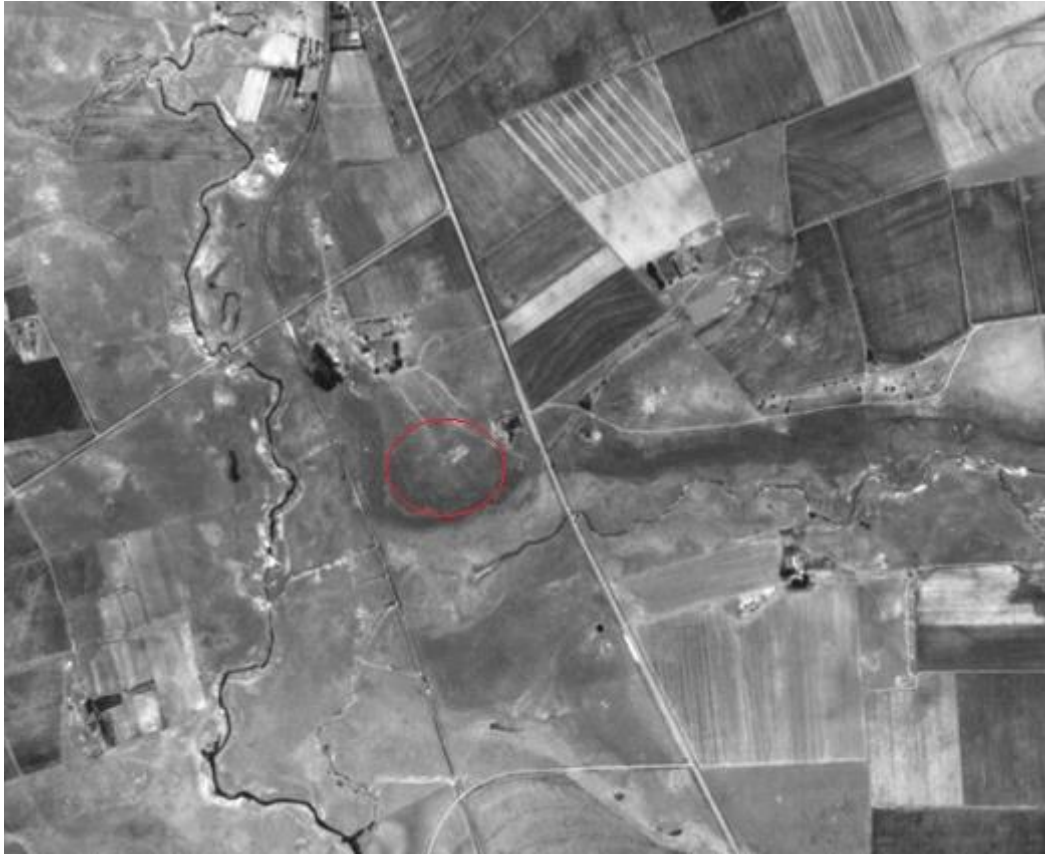
Figure 6-1: Aerial image from 10/05/1979 showing the project area

In Figure 6-3, taken on 10/05/1979 of the area and surrounding landscape it is visible that the site is used for grazing and agricultural use. There is an excavated area already on the site which was likely used previously for the material for road construction and was already by then used for a livestock drinking area.

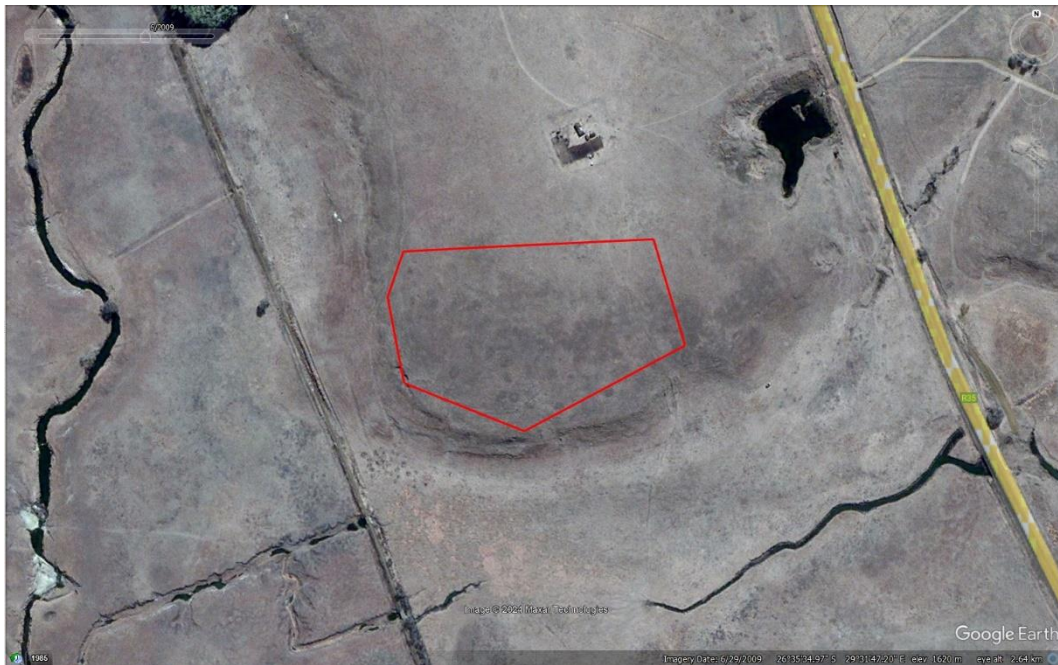
Figure 6-2: Google Earth image dated 06/29/2009.

In Figure 6-3, taken on 06/29/2009 of the area and surrounding landscape it is visible that the site has not changed since the 1970s. The dwellings on site have been constructed. As seen in Figure 6-3 which was taken on 09/06/2011 it is visible that excavation activities have commenced from the previously excavated pit area.

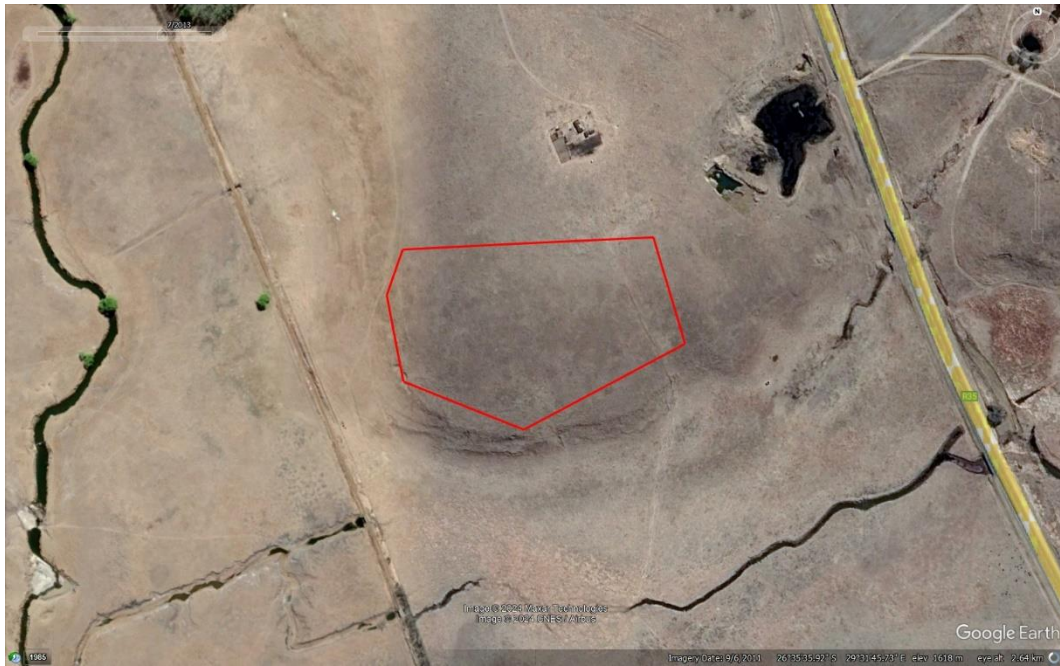
Figure 6-3: Google Earth image dated 09/06/2011.

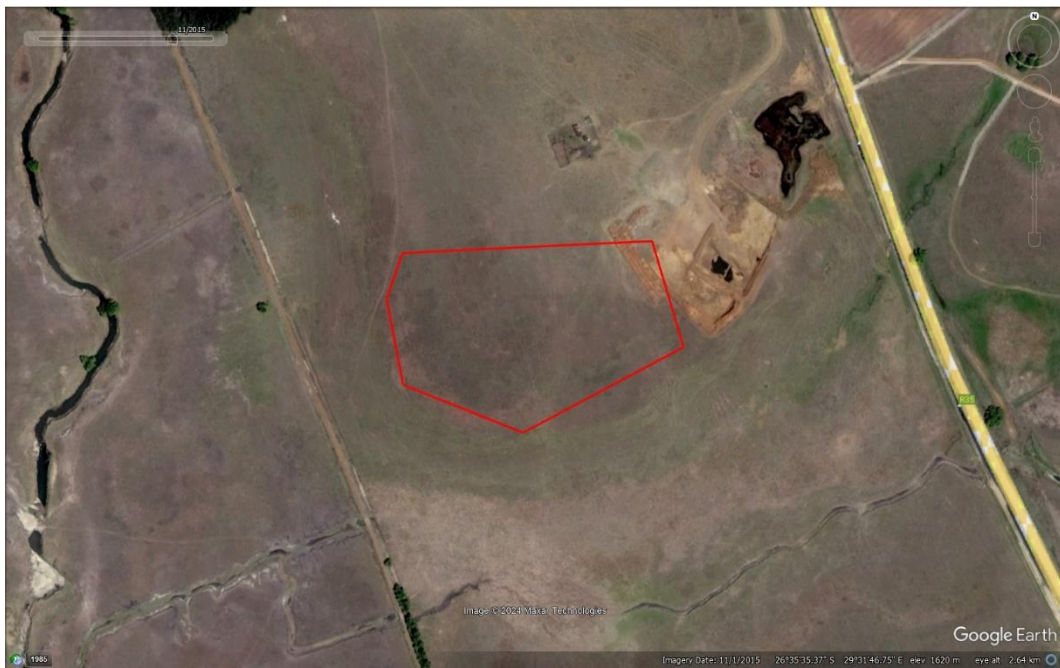
Figure 6-4: Google Earth image dated 11/01/2015.

It is visible from the satellite image taken in 2015 in Figure 6-4 that excavations have been undertaken next to the proposed borrow pit site. The previously excavated area was extended and the currently used access road has been constructed. Stockpiles were placed within the proposed borrow pit area.

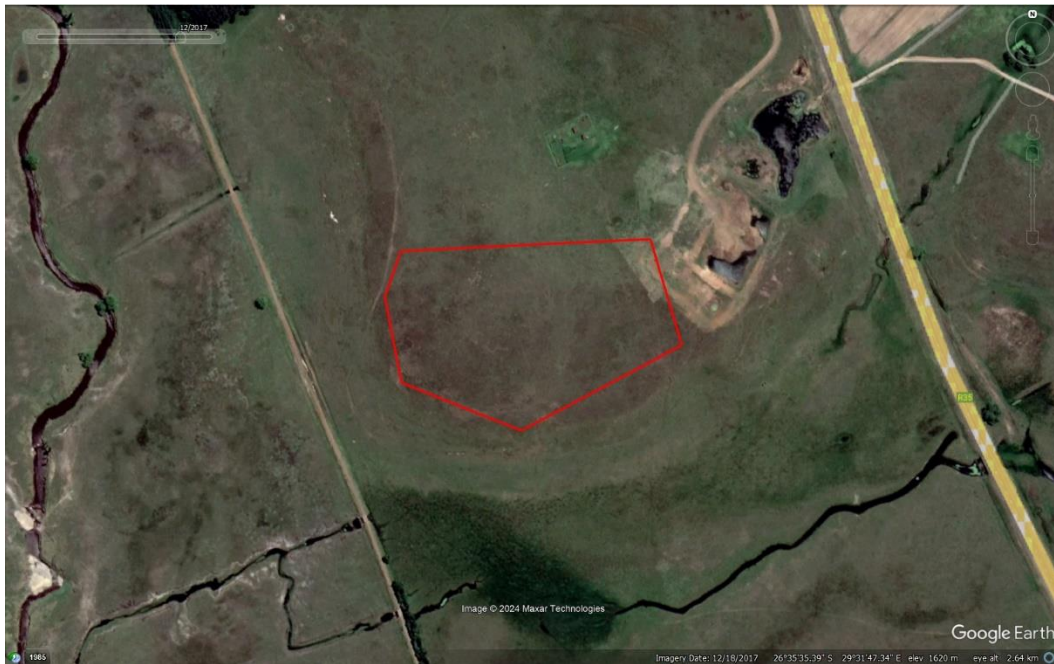
Figure 6-5: Google Earth image dated 12/18/2017.

In Figure 6-5 it is visible that by 2017 the site was rehabilitated, and the dwellings have remained. The dwellings are used by workers on the farm from time to time. Figure 6-6 from 2024, indicates that from 2017 to 2024 there has been no change in land use within the site area. The site is still used for cattle /livestock grazing.

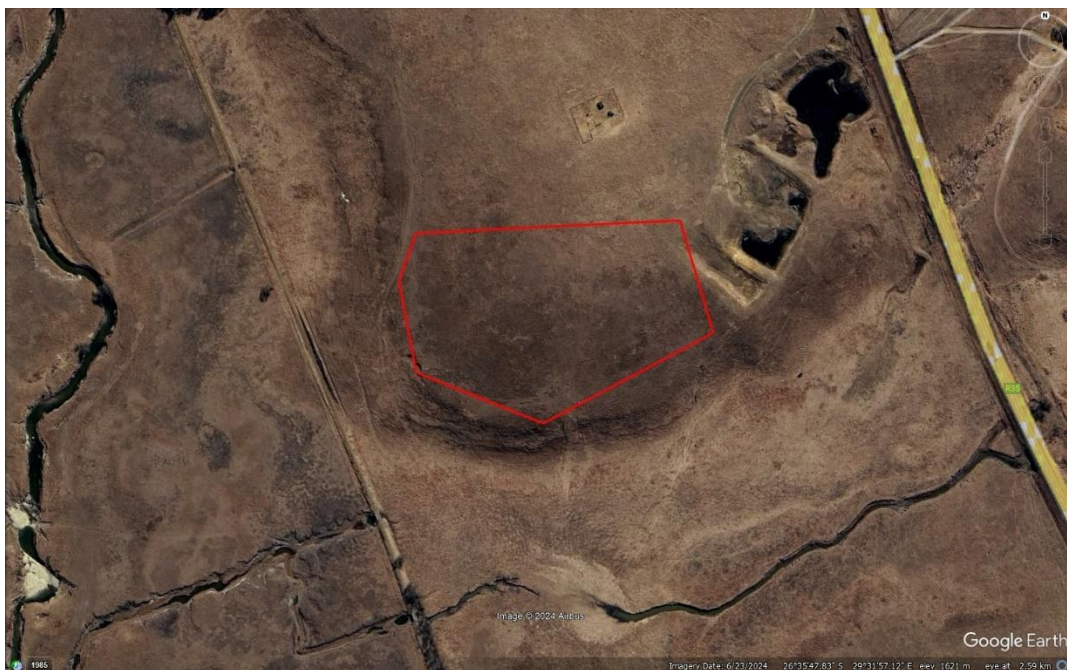
Figure 6-6: Google Earth image dated 06/23/2024.

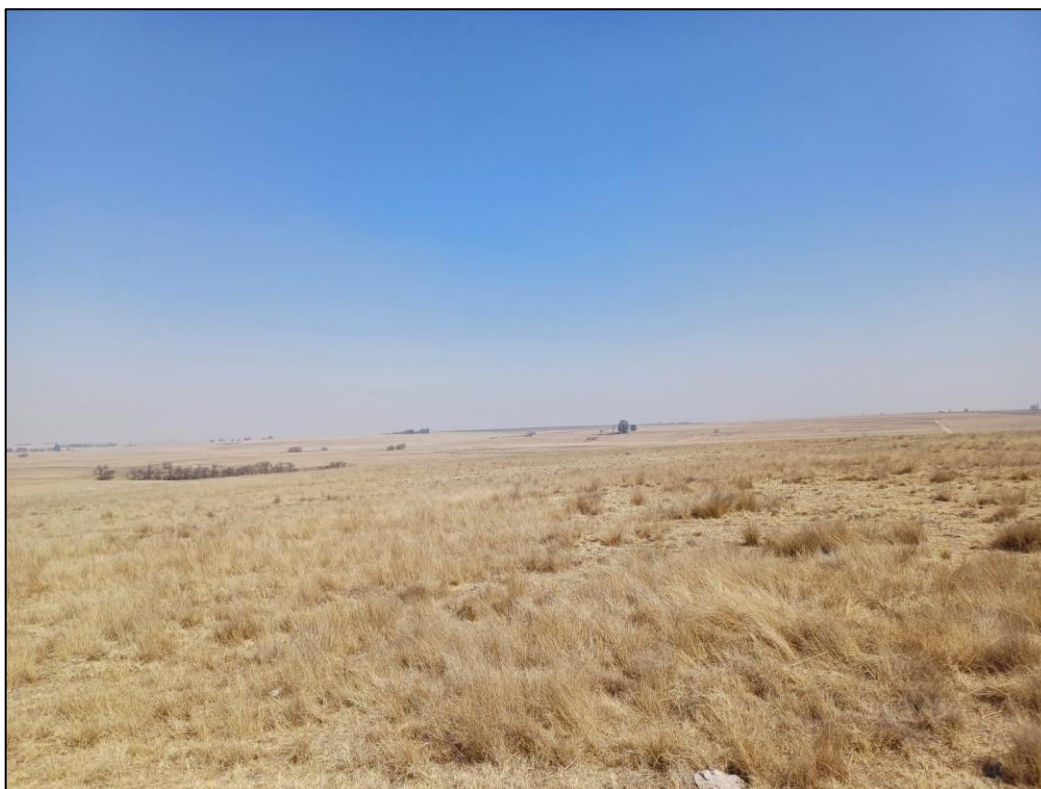
Figure 7-1: Current vegetation on the site area where the proposed borrow pit will be developed.

The vegetation at the project site displays evidence of change, likely due to grazing by livestock and possibly from operations related to the nearby old borrow pit. Figure 7-1 provides a photograph of the current vegetation on the site. Figure 7-2 illustrates the current situation on site and the view towards the R35.

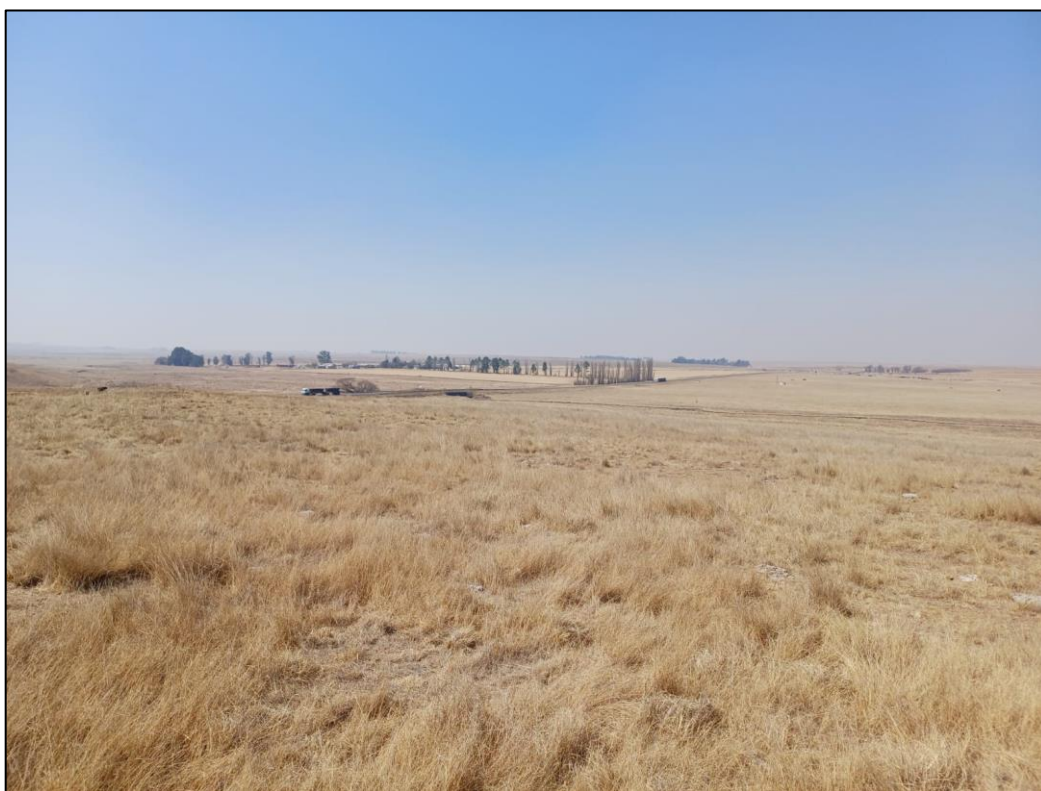
Figure 7-2: Vegetation of the site area towards the R35.

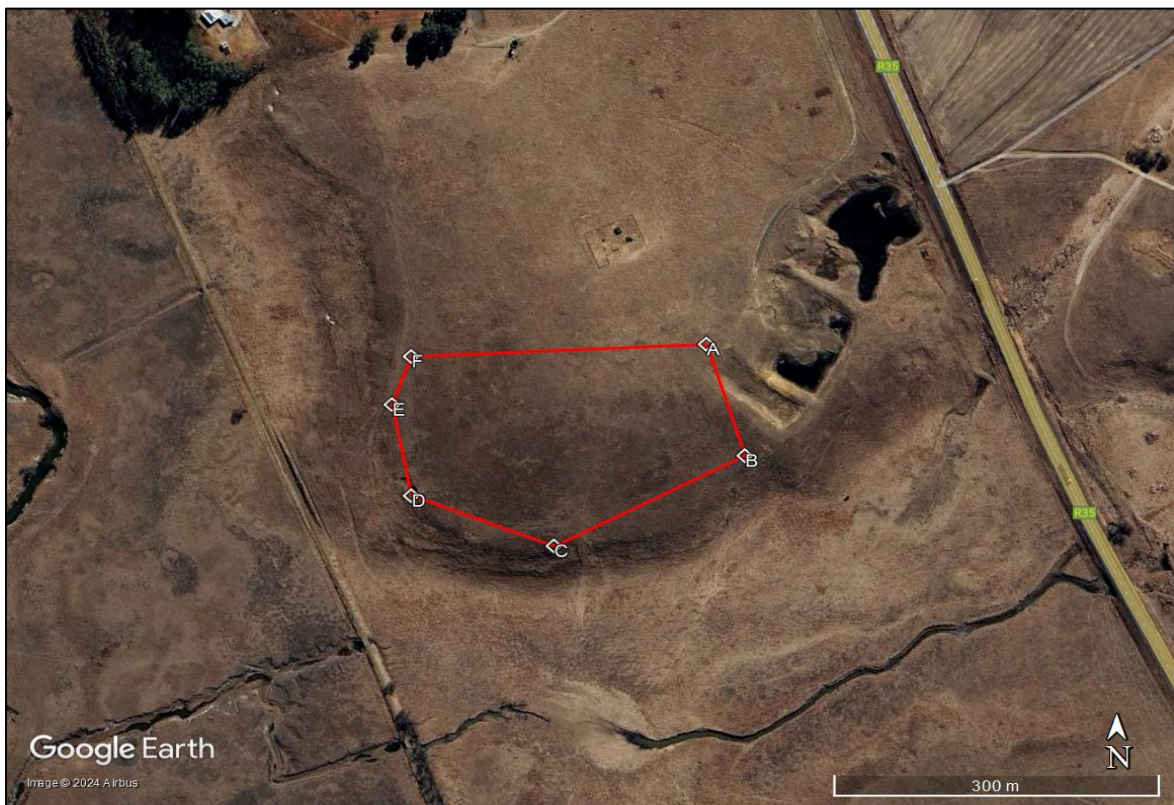
Figure 2-2: Extent of the borrow pit

The proposed borrow pit is located approximately 16km to the southeast of the town of Bethal along the R35 road between Bethal and Morgenzon (see Figure 2-1). To meet the requirements for a Mining Permit Application in accordance with the Mineral and Petroleum Resources Development Act (Act No. 28 of 2002), the extent of the borrow pit is limited to maximum area of 5ha. The corner point coordinates of the borrow pit is provided in Table 2-1 with the extent shown in Figure 2-2.

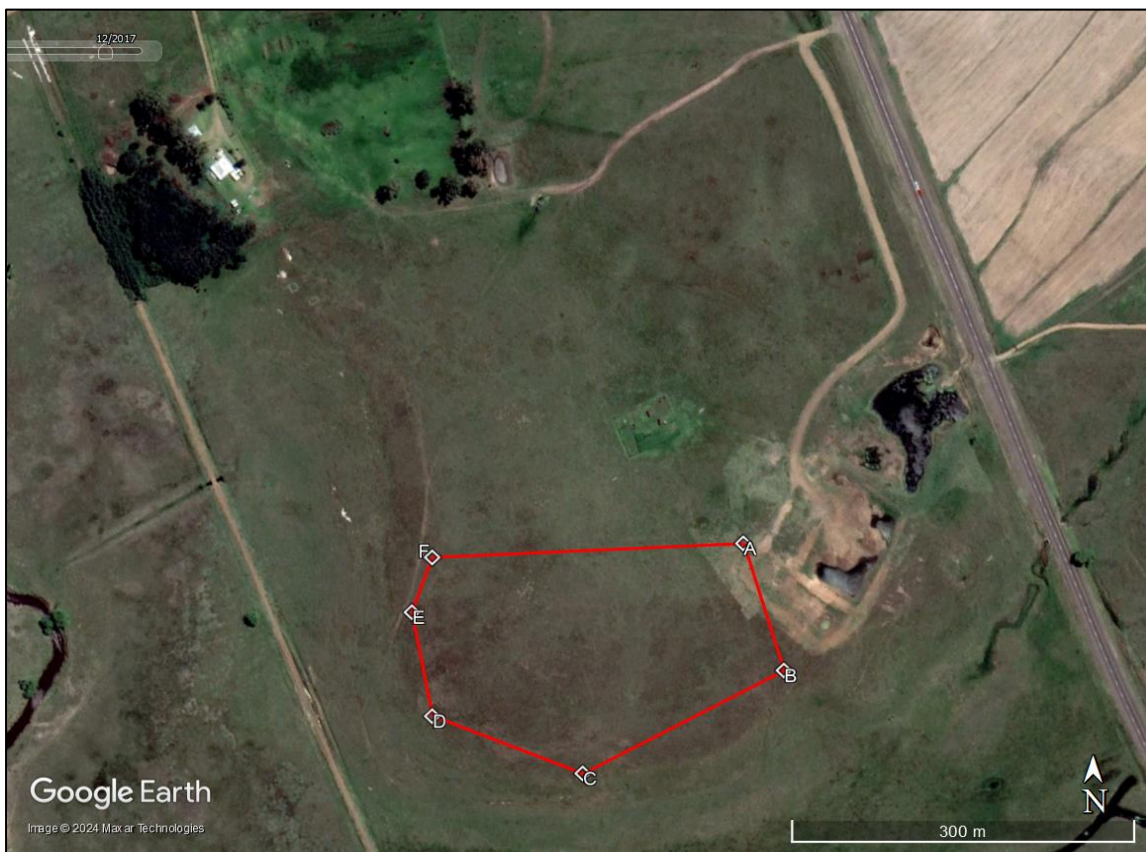
Figure 2-5: Aerial image (2017) in which the old borrow pit area shows signs of use

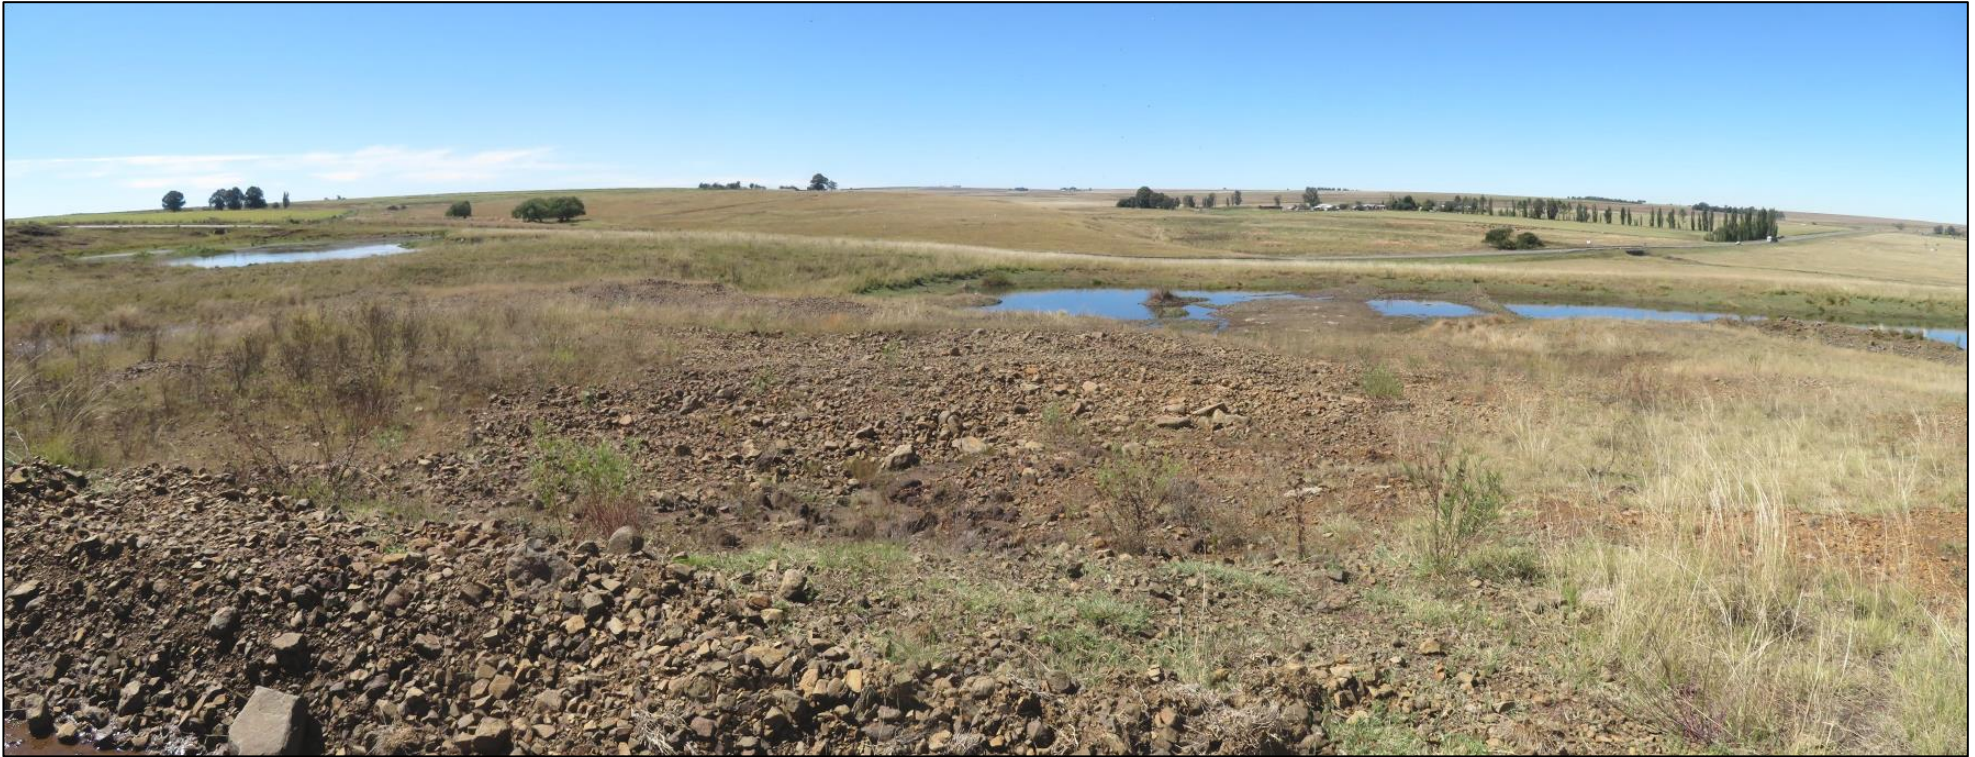
Plate 2-1: View of the existing old borrow pit area, looking in a southerly direction

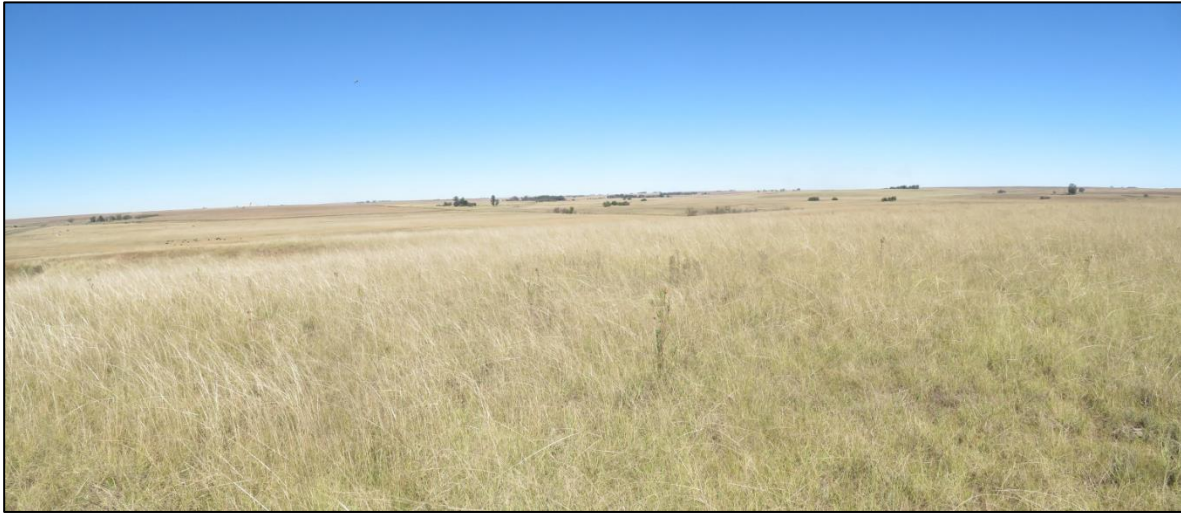
Plate 9-1: View of the vegetation on the project site, looking in a southerly direction

The vegetation on the project site show signs of transformation due to livestock grazing activities and possibly activities associated with the working of the old borrow pit immediately next to the project site. The dominant grass species consists of *Elionurus muticus* (Wire Grass) and *Tristachya leucothrix* (Hairy Trident Grass).

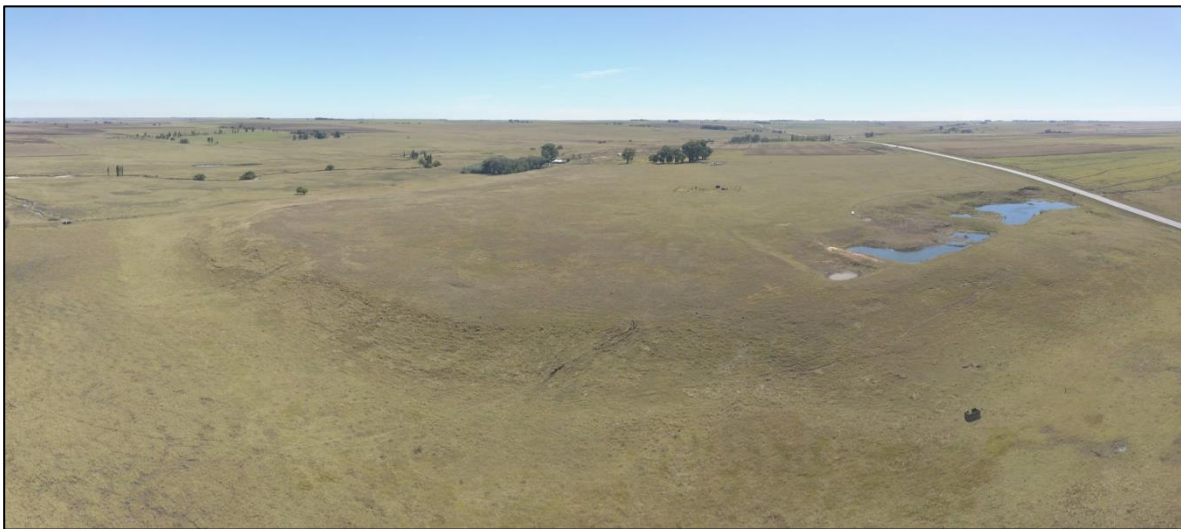
The project site is located on a low, east to west ridge line that forms the northern edge of the Heilveispruit valley. The site is flat and drains in a southerly direction. No significant topographical features occur on the site.

Plate 9-2: Aerial view of the project site showing the topography, looking in a northerly direction

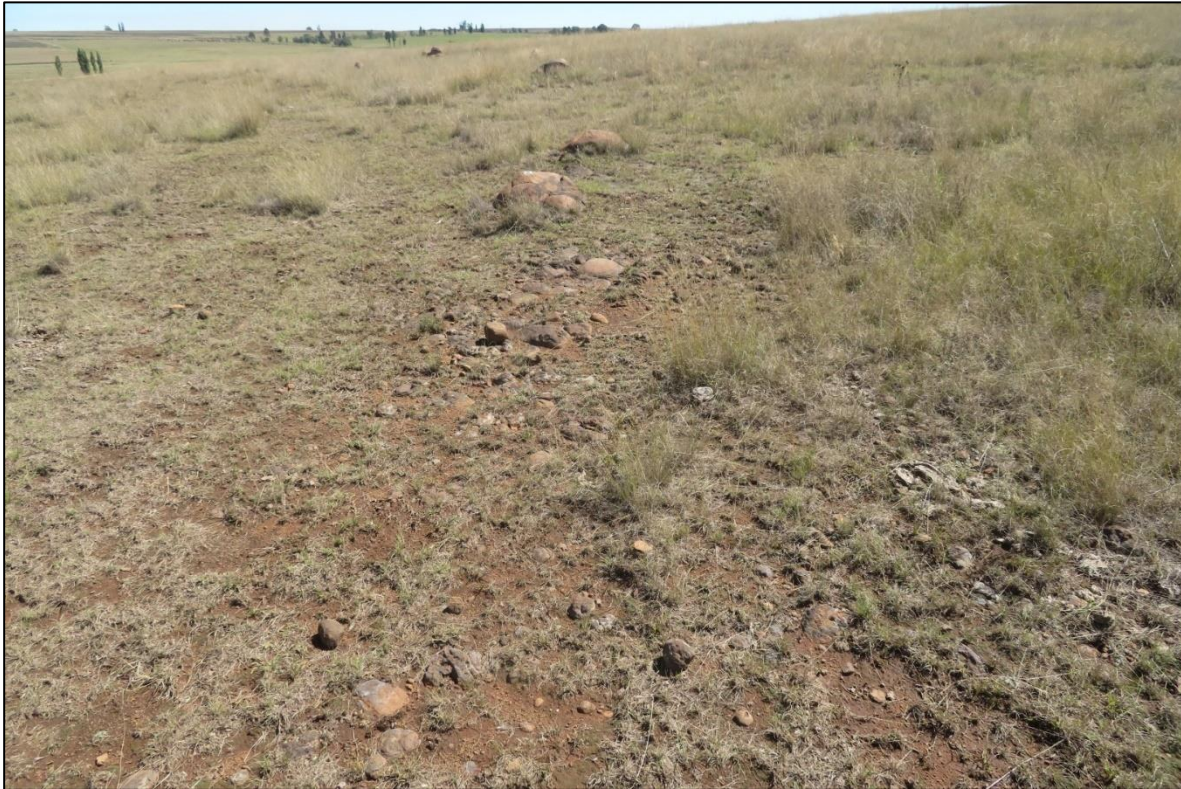
Plate 9-3: View of the weathered dolerite at or near the surface in the project site

The land use surrounding the project site largely consists of agricultural activities made up of veldt grazing of livestock and cultivation of maize, soyabeans and other crops in rotation. These practices have been present in the surrounding areas for decades. The land use on the project site consists of open veldt grazing. The area has not been ploughed and planted likely due to the presence of the weathered dolerite at surface that covers the majority of the site.

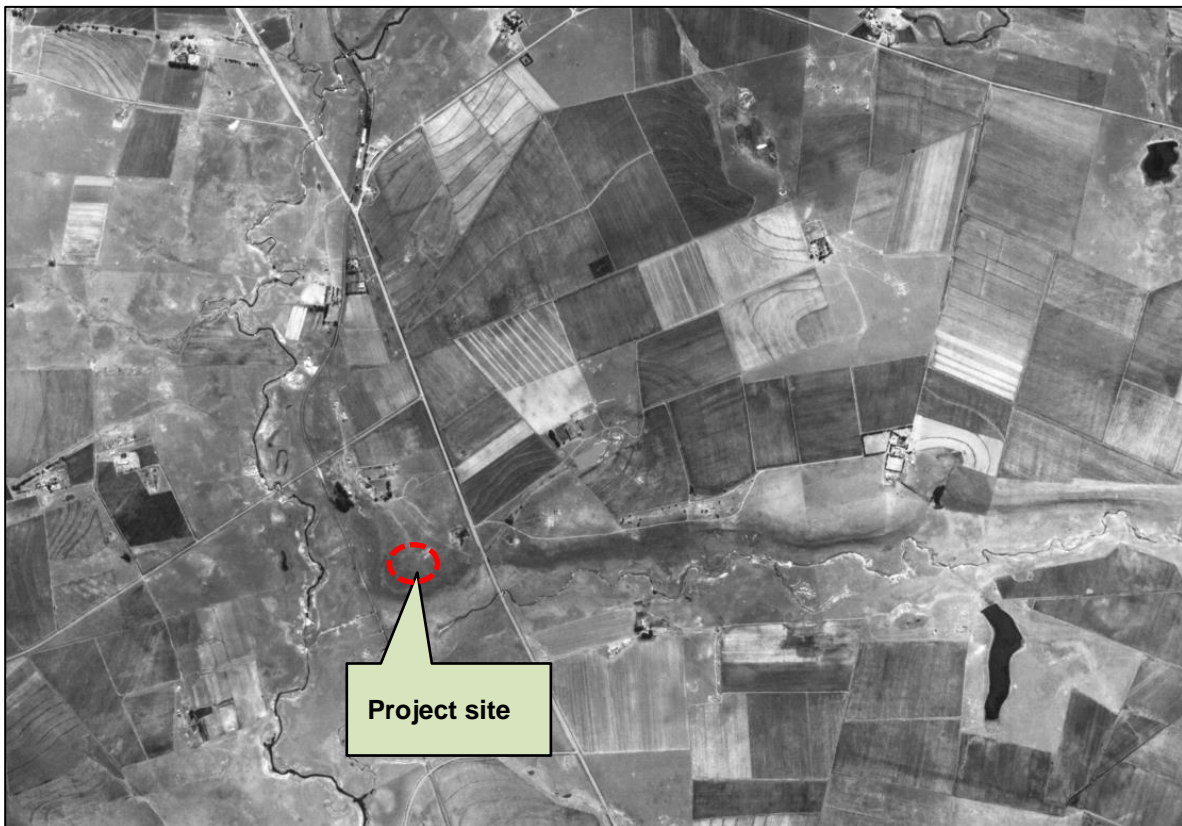
Figure 9-3: Dated aerial image (1979) of the project site showing the cultivated areas surrounding the site

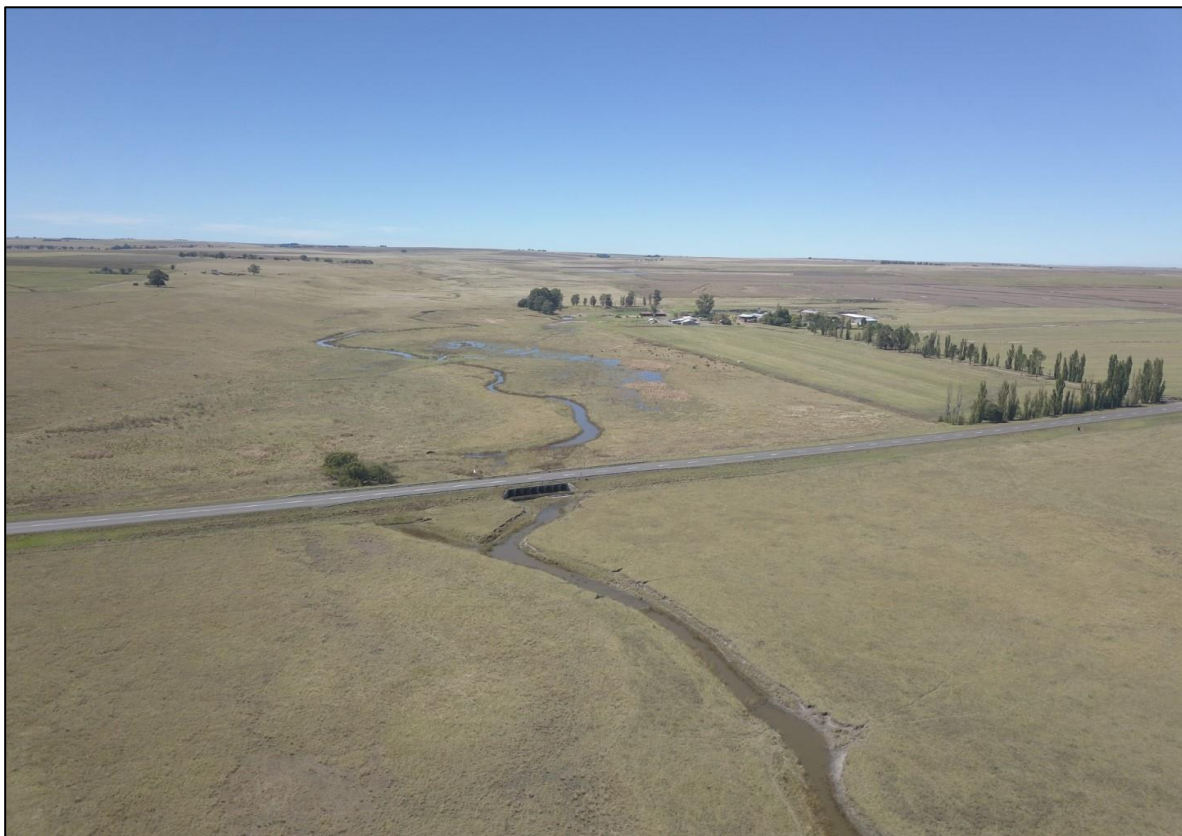
Plate 11-1: Aerial view of the Channelled Valley Bottom (CVB) associated with the Heilvleispruit

The site assessment confirmed the absence of any natural wetland features within the boundaries of the project site. Furthermore, it identified three wetland features, one a Floodplain wetland (FP) associated with the Kwaggalaagte River, one a Channelled Valley Bottom wetland (CVB) associated with the Heilvleispruit and a Seep wetland (SP) within a 500m radius of the project site. The location of these features is indicated in Figure 11-1.
