Draft Basic Assessment Report

Umbila Emoyeni Borrow Pit Application,

GCS Project Number: 23-0766

BASIC ASSESSMENT REPORT And ENVIRONMENTAL MANAGEMENT PROGRAMME REPORT

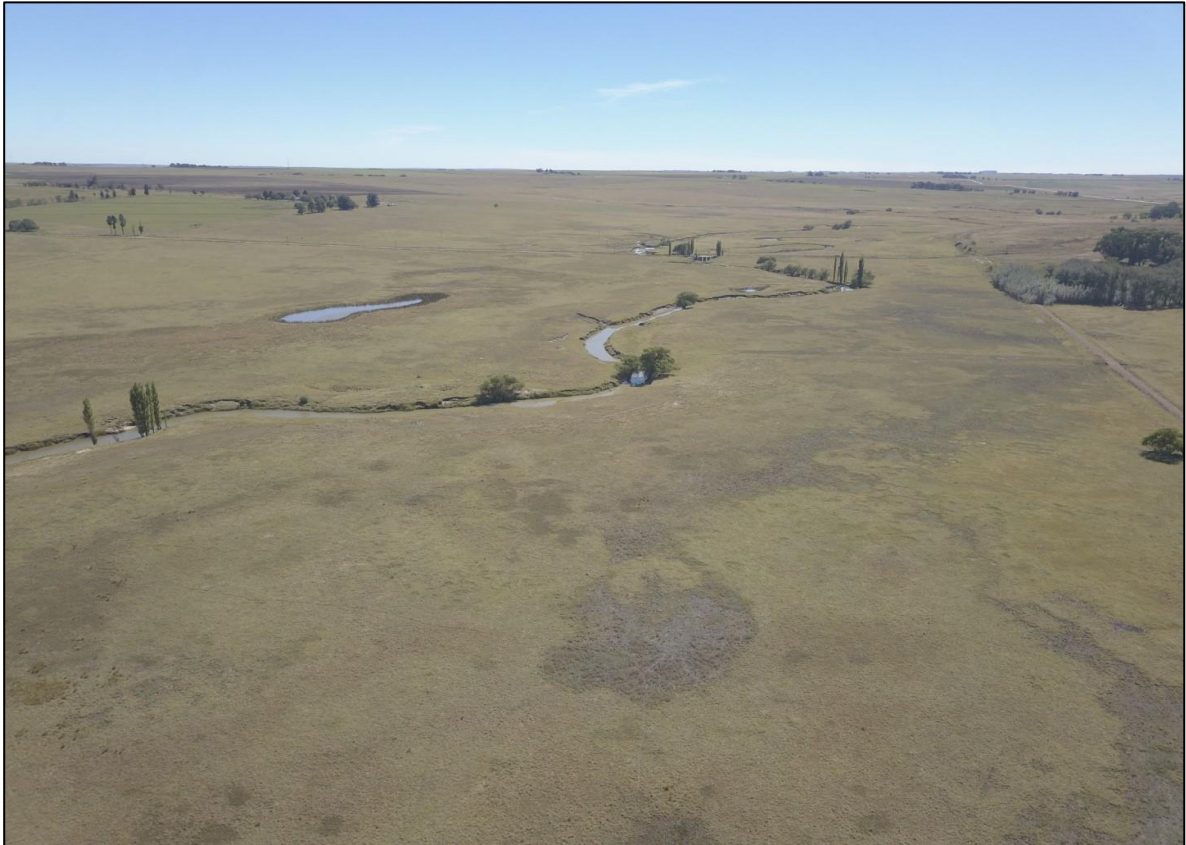
Plate 11-2: Aerial view of the Flood Plain (FP) associated with the Kwaggalaagte River

The site assessment confirmed the absence of any natural wetland features within the boundaries of the project site. Furthermore, it identified three wetland features, one a Floodplain wetland (FP) associated with the Kwaggalaagte River, one a Channelled Valley Bottom wetland (CVB) associated with the Heilvleispruit and a Seep wetland (SP) within a 500m radius of the project site. The location of these features is indicated in Figure 11-1.

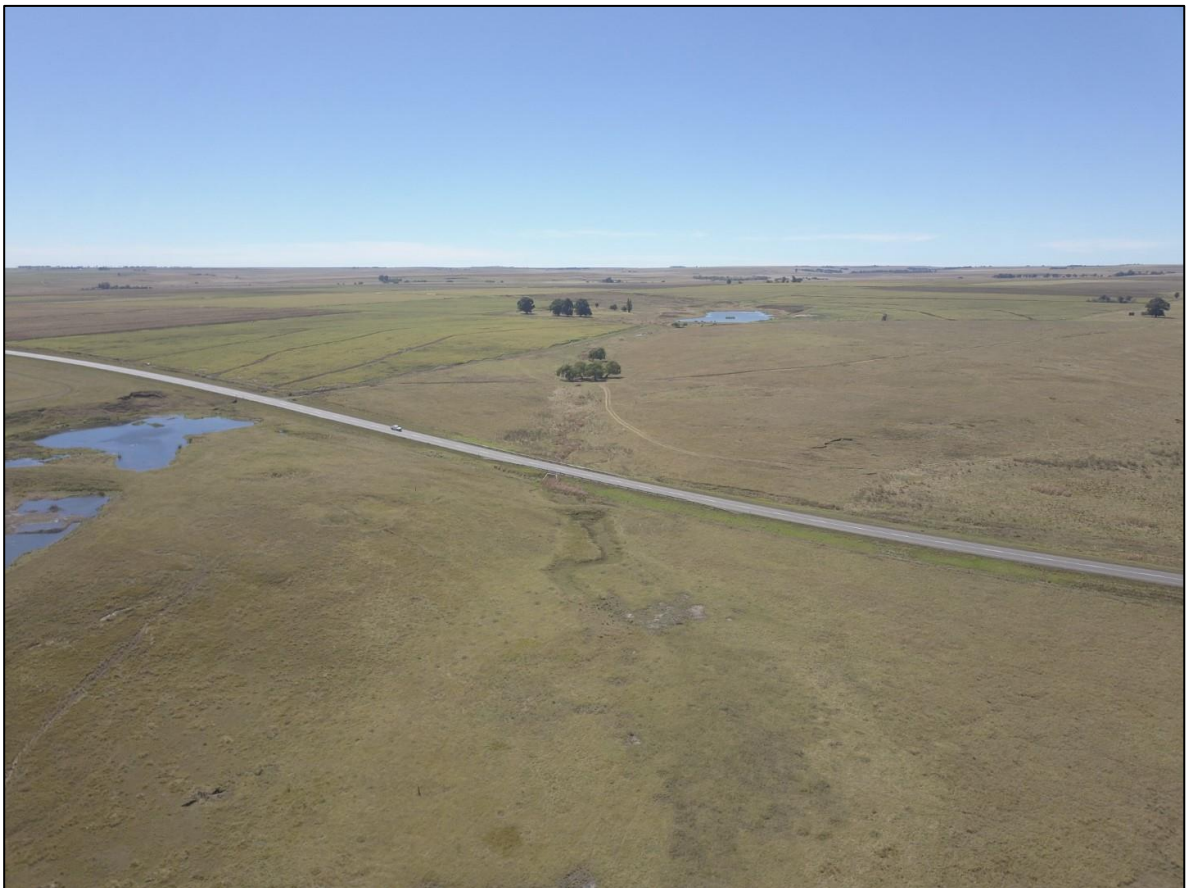
Plate 11-3: Aerial view of the Seep (SP)

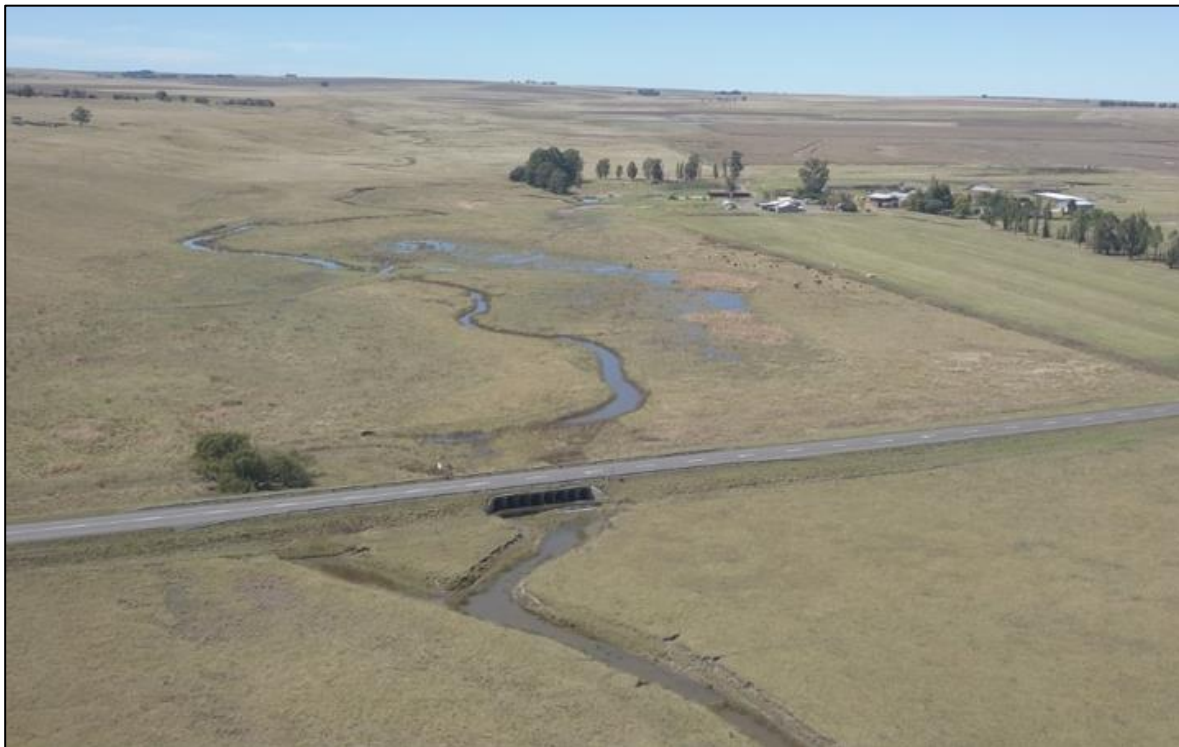
Plate 11-5: Aerial view of the road and culvert crossing through the Channelled Valley Bottom

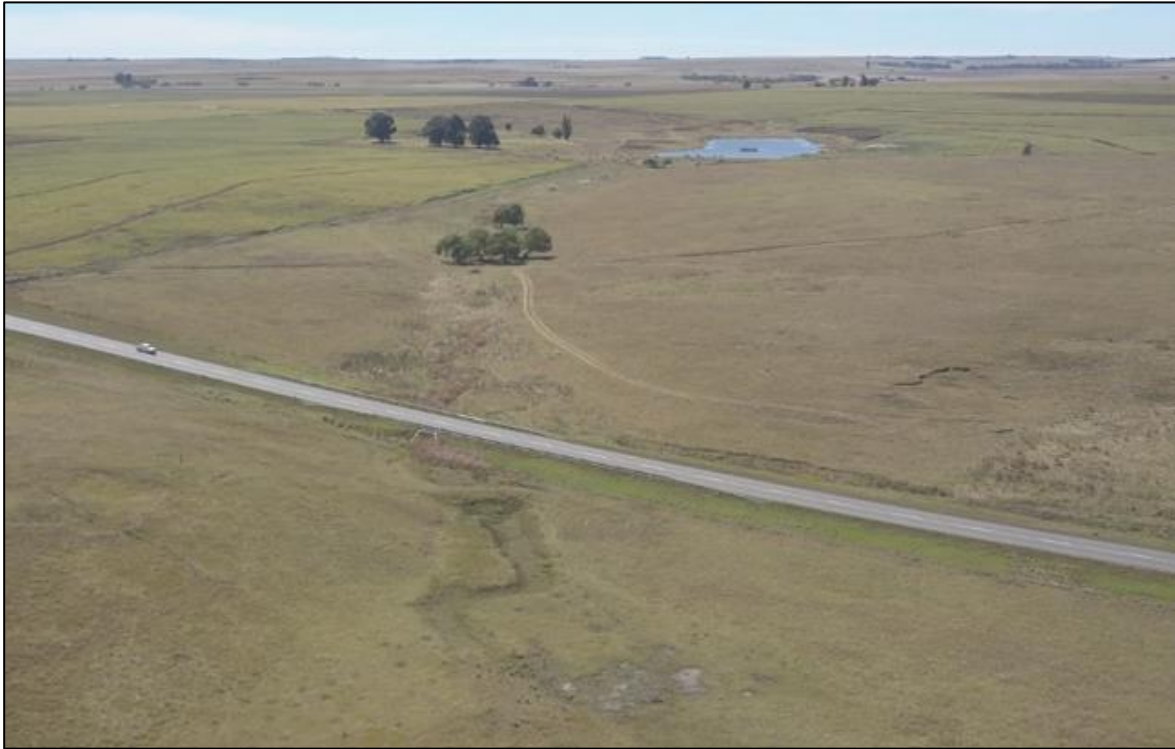
Plate 11-6: Aerial view of the culvert and road crossing the Seep as well as the dam and impoundment area

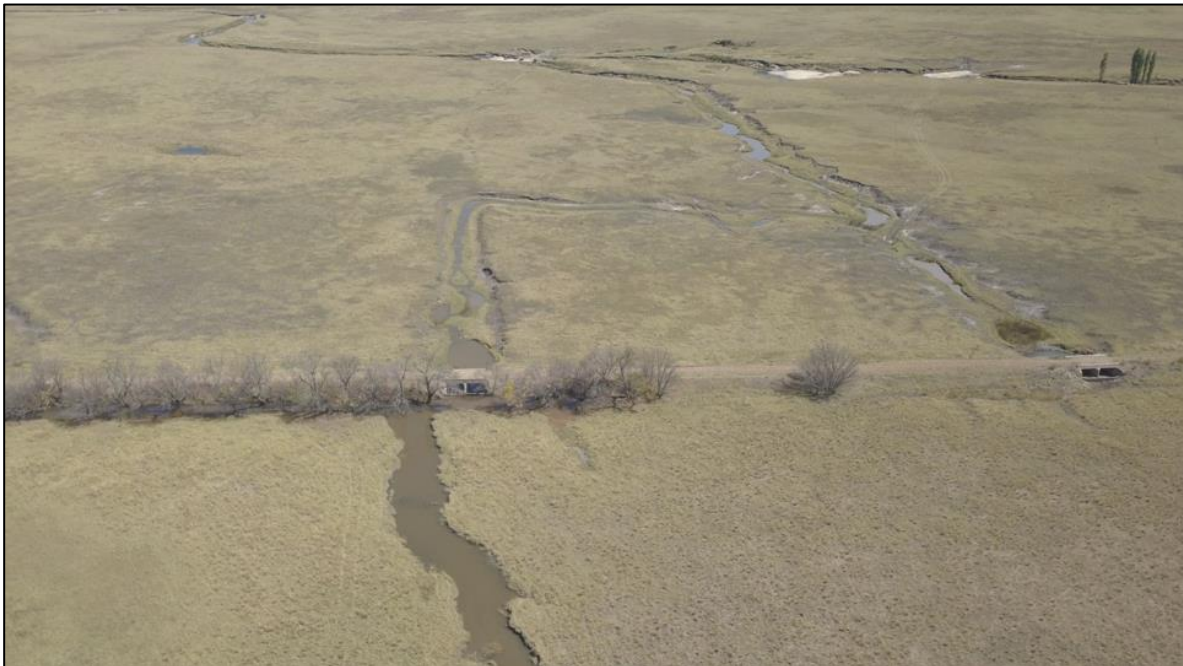
Plate 11-7: Aerial view of the railway and culvert crossings in the Flood Plain as well as the canalised water flow

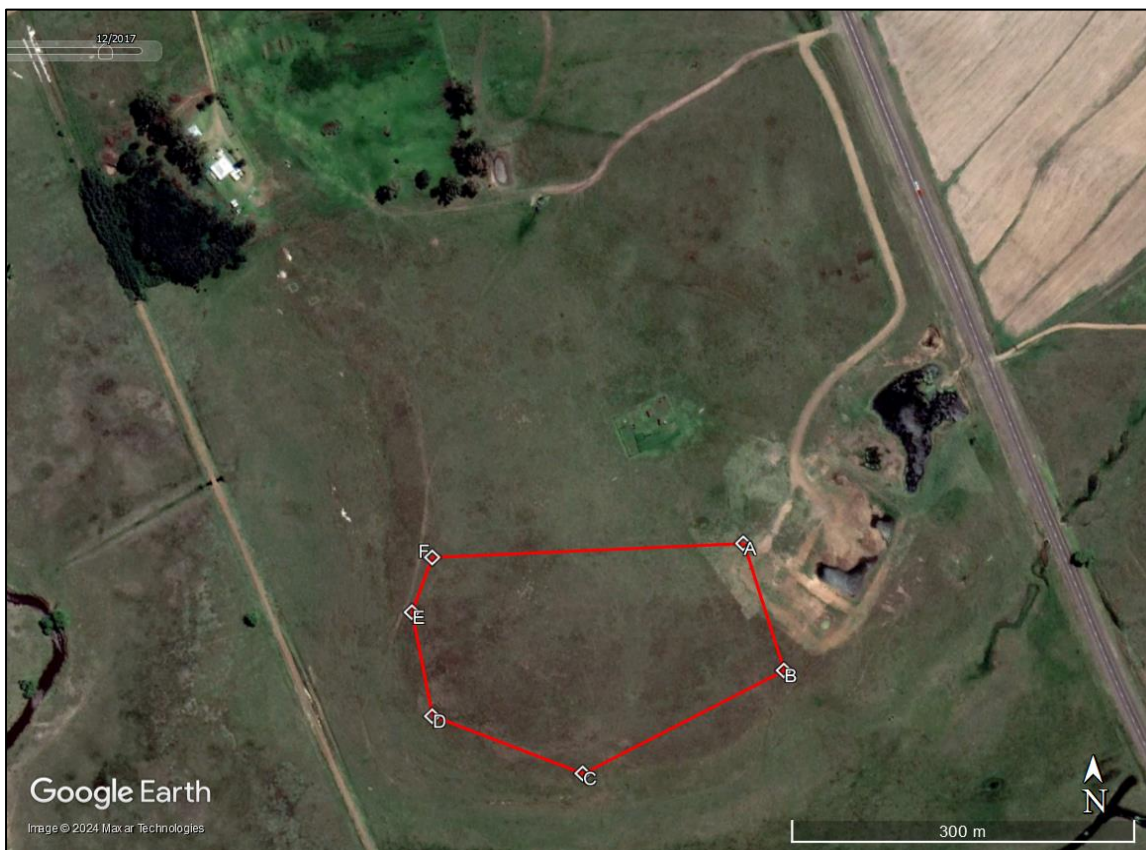
Figure 2-5: Aerial image (2017) in which the old borrow pit area shows signs of use

The proposed borrow pit is located immediately to the west of an old borrow pit area that was opened *circa* 1968 (see Figure 2-4) and showing signs of use as recent as 2017 (see Figure 2-5). The material sourced from the borrow pit area was likely used for the upgrading of the provincial district roads in the area by the provincial roads' authority.

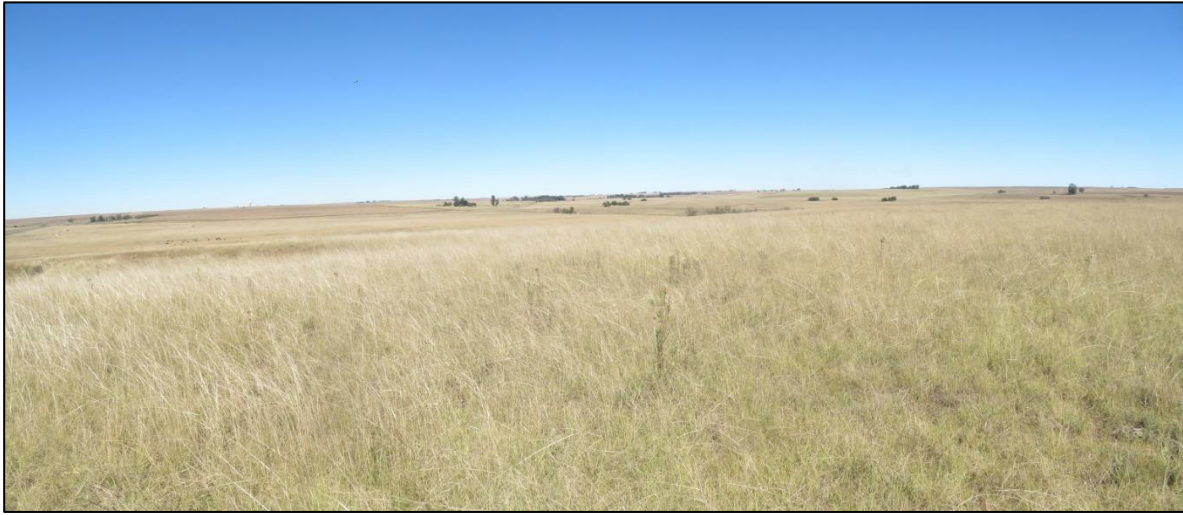
Plate 9-1: View of the vegetation on the project site, looking in a southerly direction

The vegetation on the project site show signs of transformation due to livestock grazing activities and possibly activities associated with the working of the old borrow pit immediately next to the project site. The dominant grass species consists of *Elionurus muticus* (Wire Grass) and *Tristachya leucothrix* (Hairy Trident Grass).

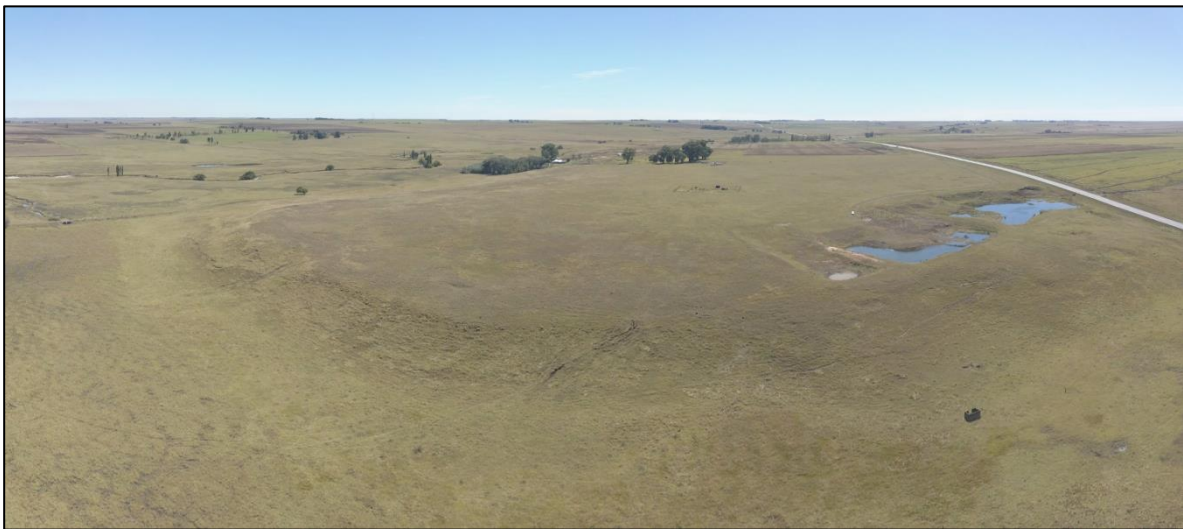
Plate 9-2: Aerial view of the project site showing the topography, looking in a northerly direction

The project site is located on a low, east to west ridge line that forms the northern edge of the Heilveispruit valley. The site is flat and drains in a southerly direction. No significant topographical features occur on the site.

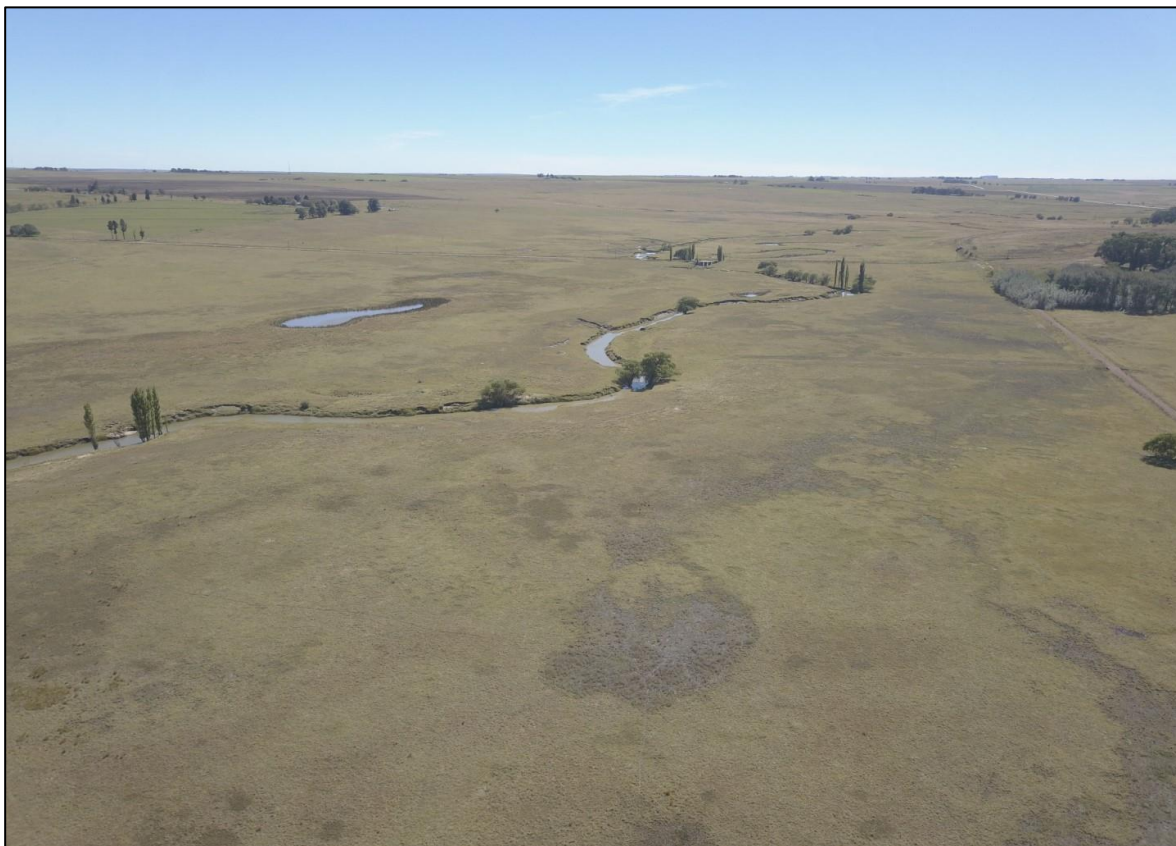
Plate 11-2: Aerial view of the Flood Plain (FP) associated with the Kwaggalaagte River

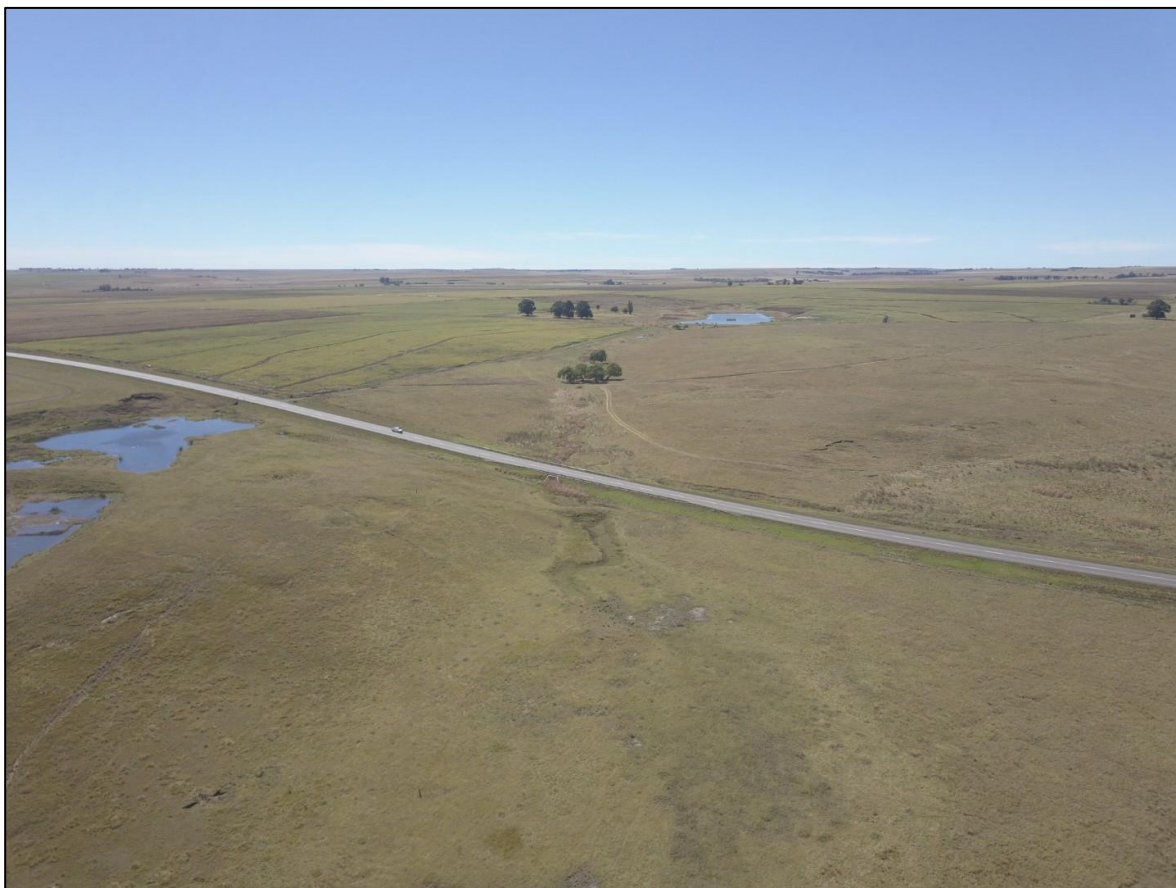
Plate 11-3: Aerial view of the Seep (SP)

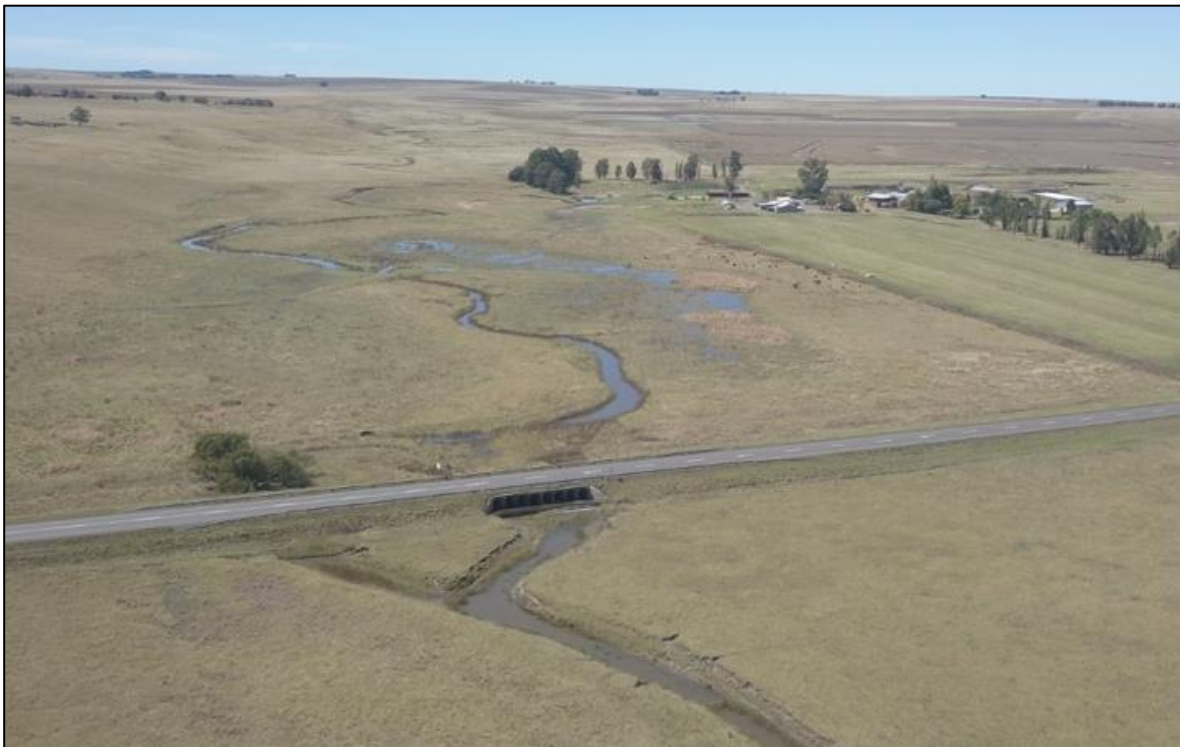
Plate 11-5: Aerial view of the road and culvert crossing through the Channelled Valley Bottom

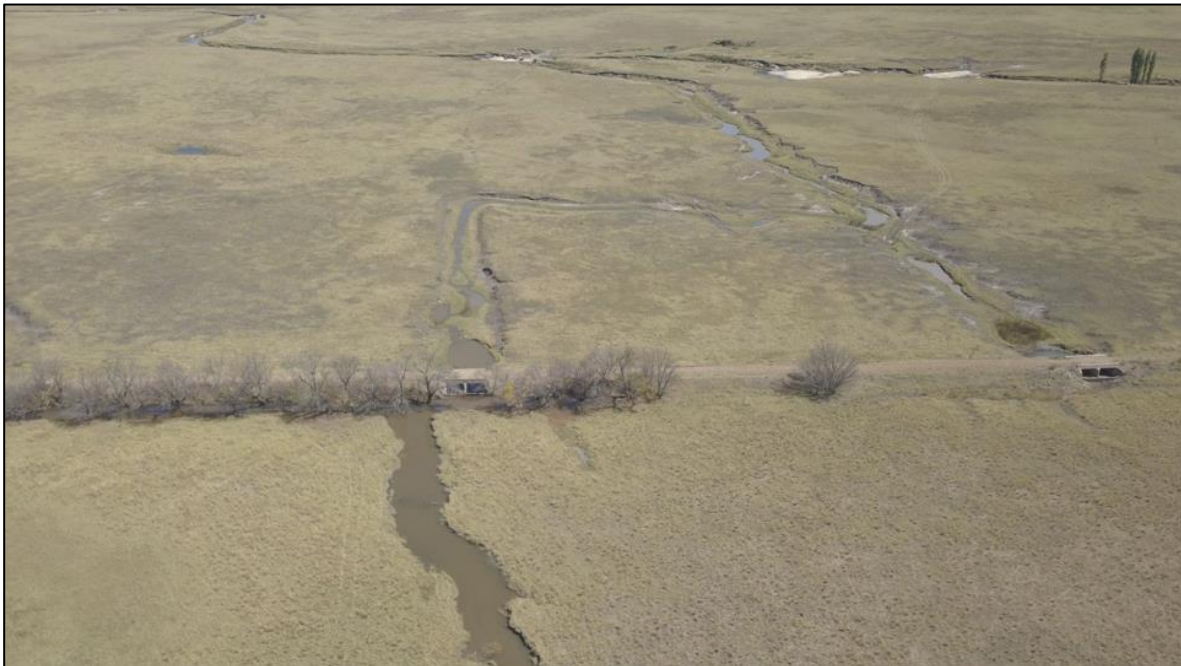
Plate 11-7: Aerial view of the railway and culvert crossings in the Flood Plain as well as the canalised water flow
