# Umbila Emoyeni Borrow Pit Water Use Licence Technical Report

Version -Final

15 August 2025

GCS Project Number:23-0766

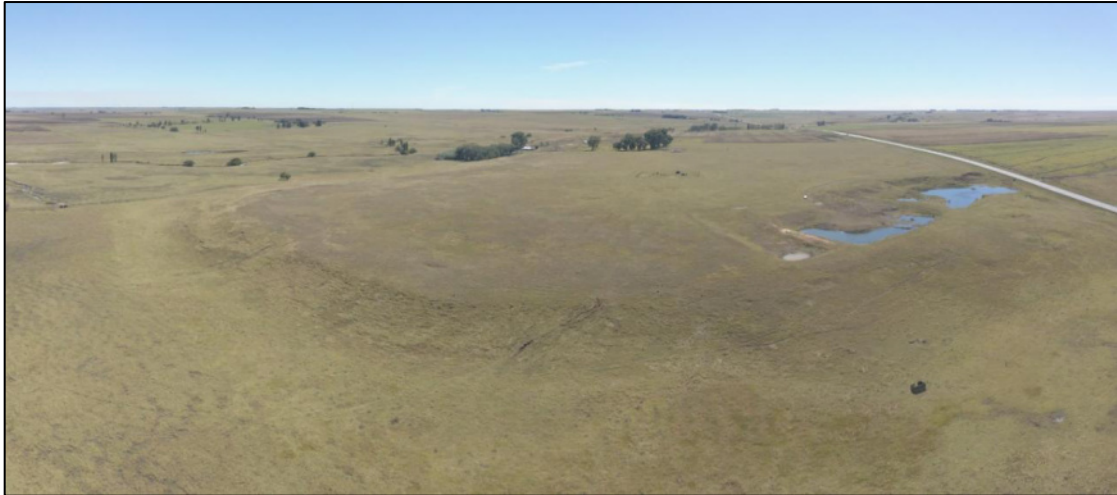
The project site is situated on a low east-west ridge line forming the northern boundary of the Heilvleispruit Valley (Figure 4-2). The terrain is generally flat, with surface drainage flowing southwards. No significant topographical features are present on the site.

**Figure 4-2: Aerial view of the project site showing the topography, looking in a northerly direction**

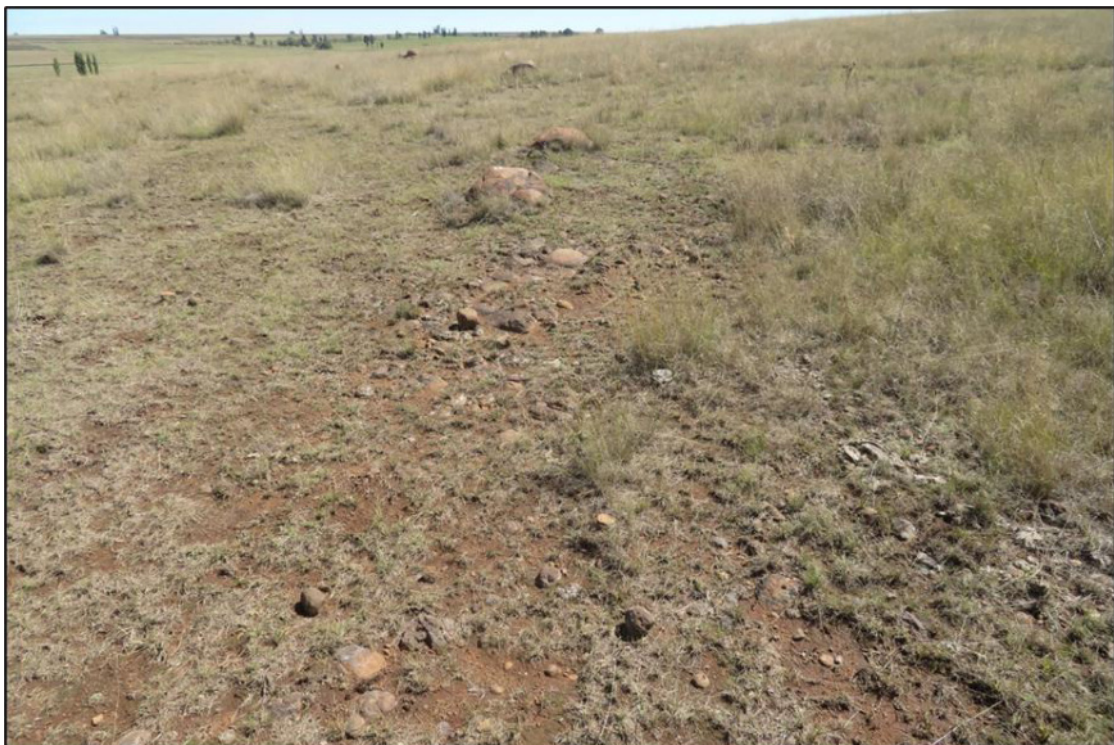
**Figure 4-3: View of the weathered dolerite at or near the surface in the project site**

The land surrounding the project site is predominantly used for agricultural purposes, including livestock grazing and the cultivation of maize, soybeans, and other rotational crops (Figure 4-4). These farming practices have been established in the area for decades. The project site itself is currently used for grazing and has not been ploughed or planted, likely due to the presence of surface weathered dolerite (Figure 4-3), which covers much of the site.

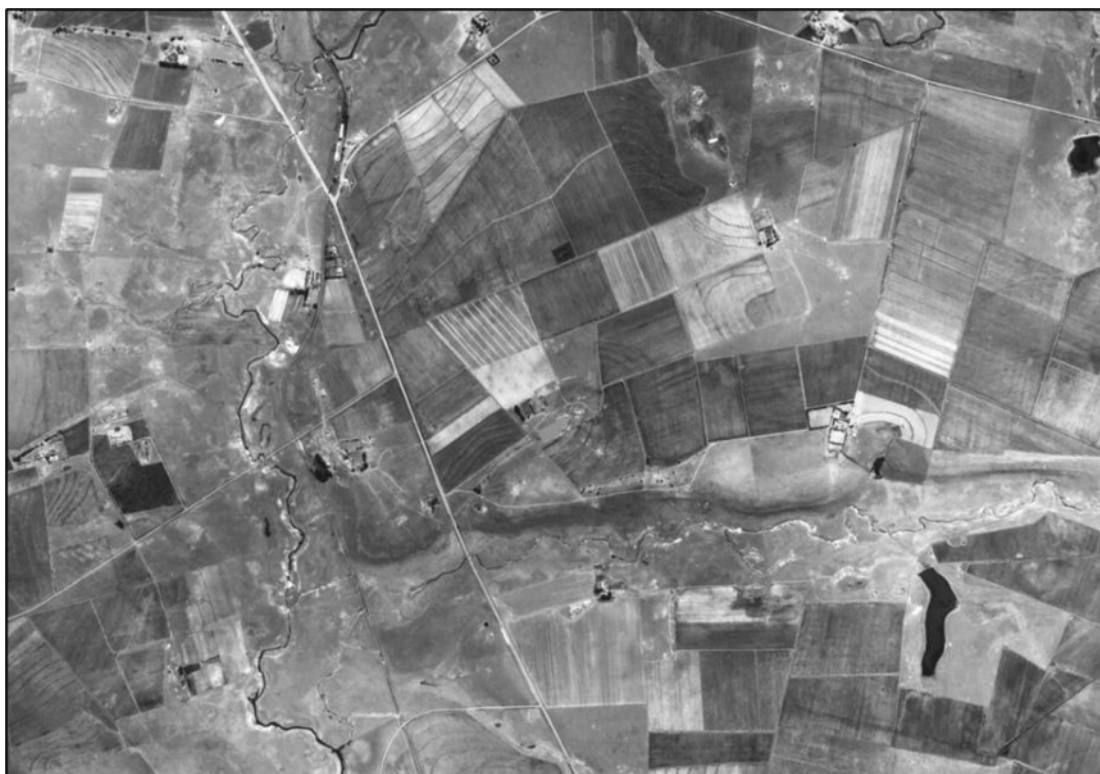
**Figure 4-4: Dated aerial image (1979) of the project site showing the cultivated areas surrounding the site**

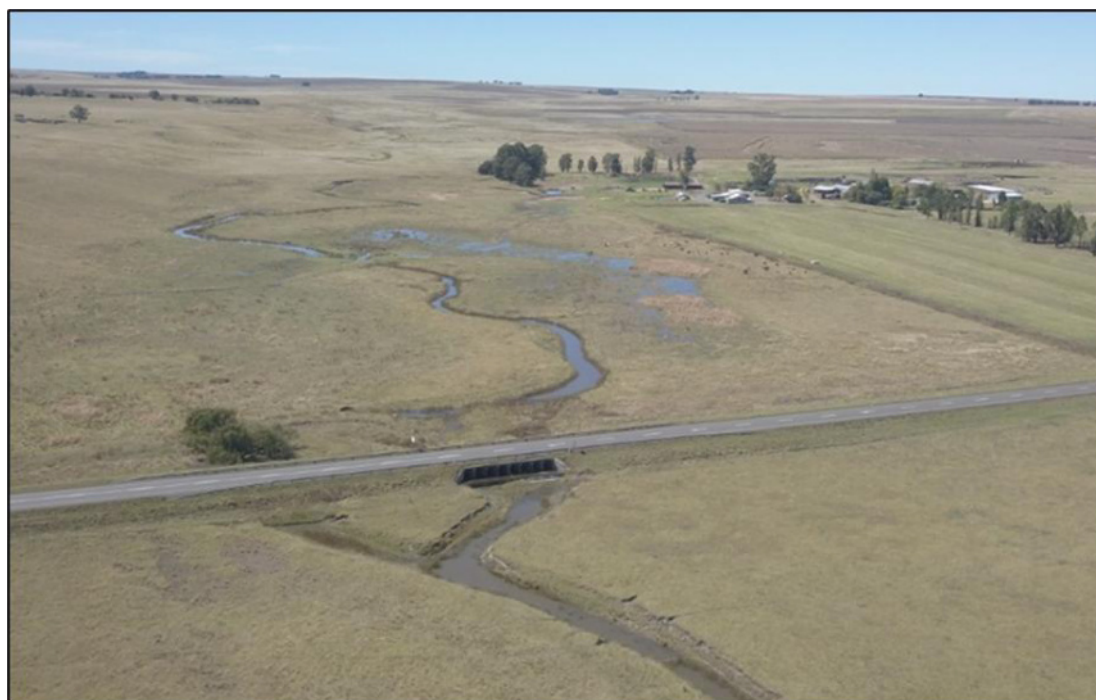
Figure 5-3: Aerial view of the road and culvert crossing through the Channelled Valley Bottom

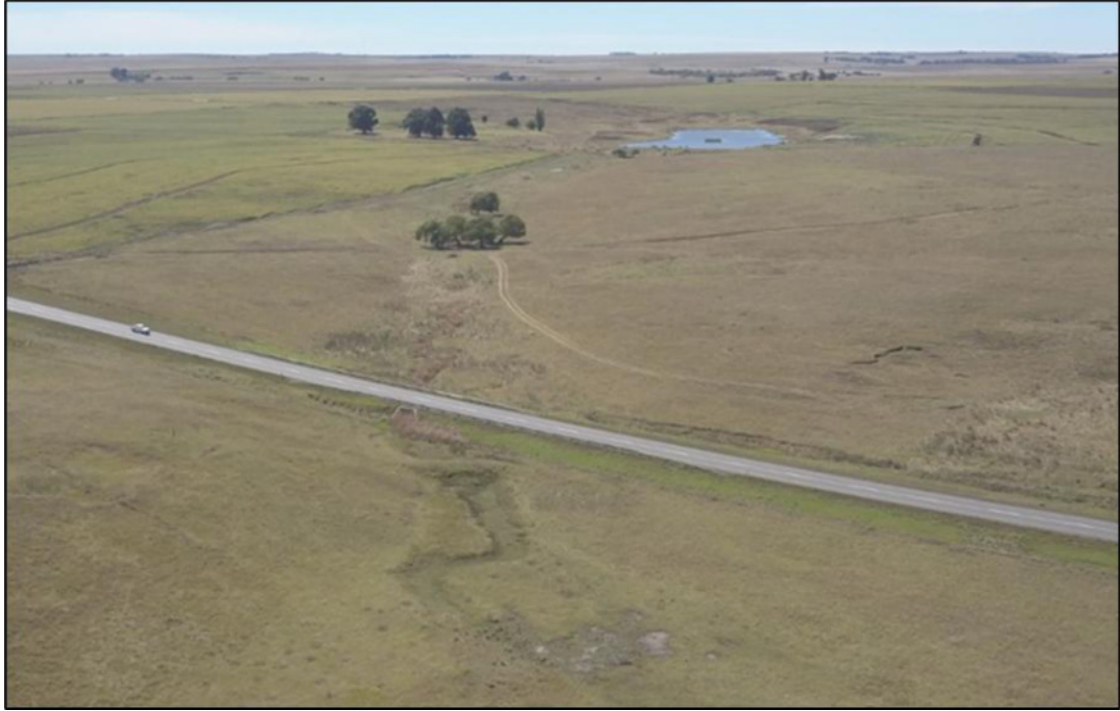
**Figure 5-4: Aerial view of the culvert and road crossing the Seep as well as the dam and impoundment area**

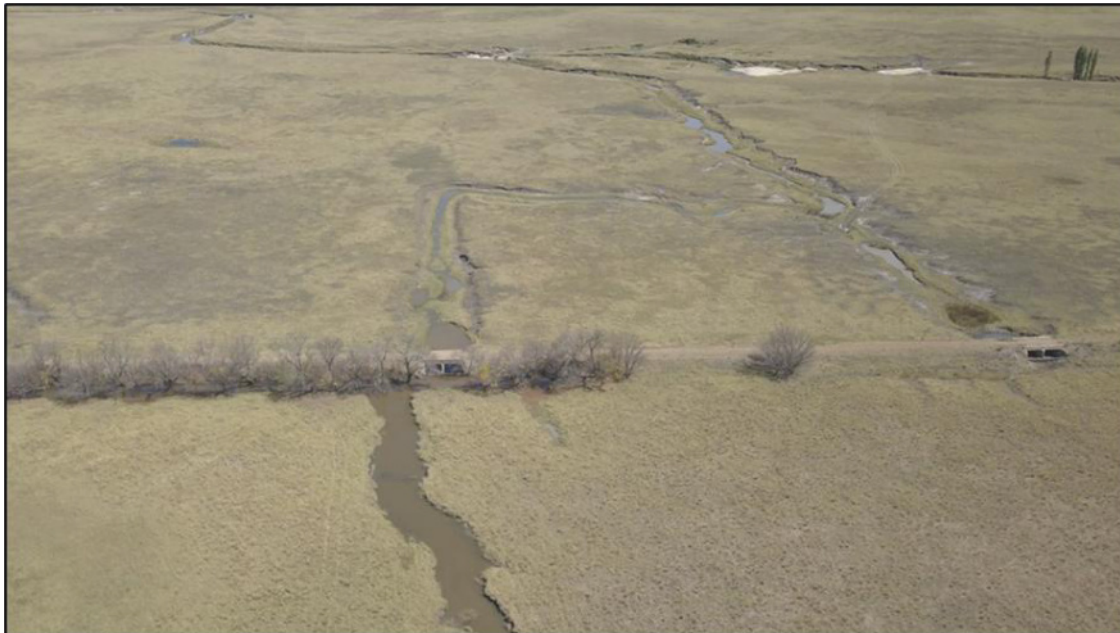
**Figure 5-5: Aerial view of the railway and culvert crossings in the Flood Plain as well as the canalised water flow**

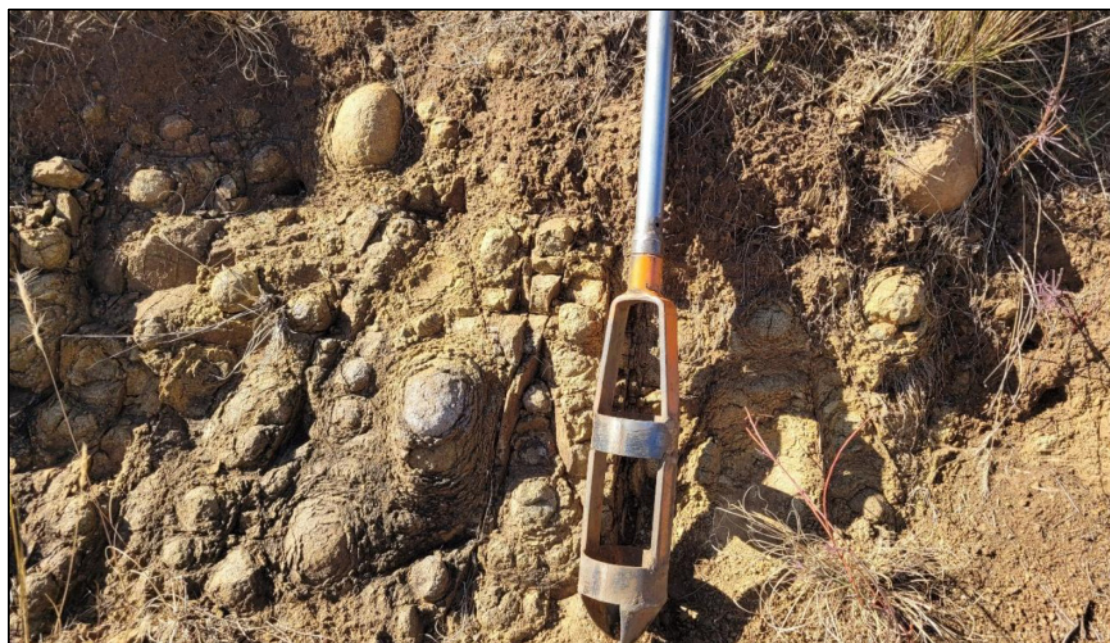
**Figure 5-11: Mispah/Glenrosa Soil Profile**

Soil Form	Hydropedological Group
Tukulu (Figure 5-12)	Interflow (Soil/Bedrock)
Glenrosa/Mispah (Figure 5-11)	Responsive (Shallow)
Hydromorphic (Figure 5-13)	Responsive (Saturated)

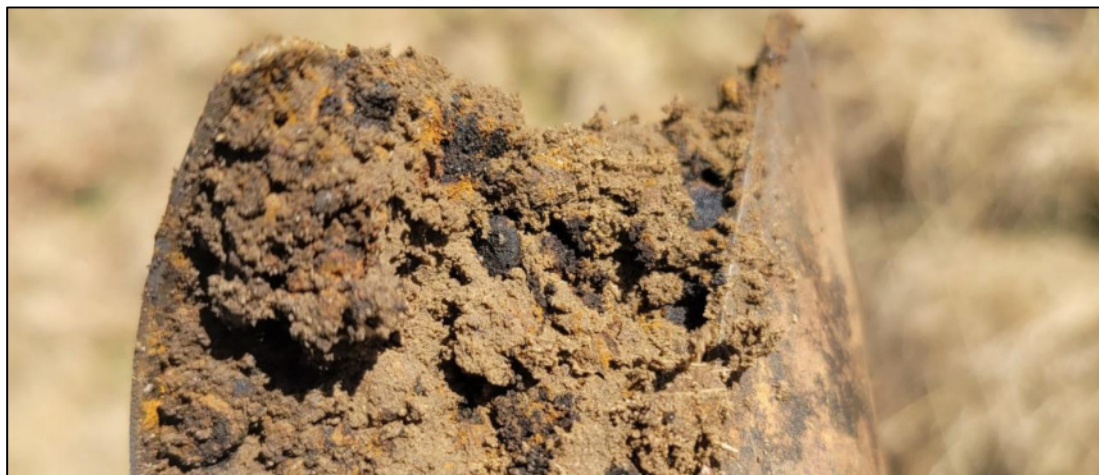
**Figure 5-12: Plinthic Concretions in the Lower Soil Profile of the Tukulu soil**

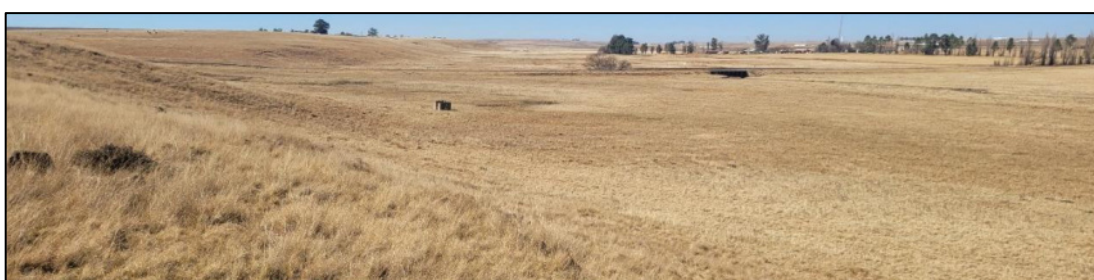
**Figure 5-13: Hydromorphic Wetland System in Valley Bottom Landscape**

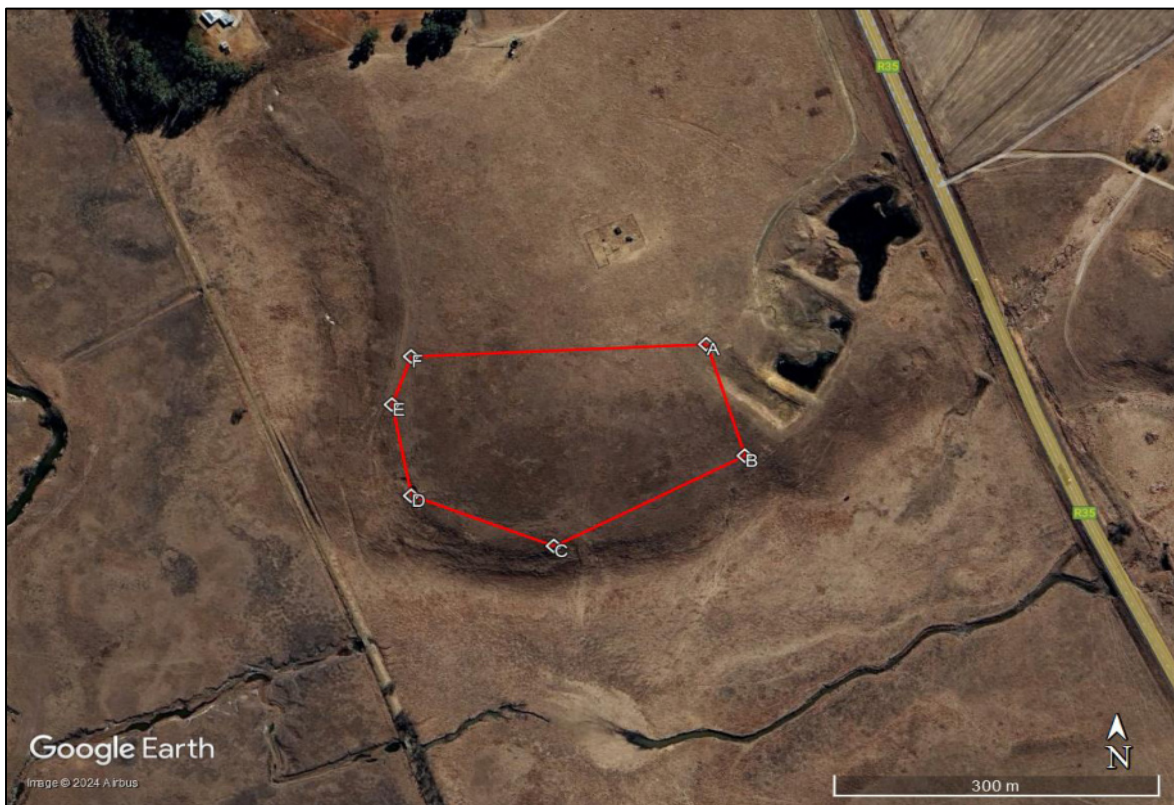
**Figure 2-2: Extent of the borrow pit**

Coordinate	Latitude	Longitude
A	26° 35' 40.97" S	29° 32' 09.55" E
B	26° 35' 44.70" S	29° 32' 10.83" E
C	26° 35' 47.72" S	29° 32' 04.48" E
D	26° 35' 46.04" S	29° 31' 59.73" E
E	26° 35' 42.99" S	29° 31' 59.09" E
F	26° 35' 41.38" S	29° 31' 59.73" E

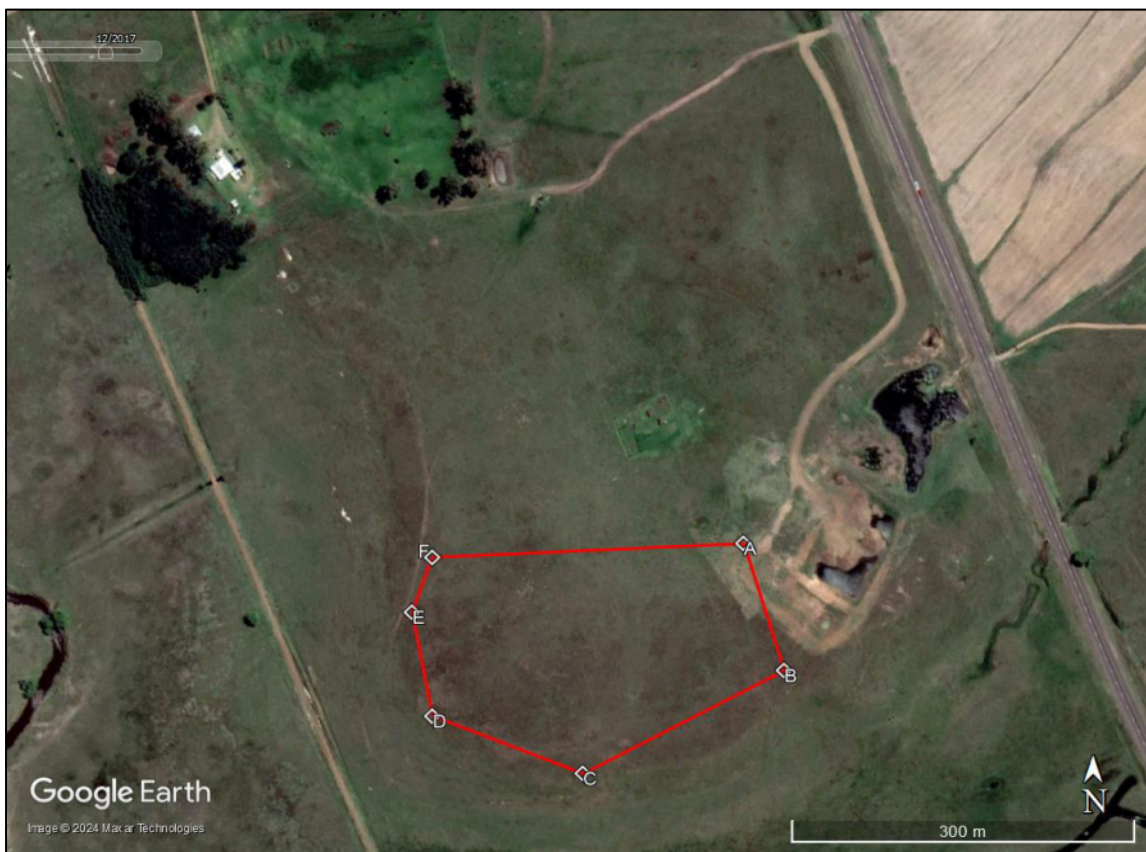
The proposed borrow pit is located immediately to the west of an old borrow pit area that was opened *circa* 1968 (see Figure 2-4) and showing signs of use as recent as 2017 (see Figure 2-5). The material sourced from the borrow pit area was likely used for the upgrading of the provincial district roads in the area by the provincial roads' authority.

Figure 2-5: Aerial image (2017) in which the old borrow pit area shows signs of use

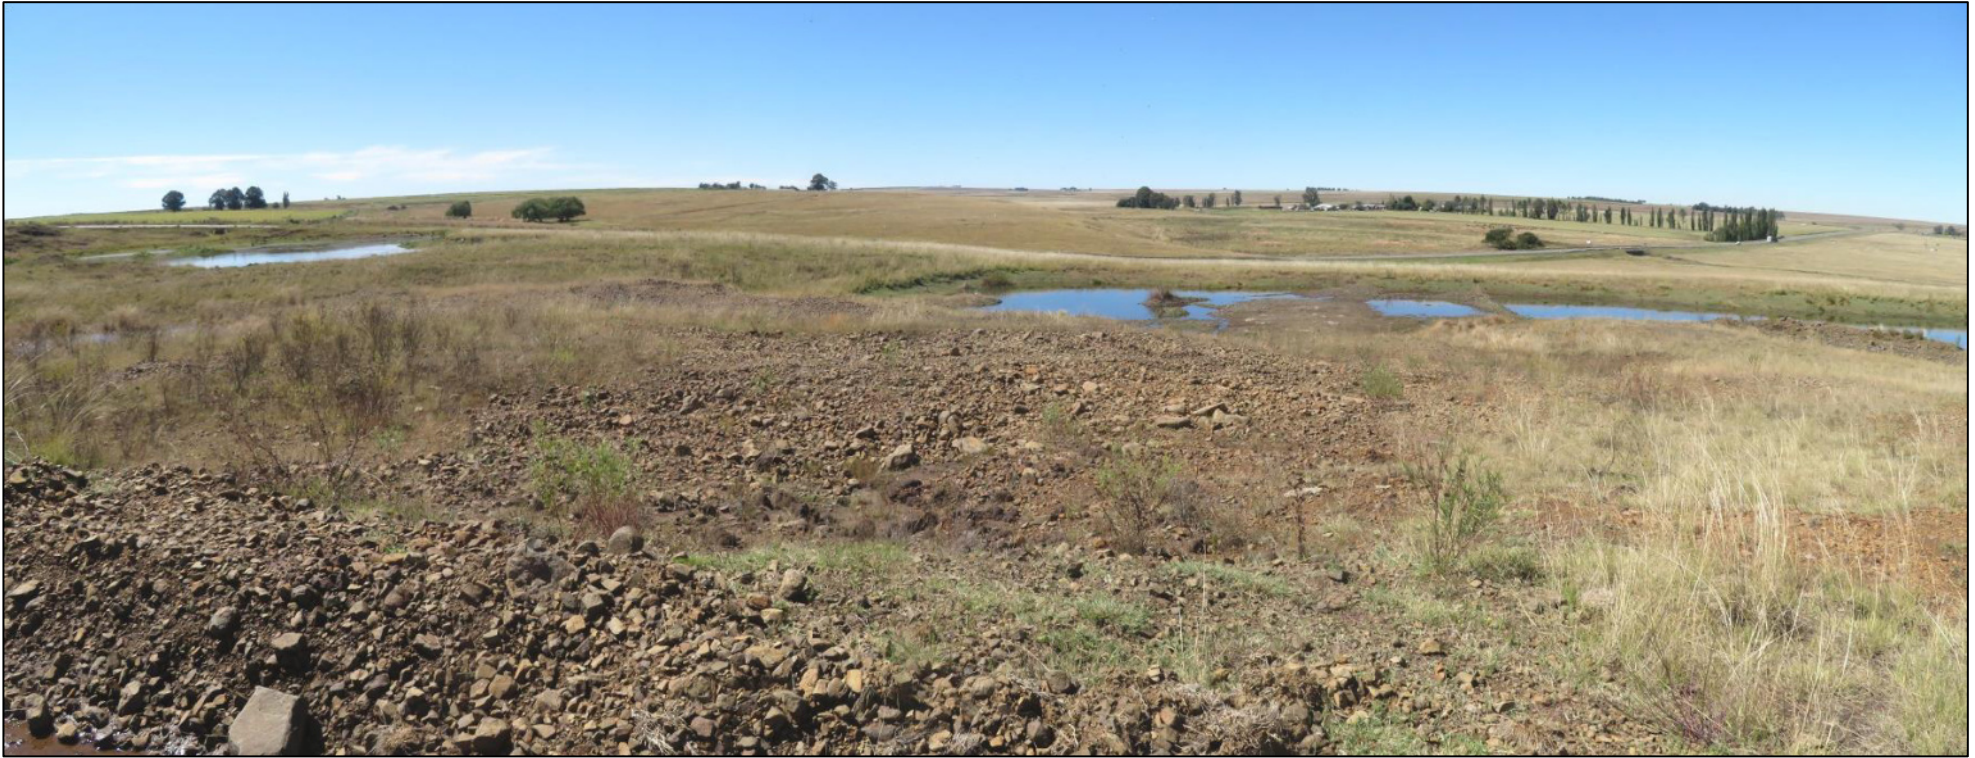
**Plate 2-1: View of the existing old borrow pit area, looking in a southerly direction**

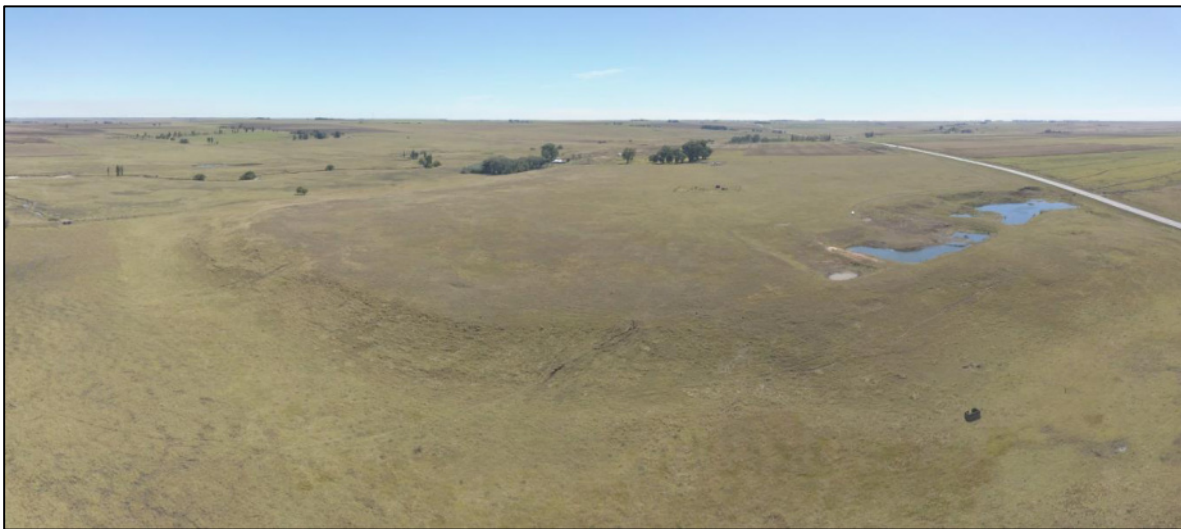
The project site is located on a low, east to west ridge line that forms the northern edge of the Heilveispruit valley. The site is flat and drains in a southerly direction. No significant topographical features occur on the site.

**Plate 9-2: Aerial view of the project site showing the topography, looking in a northerly direction**

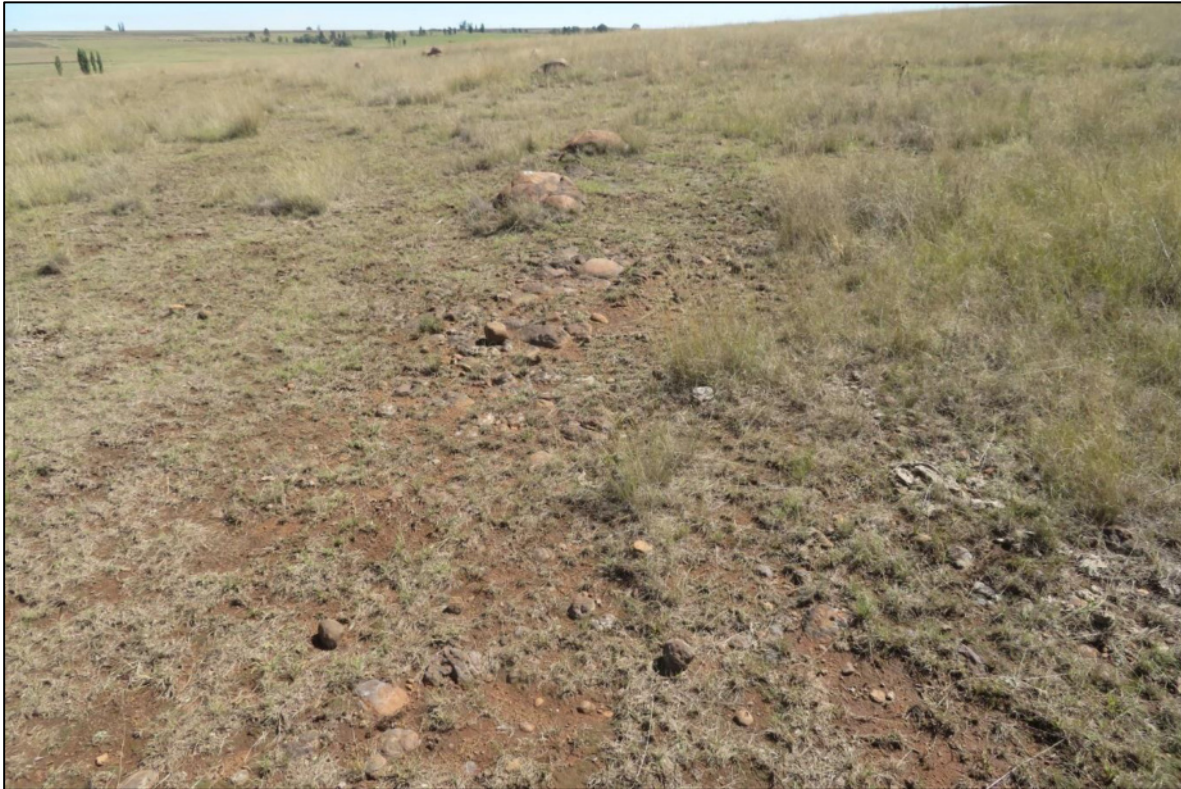
**Plate 9-3: View of the weathered dolerite at or near the surface in the project site**

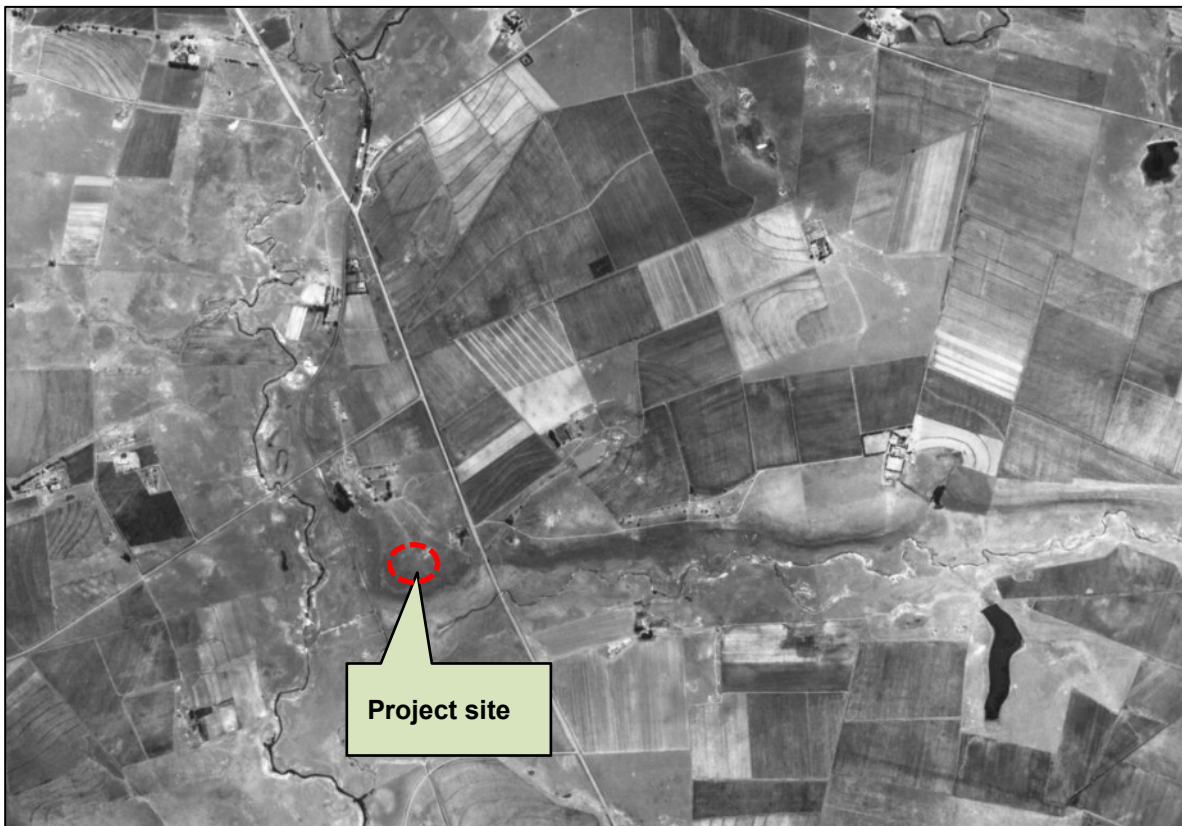
**Figure 9-3: Dated aerial image (1979) of the project site showing the cultivated areas surrounding the site**

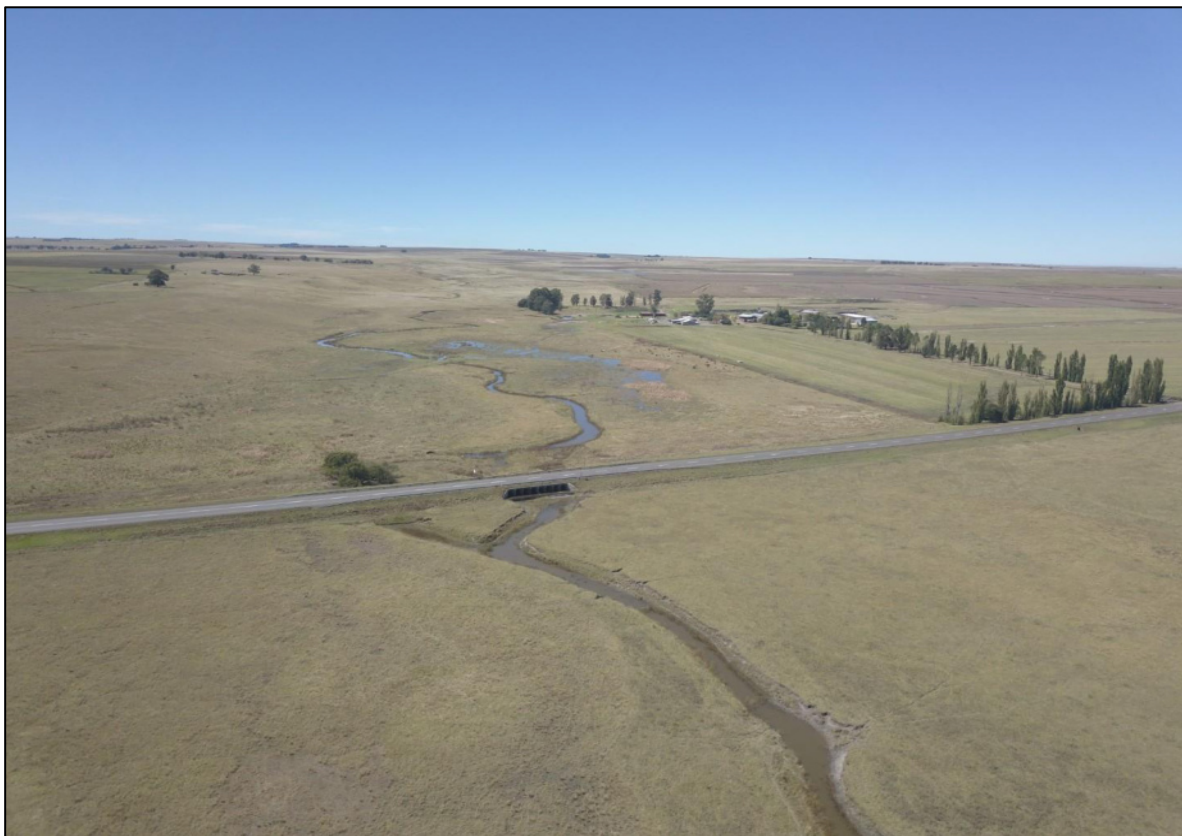
**Plate 11-1: Aerial view of the Channelled Valley Bottom (CVB) associated with the Heilvleispruit**

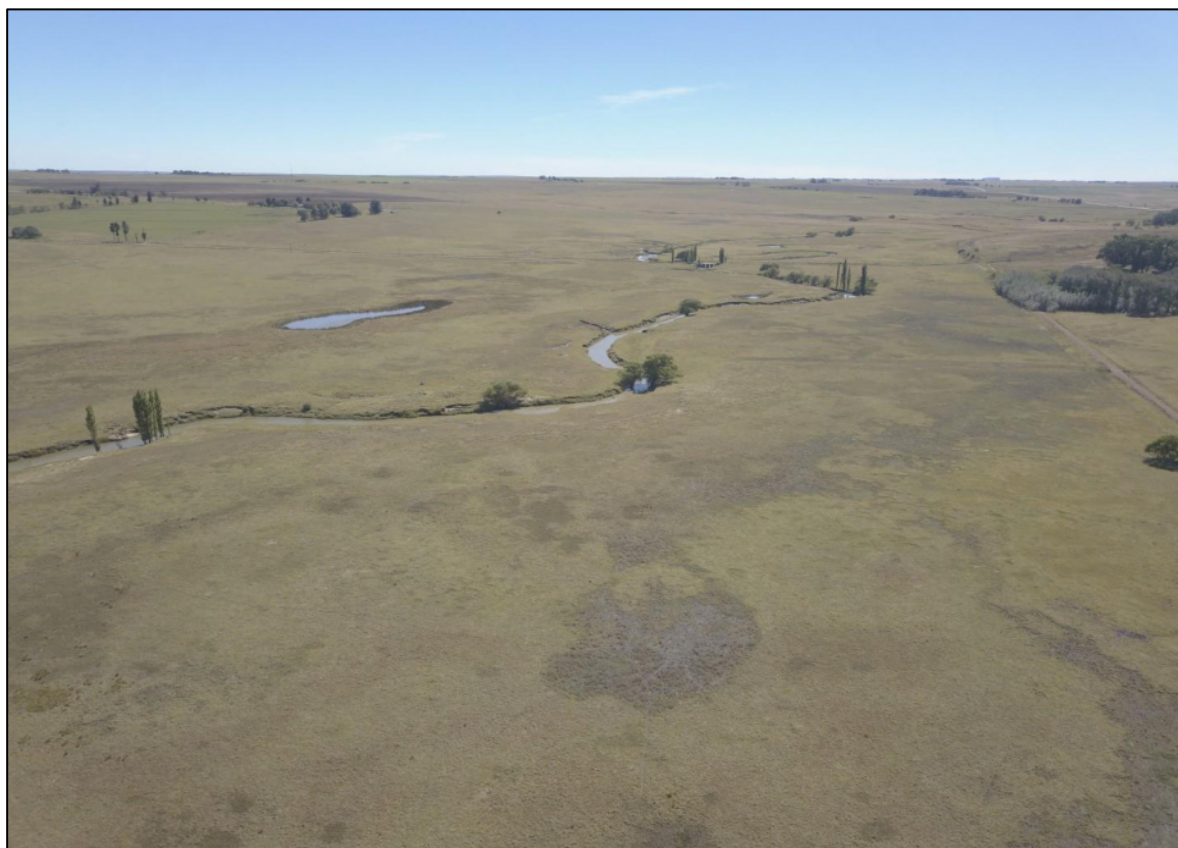
**Plate 11-2: Aerial view of the Flood Plain (FP) associated with the Kwaggalaagte River**

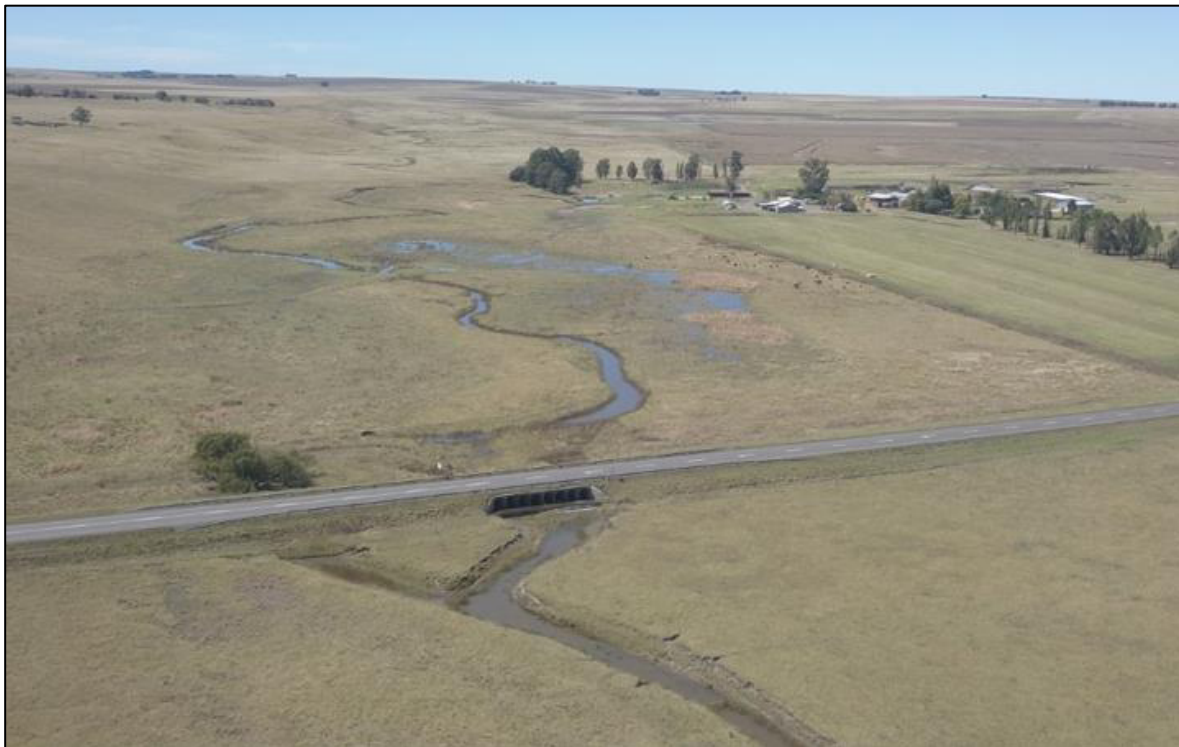
**Plate 11-5: Aerial view of the road and culvert crossing through the Channelled Valley Bottom**

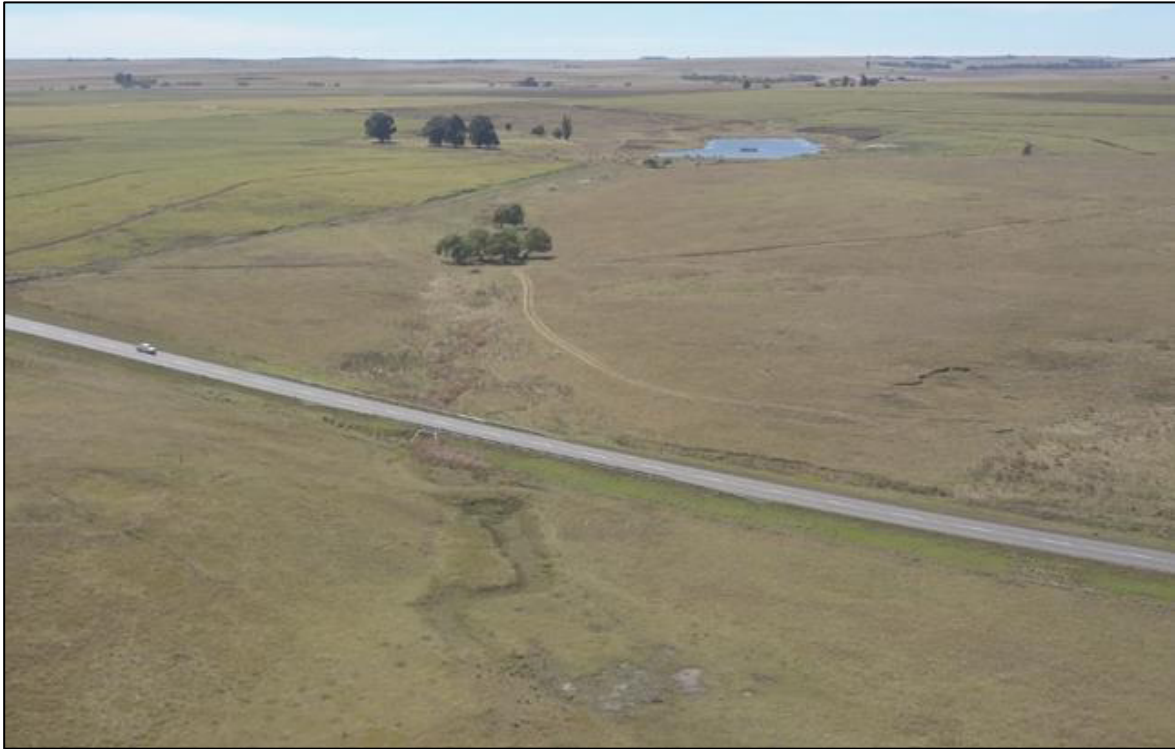
**Plate 11-6: Aerial view of the culvert and road crossing the Seep as well as the dam and impoundment area**

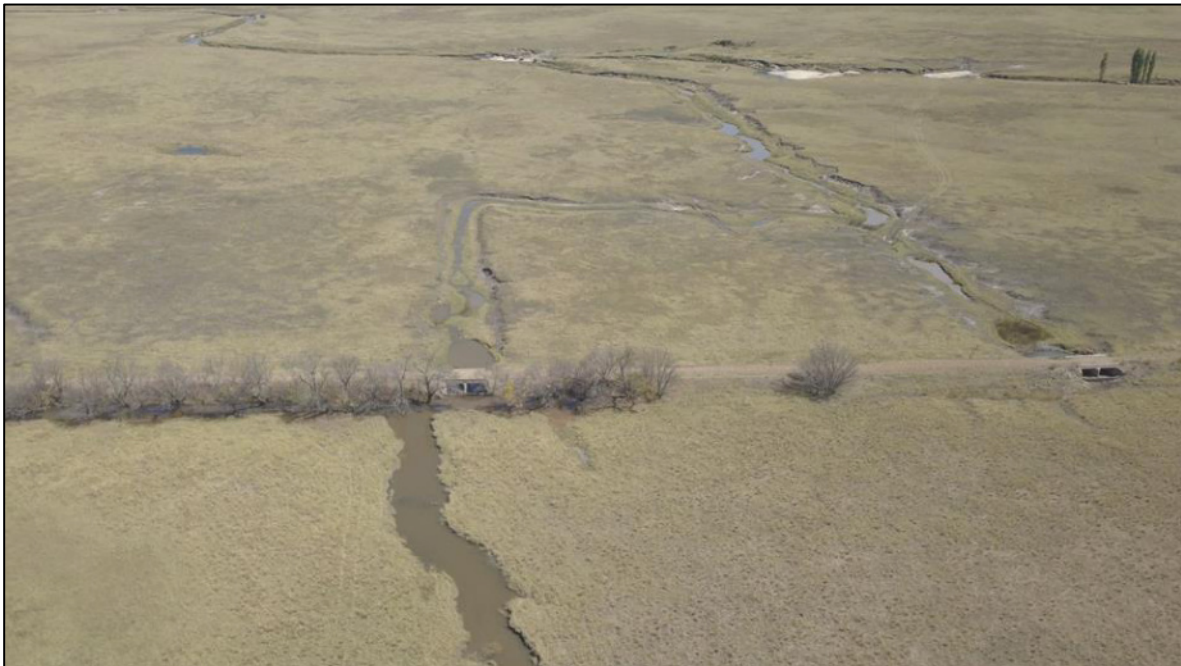
**Plate 11-7: Aerial view of the railway and culvert crossings in the Flood Plain as well as the canalised water flow**

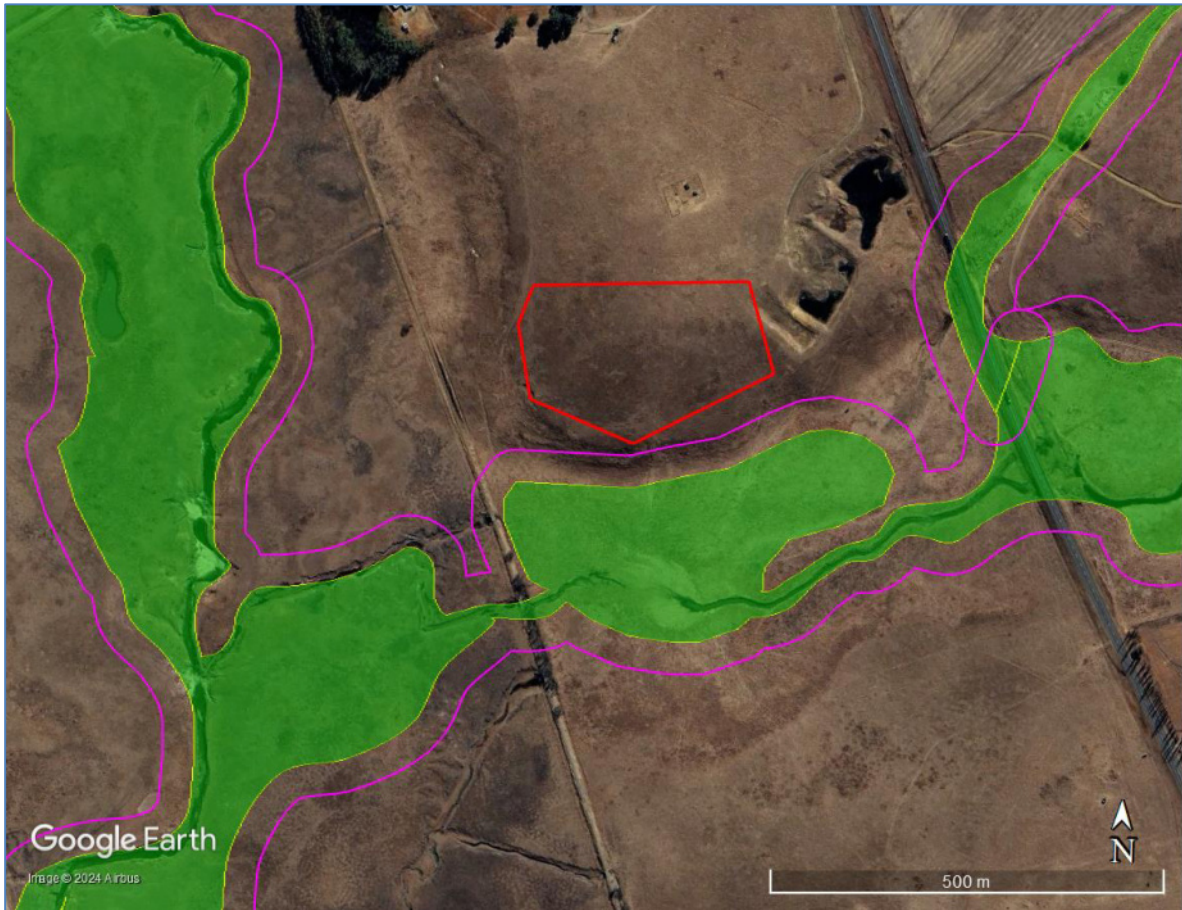
**Figure 11-6: Location and extent of the applicable 40m buffer (in purple) around the wetland features nearest to the project site (shown in red)**

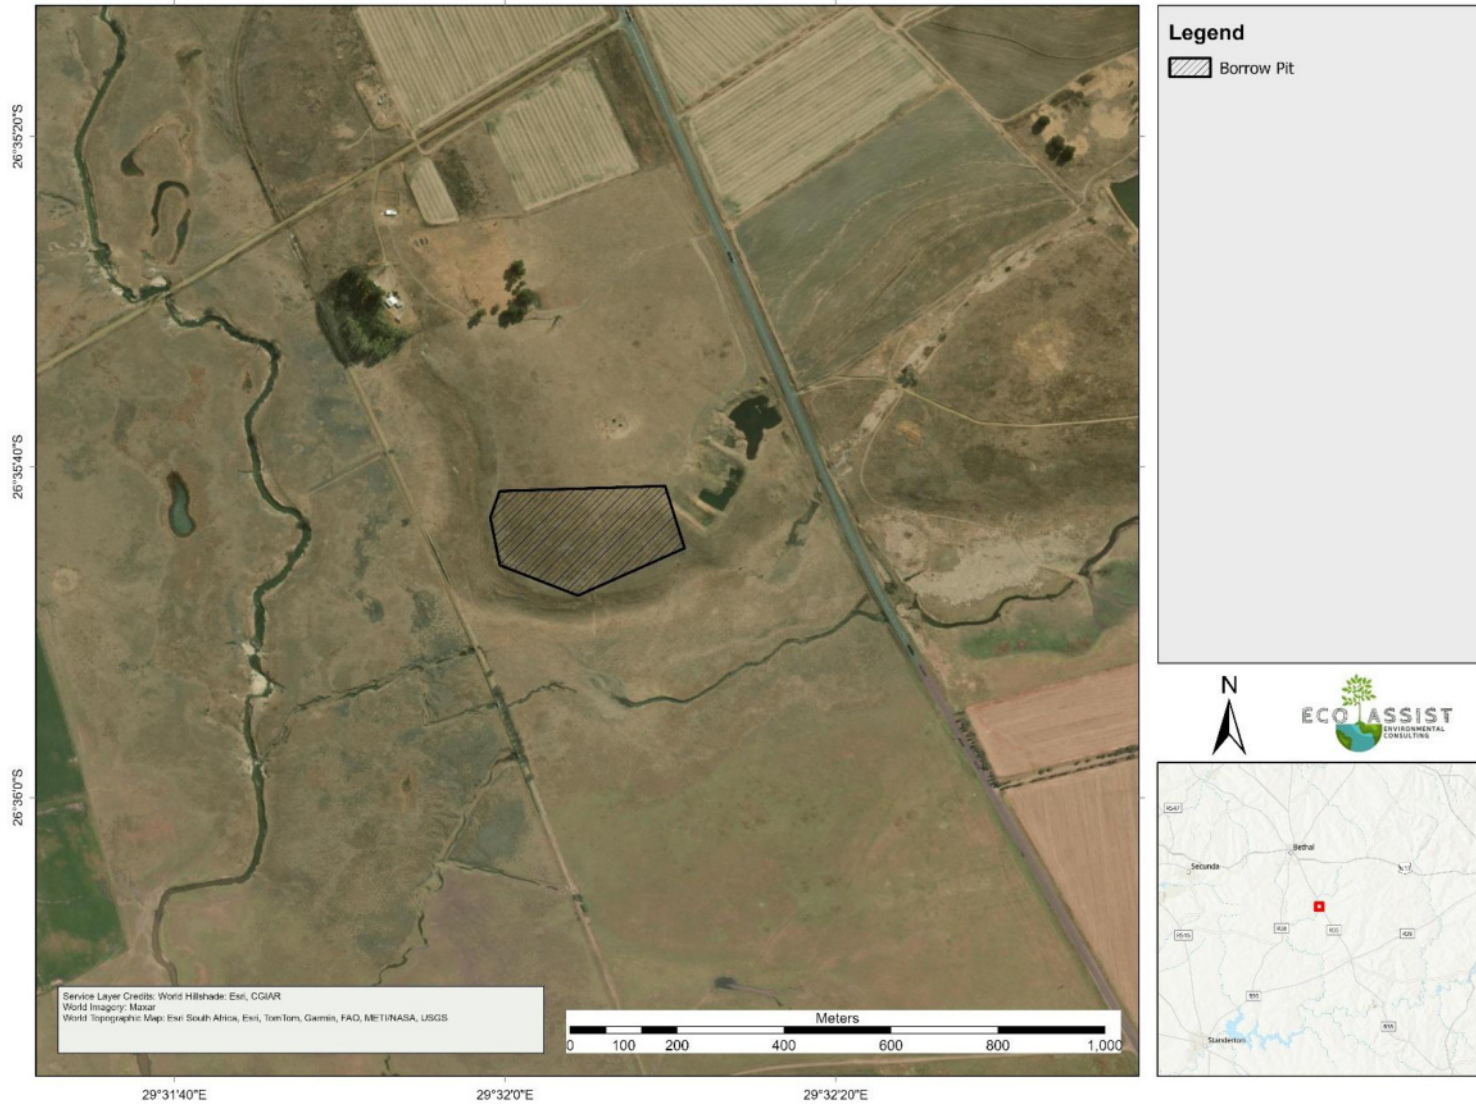
The site is located alongside the R35 in the Lekwa Local Municipality of the Gert Sibande District Municipality in Mpumalanga (Figure 1-1). The project footprint is shown in Figure 1-2.

Figure 1-2: Project layout

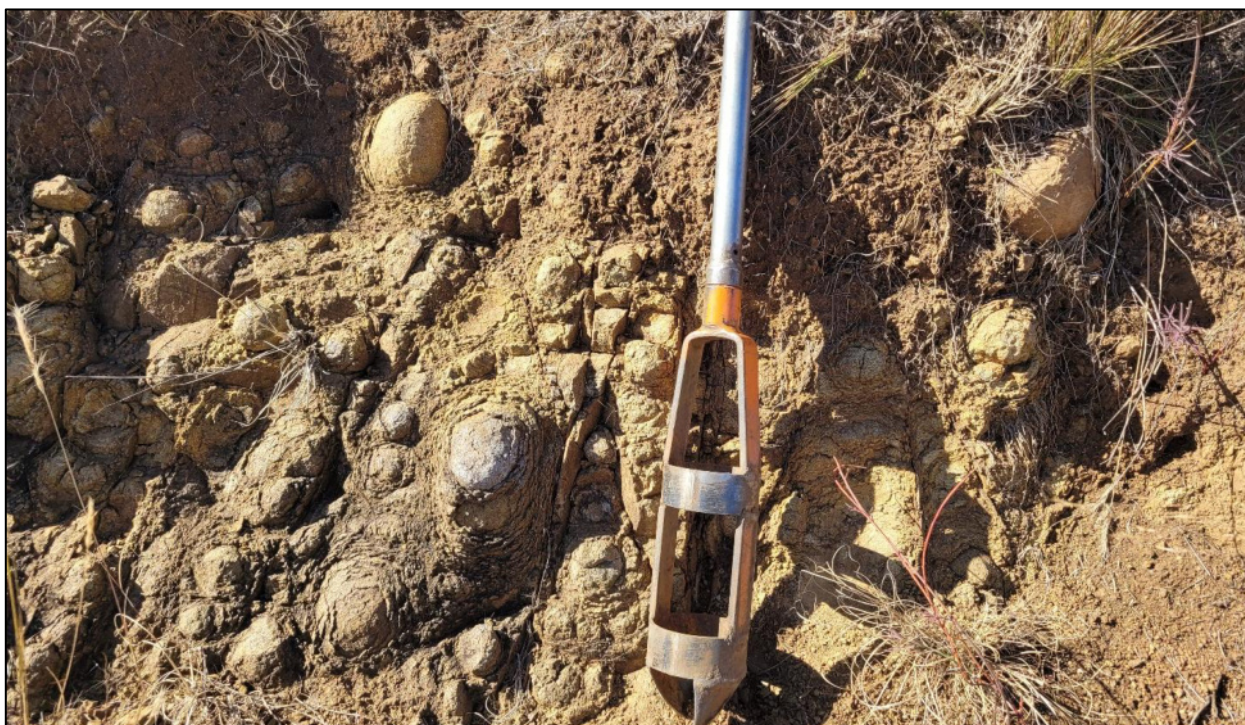
*Figure 8-1: Shows the Mispah/Glenrosa soil profile.*

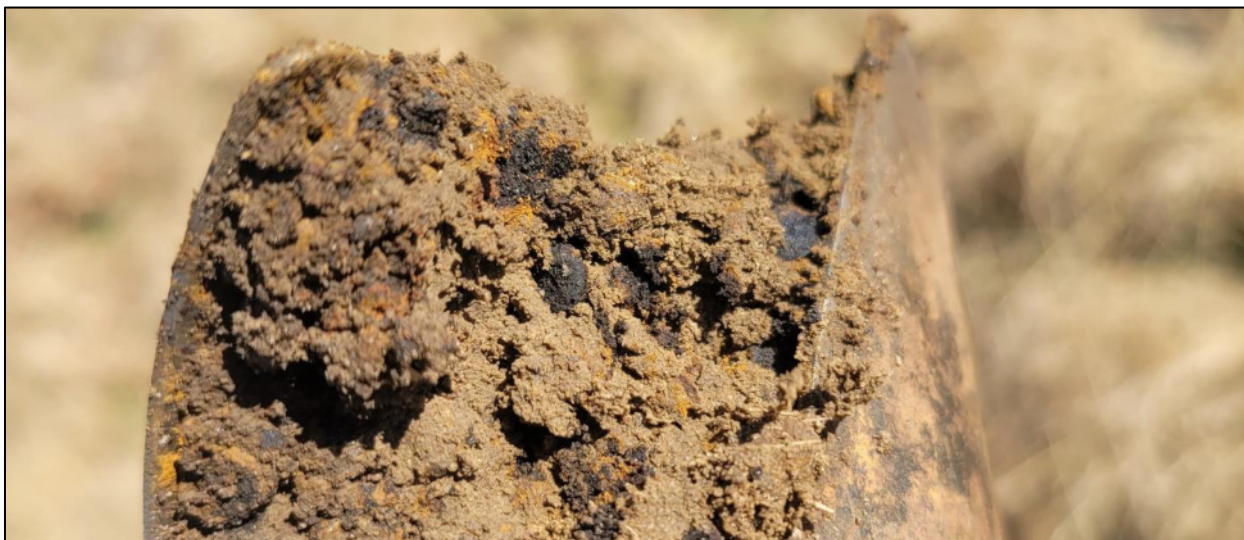
*Figure 8-2: Shows the Plinthic concretions in the lower soil profile of the Tukulu soil.*

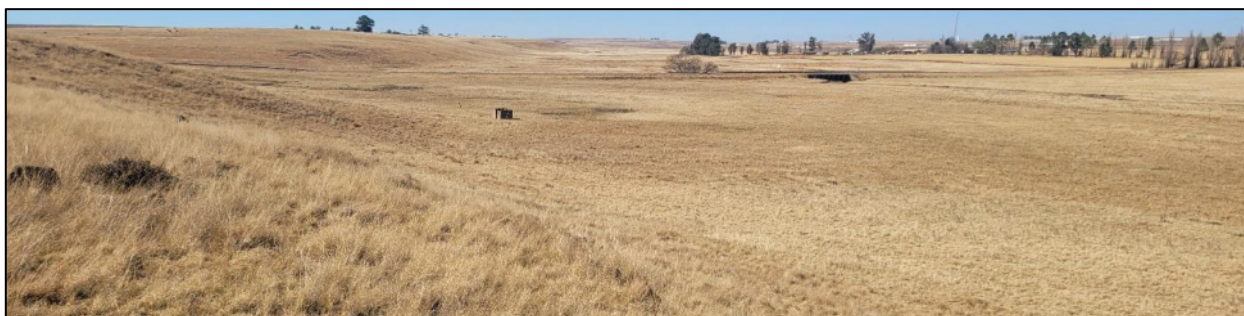
*Figure 8-3: Shows the hydromorphic wetland system in valley bottom landscape.*

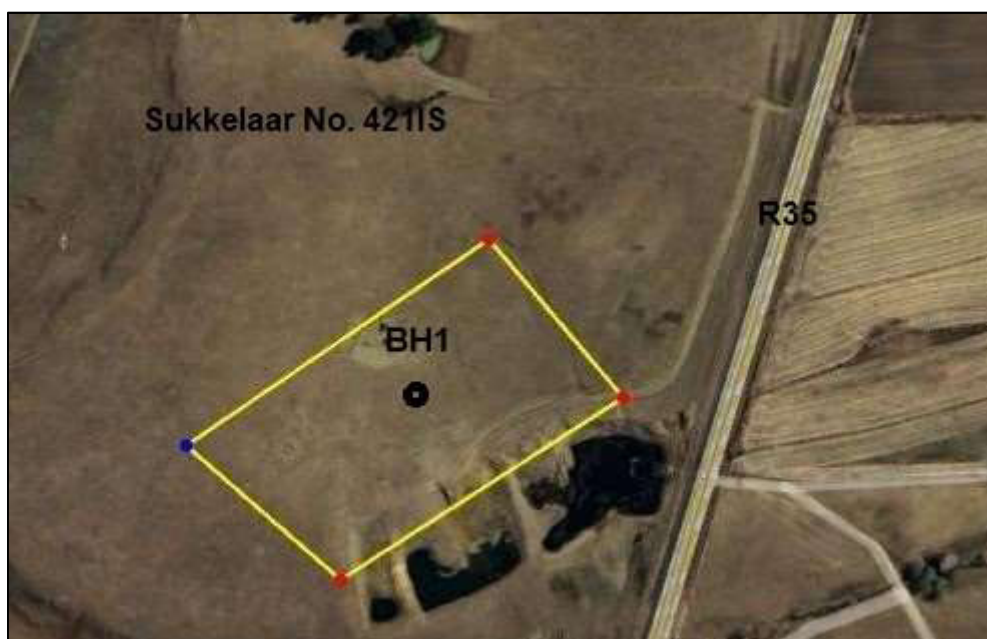
A geotechnical investigation was conducted for the Umbila Emoyeni Wind Farm project at the site of a proposed 5-hectare borrow pit located on the farm Portion 9, Sukkelaar No. 421IS in the Gert Sibande District Municipality as illustrated below. The investigation entailed drilling a rotary cored borehole, referenced BH1, within the area. The core was logged and photographed and the image and log is attached to this report.
