# Umbila Emoyeni Borrow Pit Water Use Licence Technical Report

Version -Final

15 August 2025

GCS Project Number:23-0766

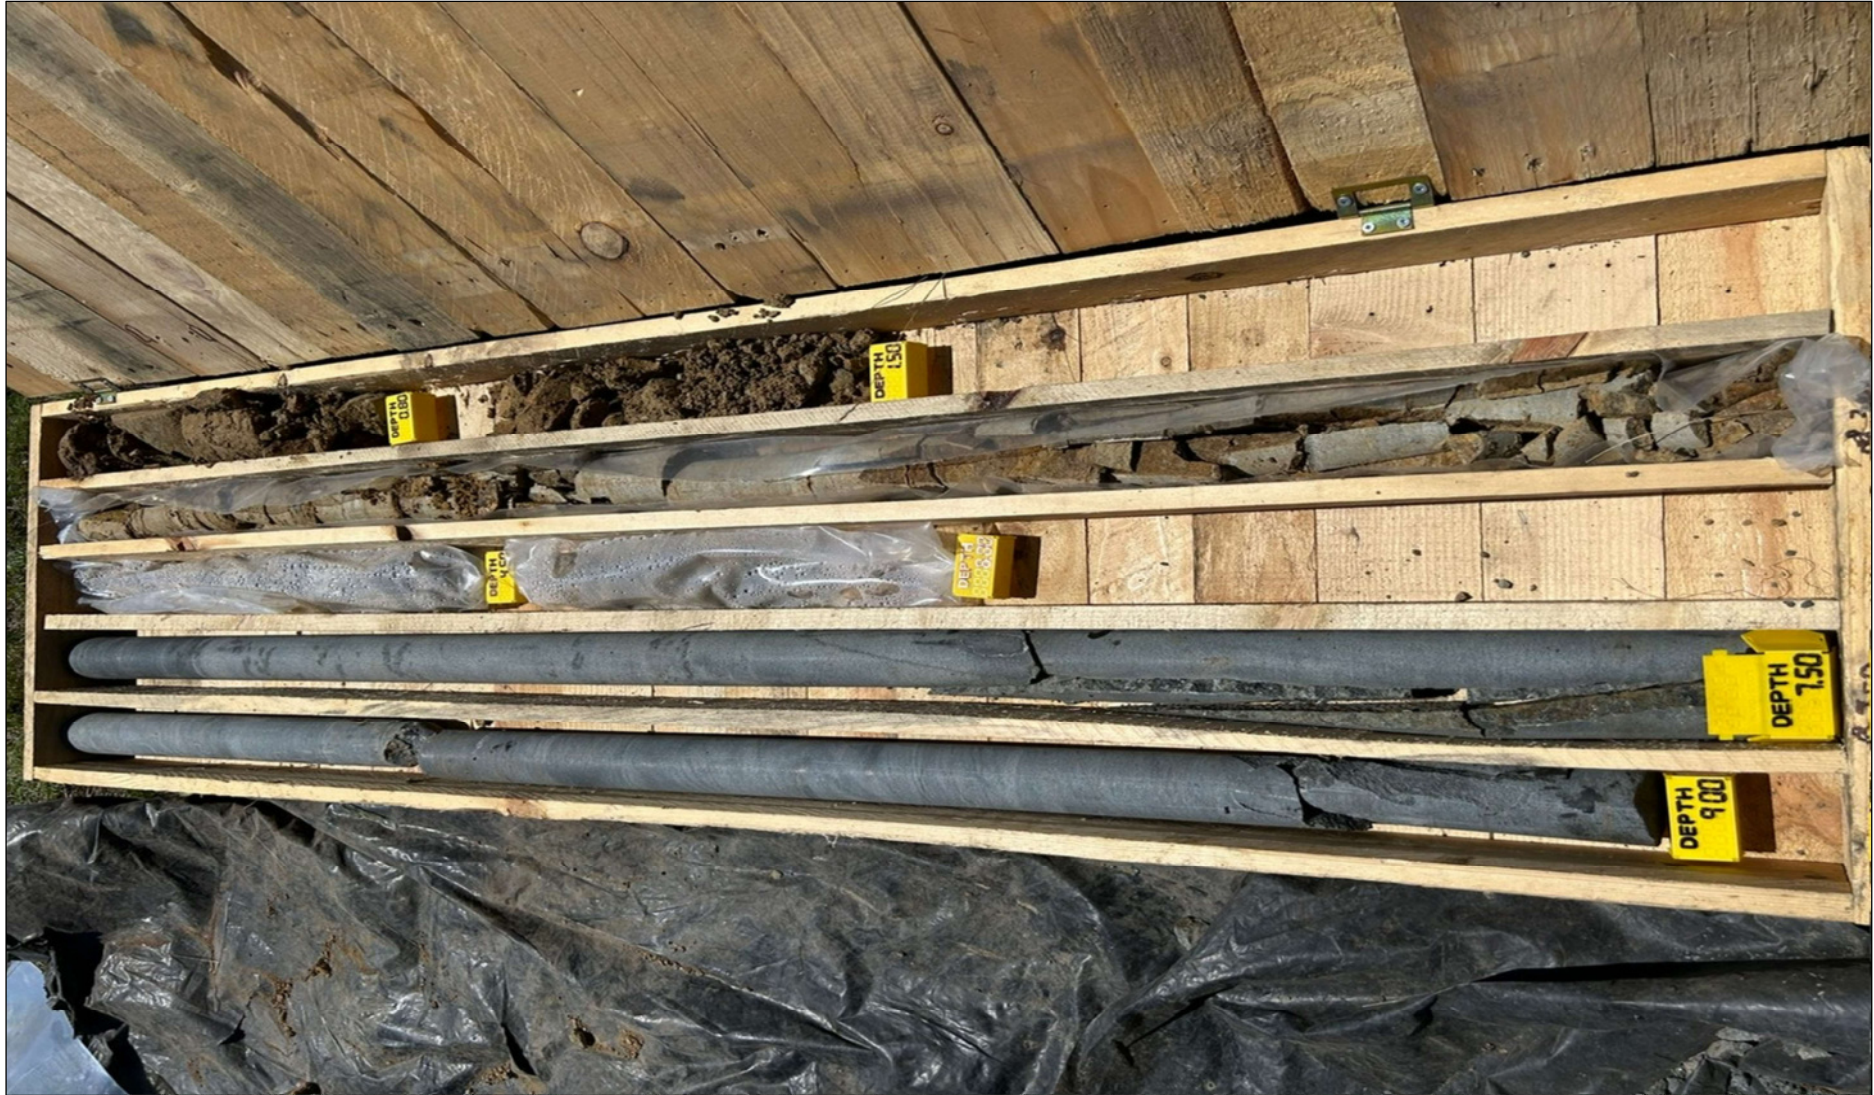
Ref: 2520/g

A 600 mm thick topsoil and transported layer blanket the area and overlay residual dolerite as a silty sand, which extends to a depth of some 1,5 m. Highly weathered, soft rock, dolerite underlies the residual soil and extends to a depth of about 6 m where unweathered, hard rock, dolerite was encountered and extends to the bottom of the borehole.

Contractor: StefannutiStocks  
 Driller: Rodney M  
 Machine: INGH152001  
 Logged by: BAH

Drilling started: 10/11/24  
 Drilling completed: 10/11/24  
 No of core boxes: 1  
 Date logged: 30/11/24
