**PROJECT NAME: BEATRIX MINING AREAS OF SIBANYE GOLD, BETWEEN WELKOM AND THEUNISSEN,
LEJWELEPUTSWA DISTRICT, ORANGE FREE STATE PROVINCE**

HERITAGE STUDY: HERITAGE AUDIT REPORT

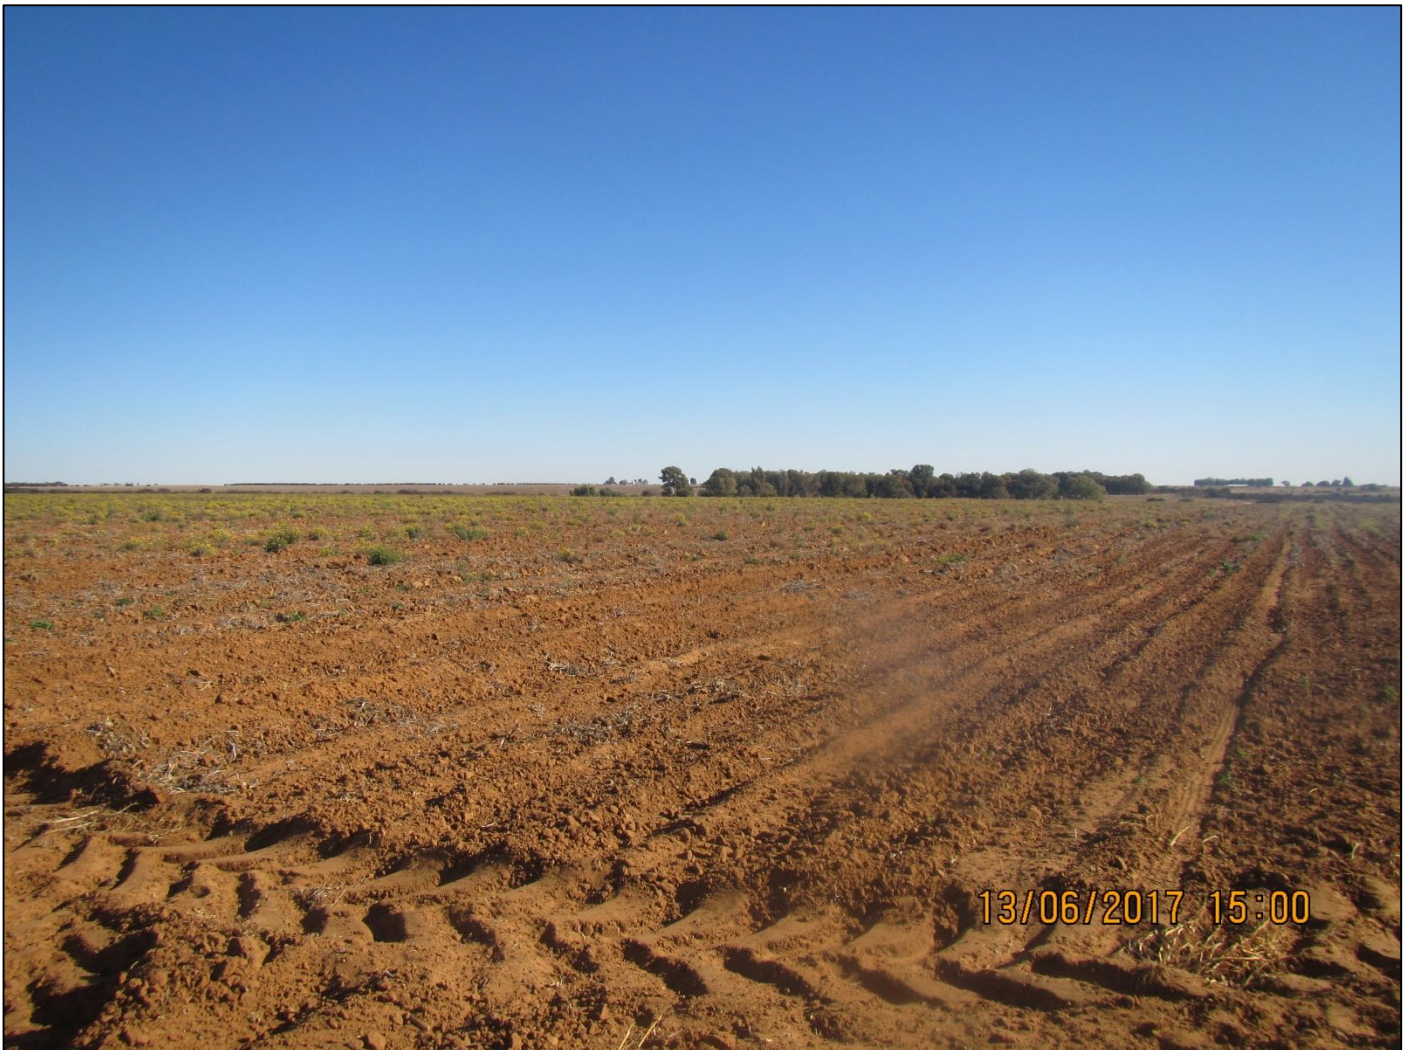
Figure 3 - General view of some of the agricultural fields located within the study area.

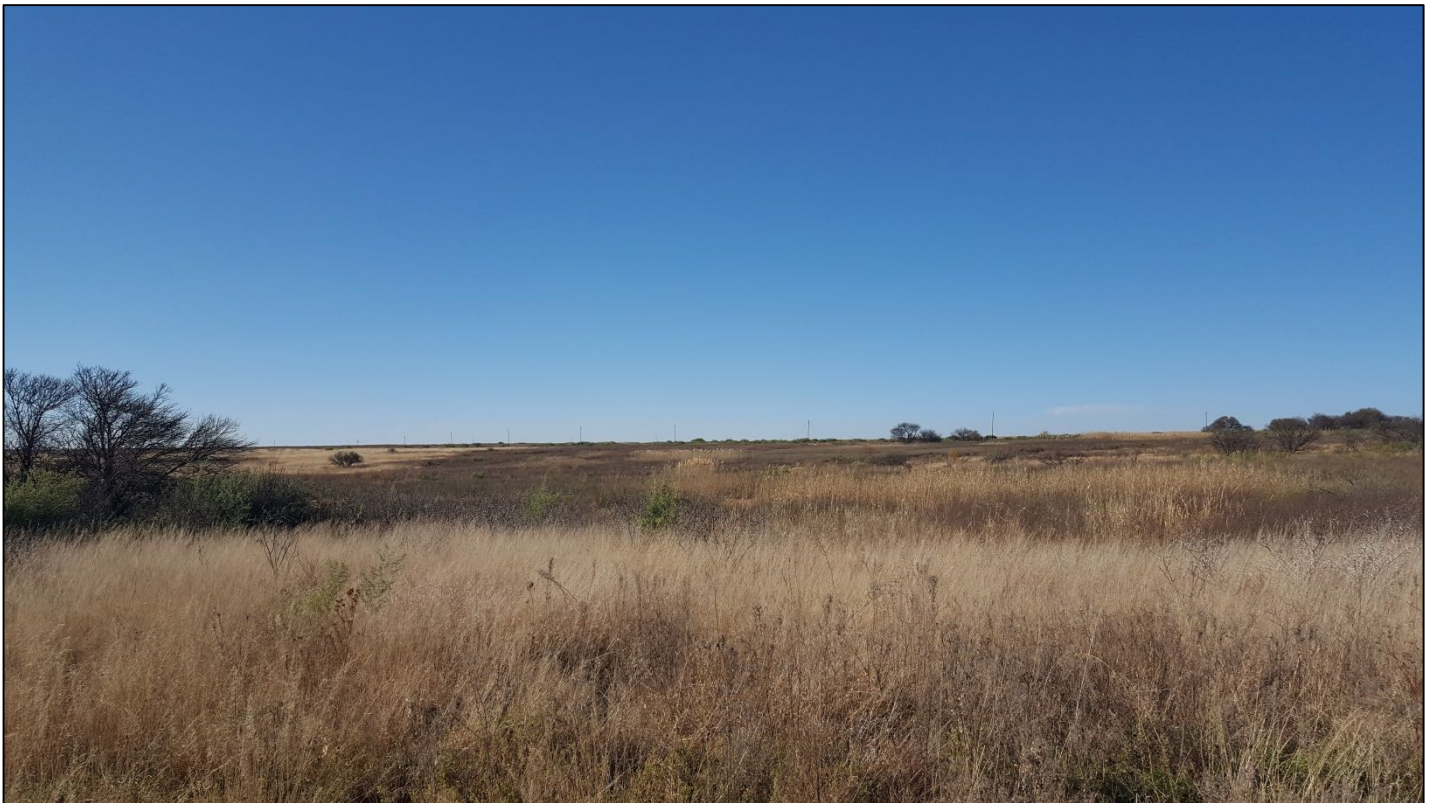
Figure 5 – General view of a wetland found within the study area.

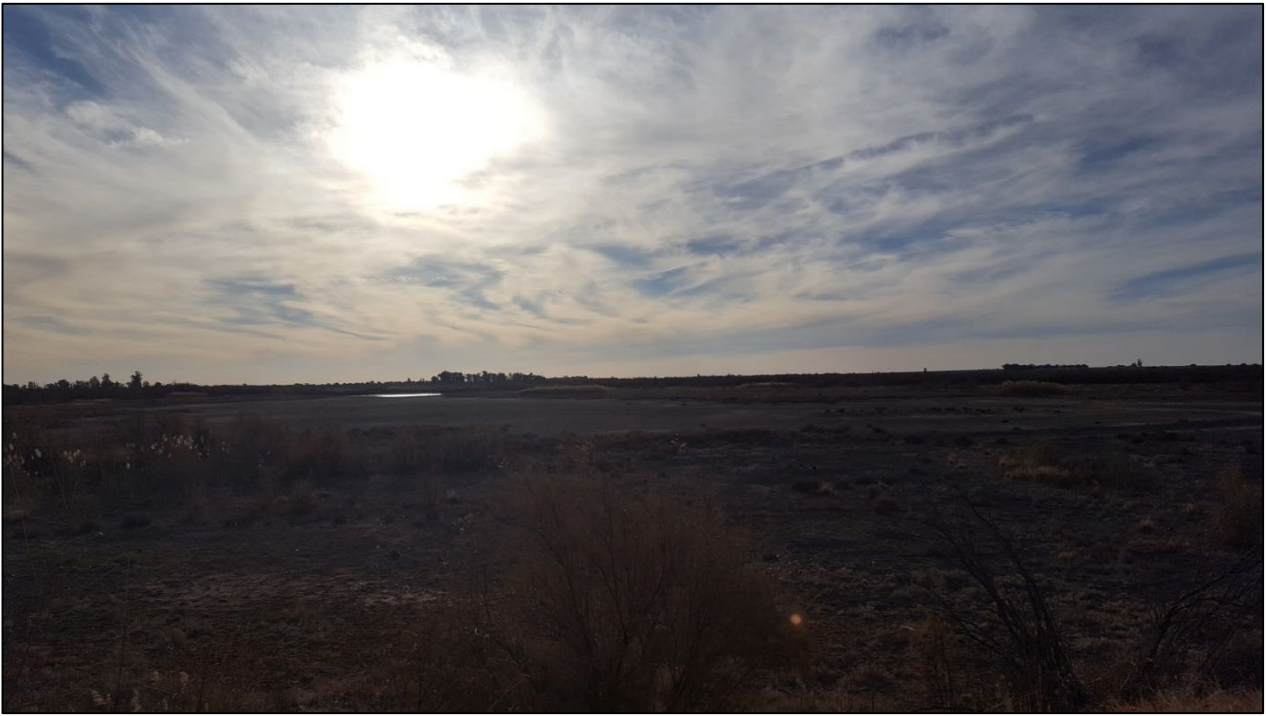
Figure 6 – General view of the Wolwepan, which covers a large section of the Northern Section of the study area.

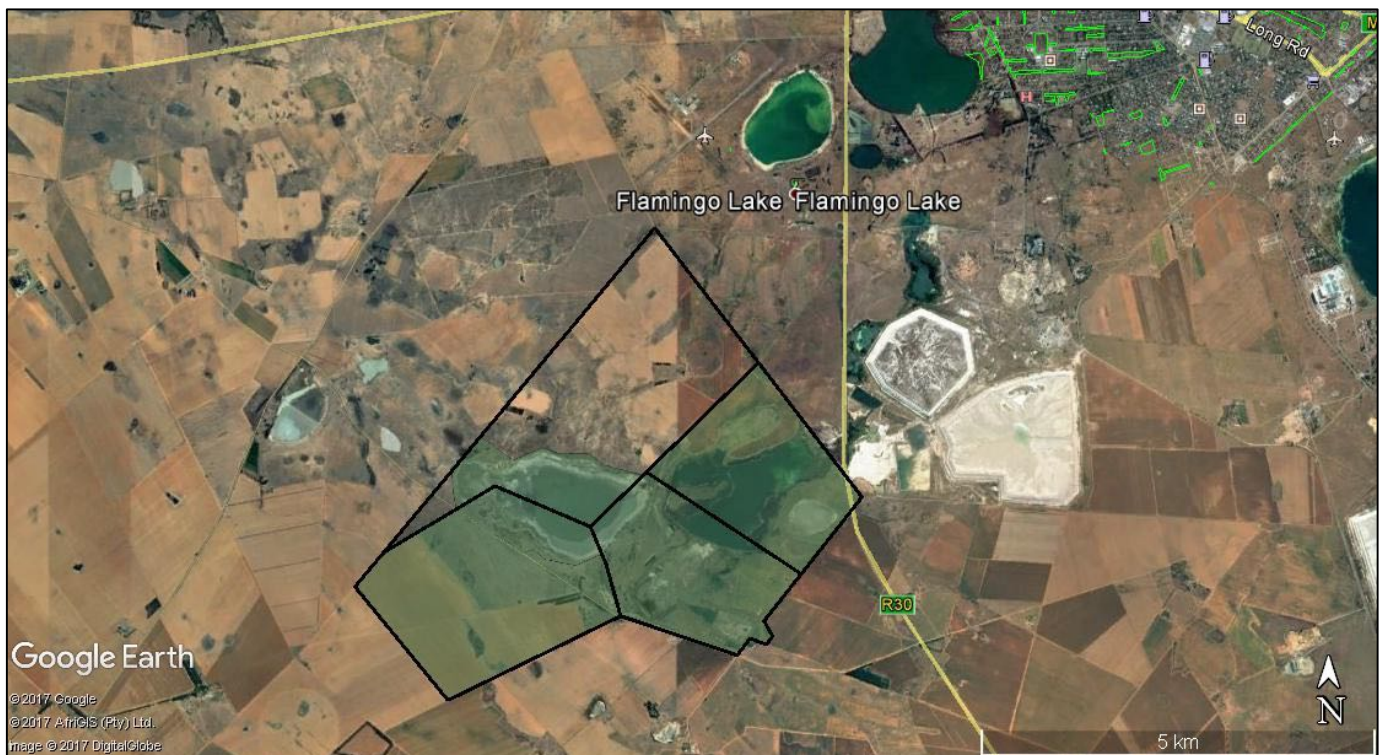
Figure 8 – The Northern Section of the Sibanye Beatrix Study. The areas shaded in green are owned by Sibanye.

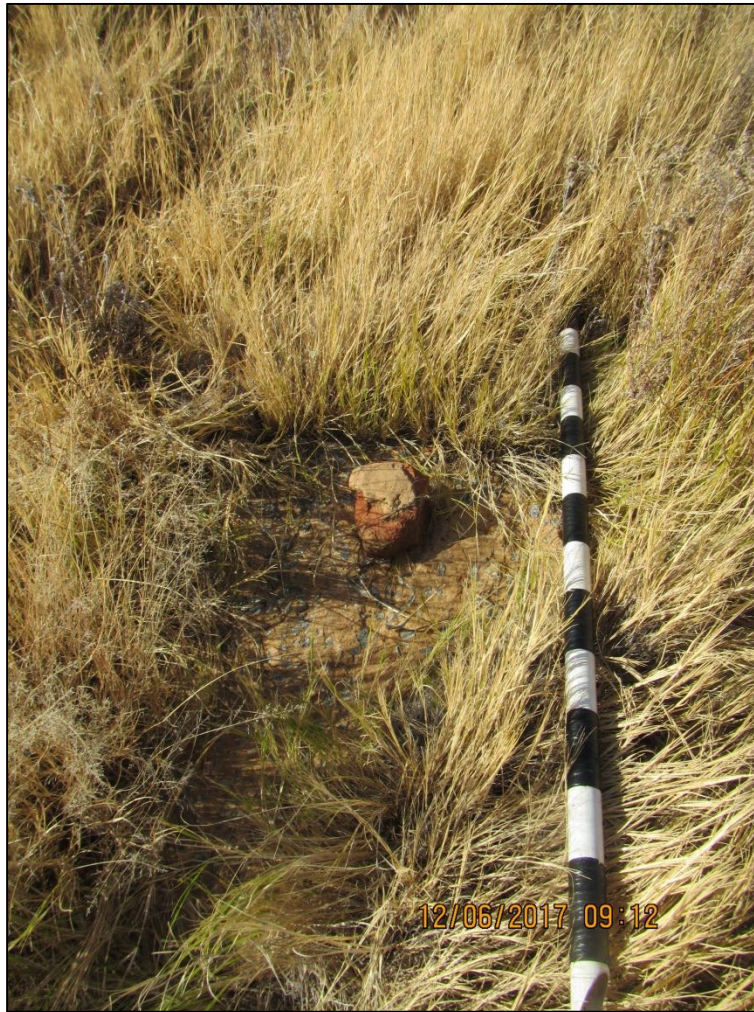
Figure 16 – View of concrete foundation and brick with mortar at Site 002. Scale in 10cm increments.

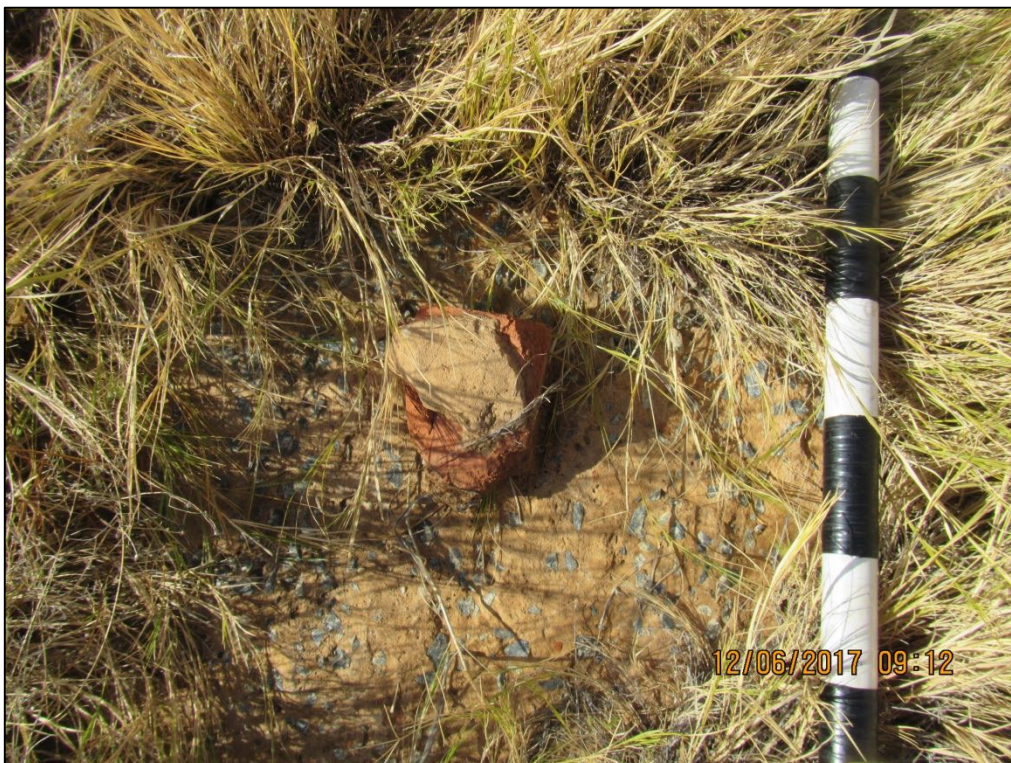
Figure 17 – Closer view of concrete foundation and brick with mortar at Site 002. Scale is in 10cm increments.

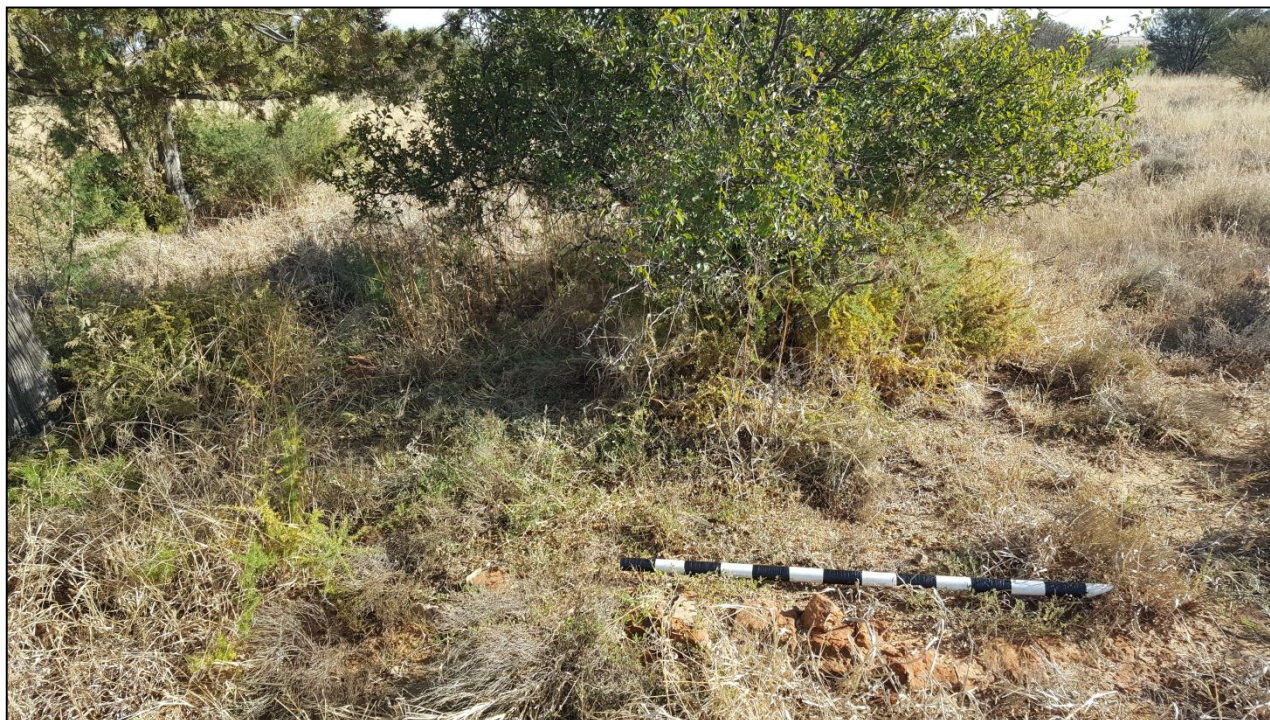
Figure 20 – General view of Site 004, with wall foundation in the foreground. Scale is in 10cm increments.

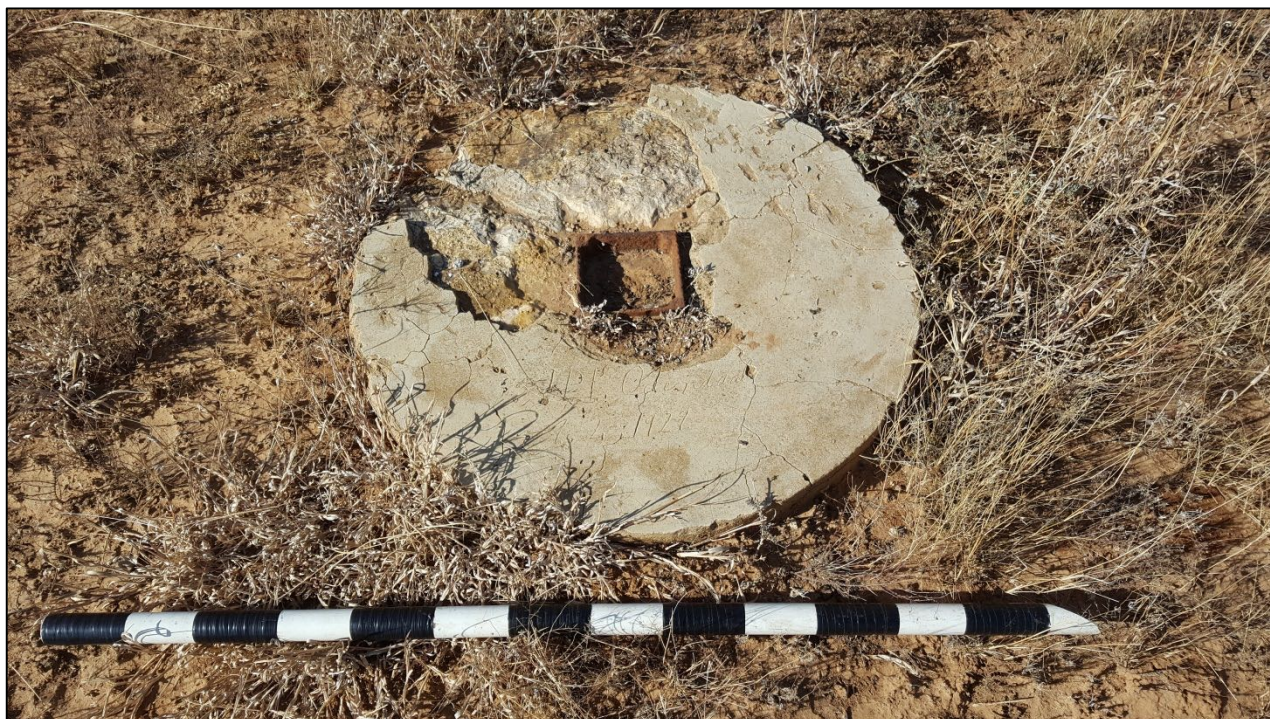
Figure 21 – Remains of borehole at Site 004 with "J.P. Odendaal 1929.9.4" inscription. Scale is in 10cm increments.

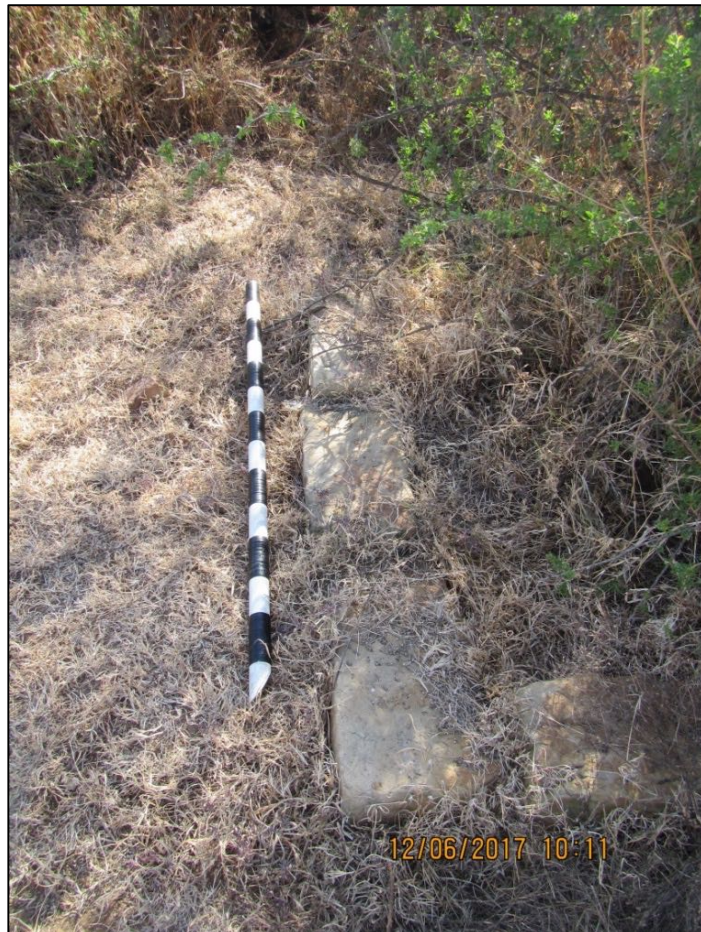
Figure 23 – Sandstone foundation of structure at Site 005. Scale is in 10cm increments.

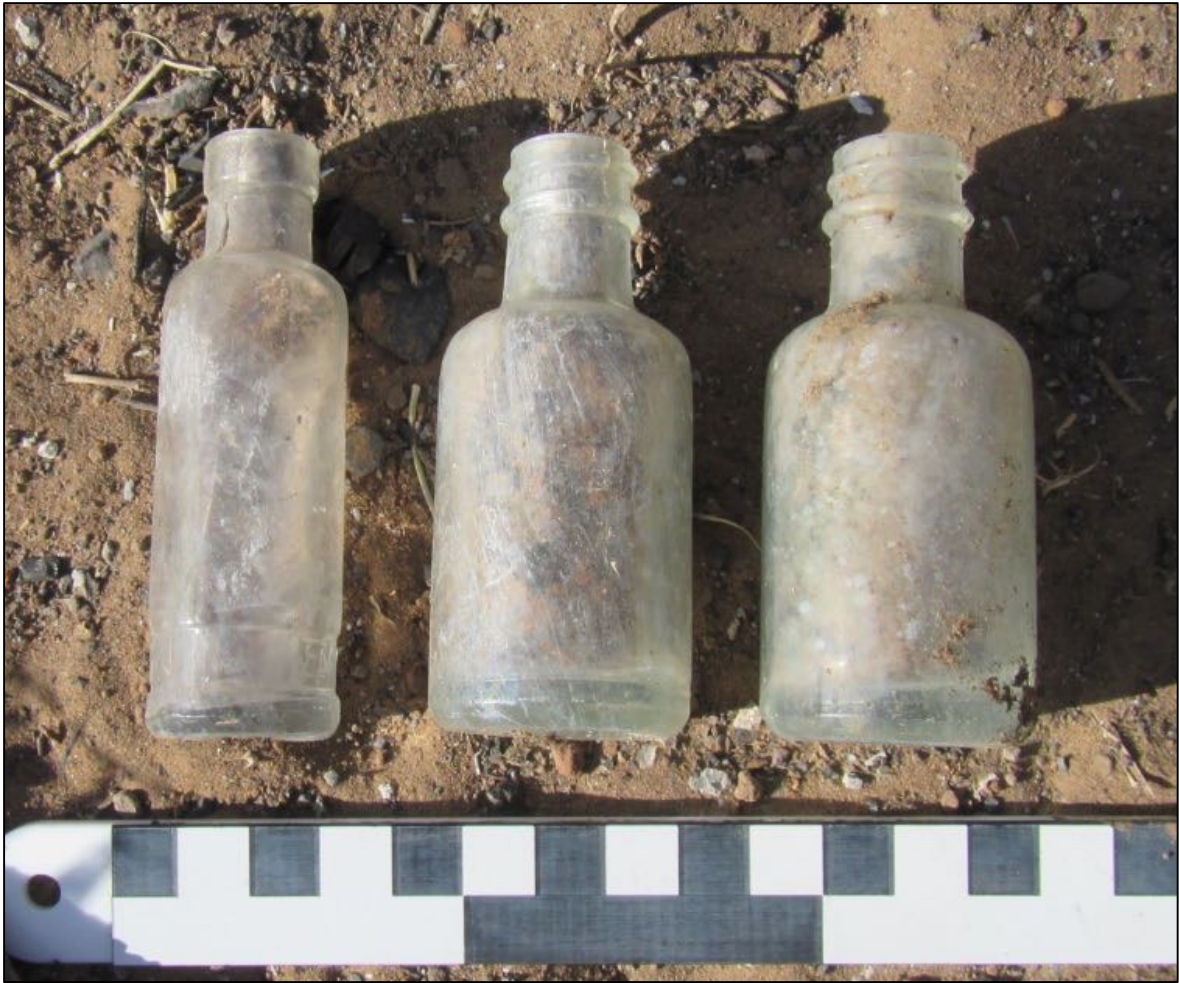
Figure 24 – Sample of glass bottles identified on the surface of the midden at Site 005. These bottles were more than likely used as medicine bottles. Scale in 1cm and 5cm increments.

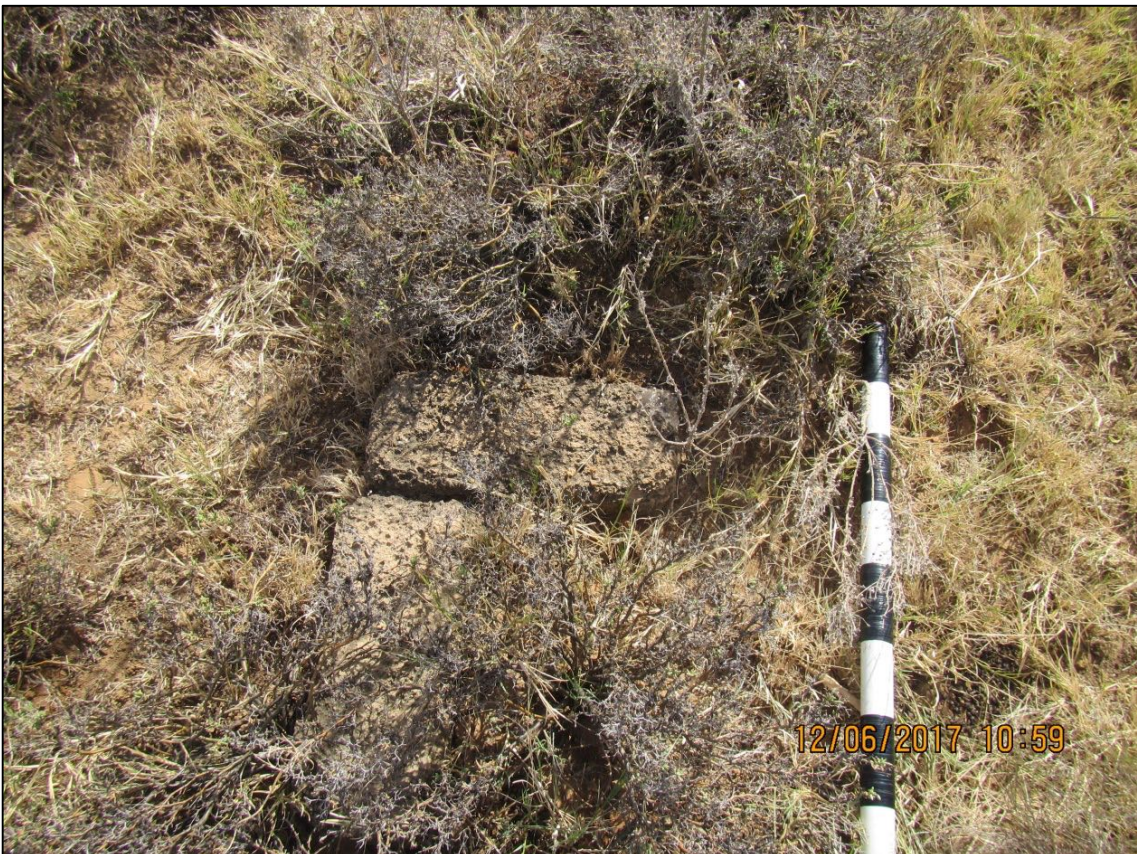
Figure 31 – Remains of structure foundation at Site 007. Scale is in 10cm increments.

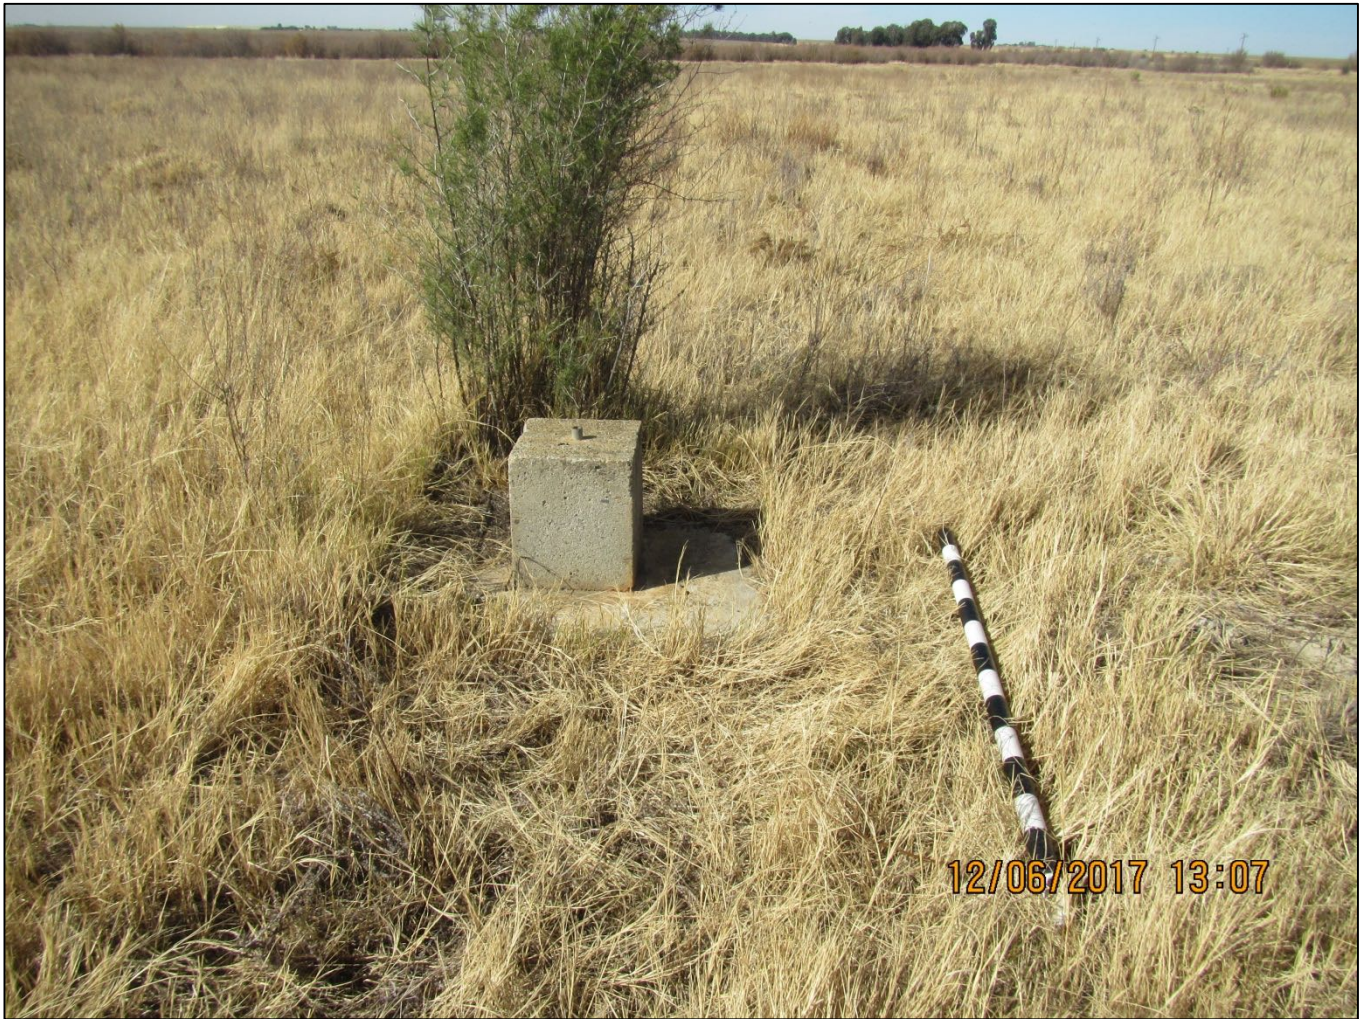
Figure 42 –View of Site 011, showing the concrete block that was identified in the field. As discussed in the text, this concrete block represents the only tangible remains of the site that could be found. Scale is in 10cm increments.

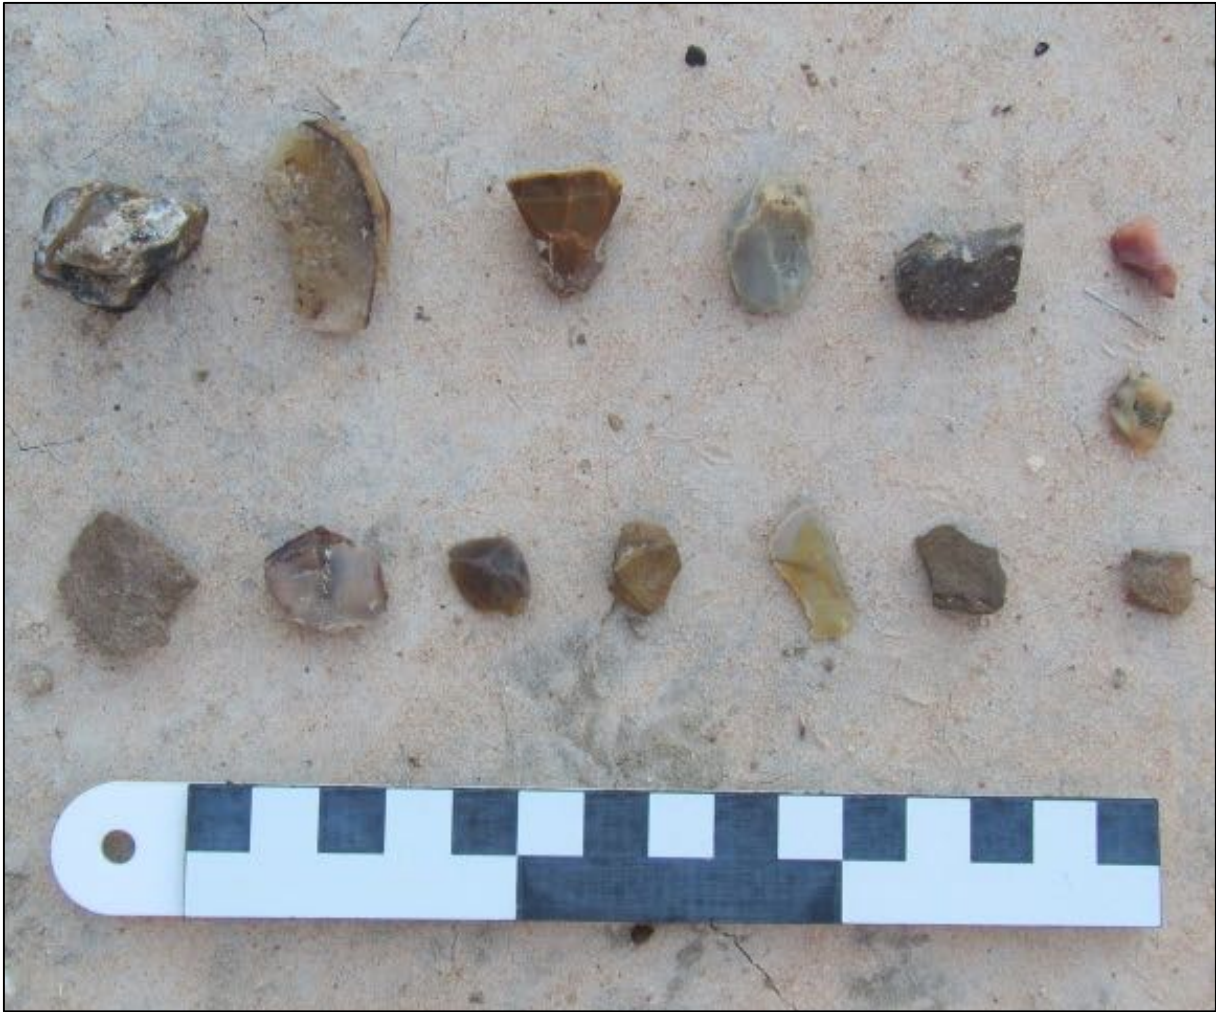
Figure 62 – Sample of LSA materials observed on the surface of Site 019. Scale is in 1cm and 5cm increments.

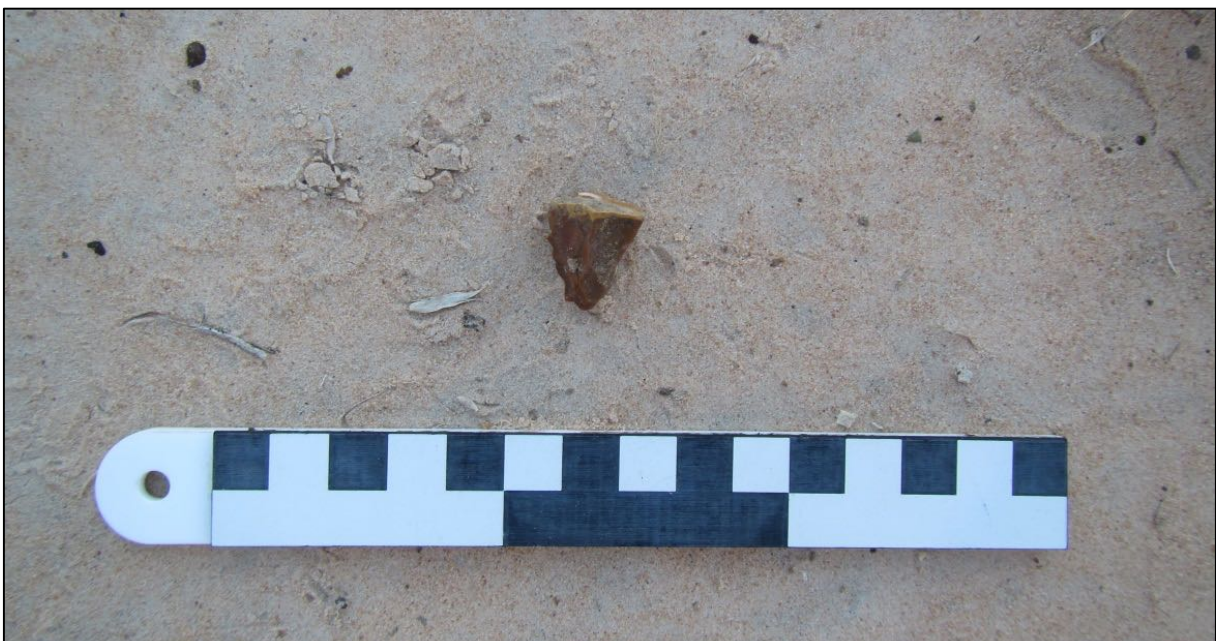
Figure 63 – LSA bladelet core from Site 019. Scale is in increments of 1cm and 5cm.

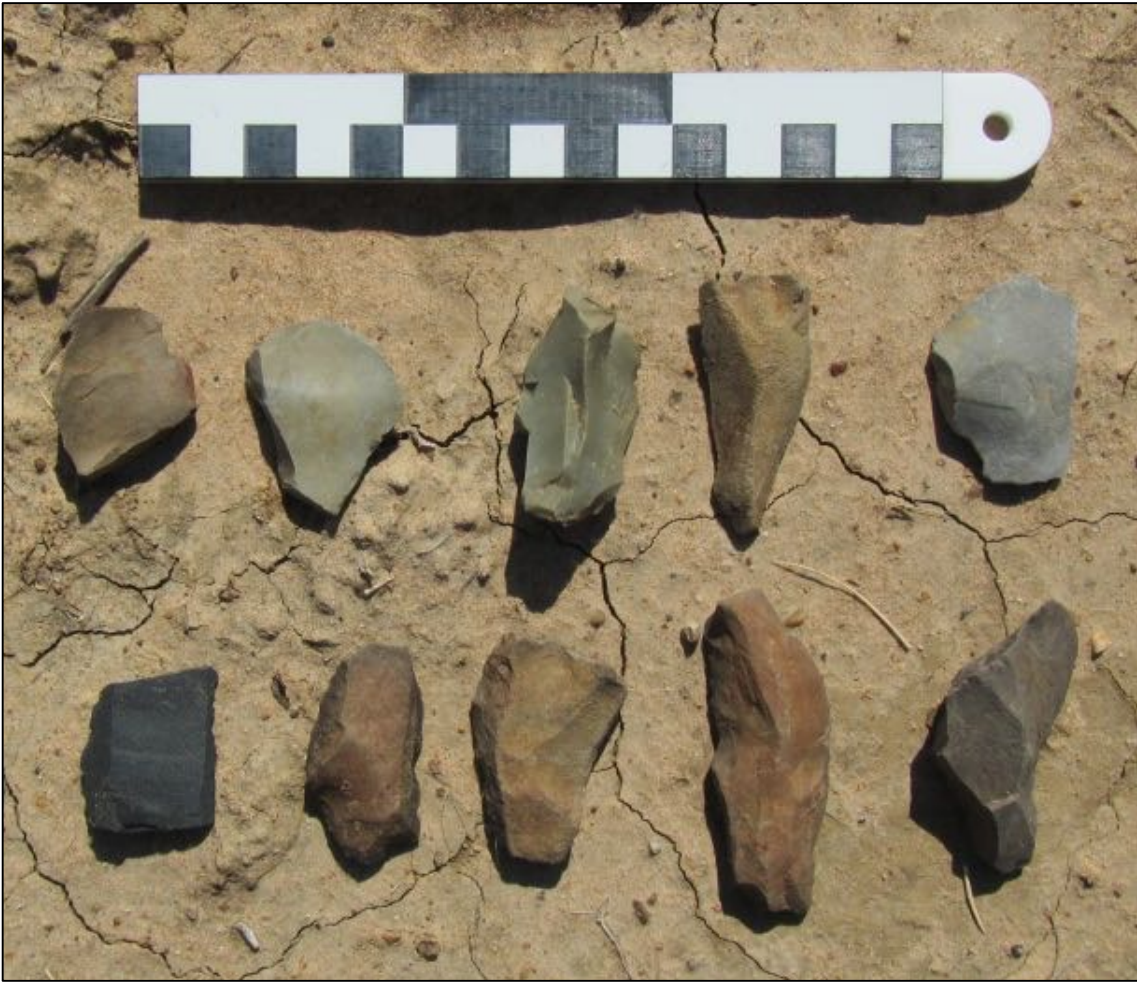
Figure 66 – MSA lithics observed on the surface of the site. Scale is in increments of 1cm and 5cm.

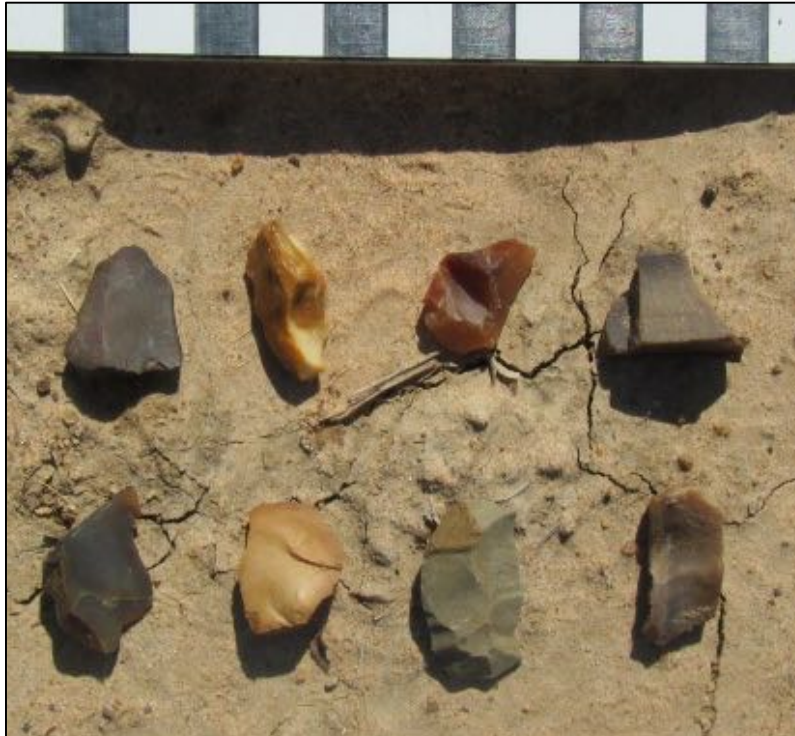
Figure 67 – LSA lithics observed on the surface of the site. Scale is in increments of 1cm and 5cm

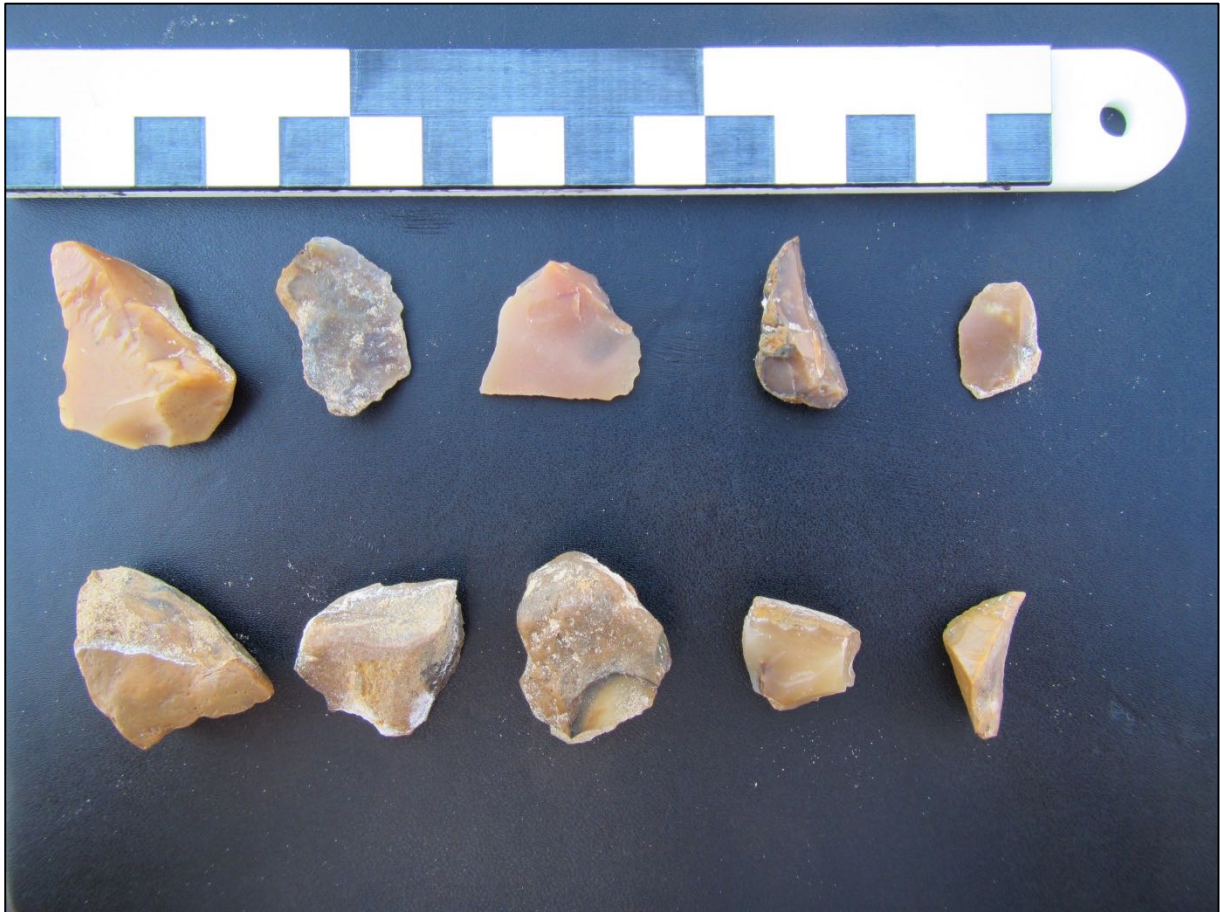
Figure 68 – View of LSA materials observed at Site 021. Scale is in increments of 1cm and 5cm.

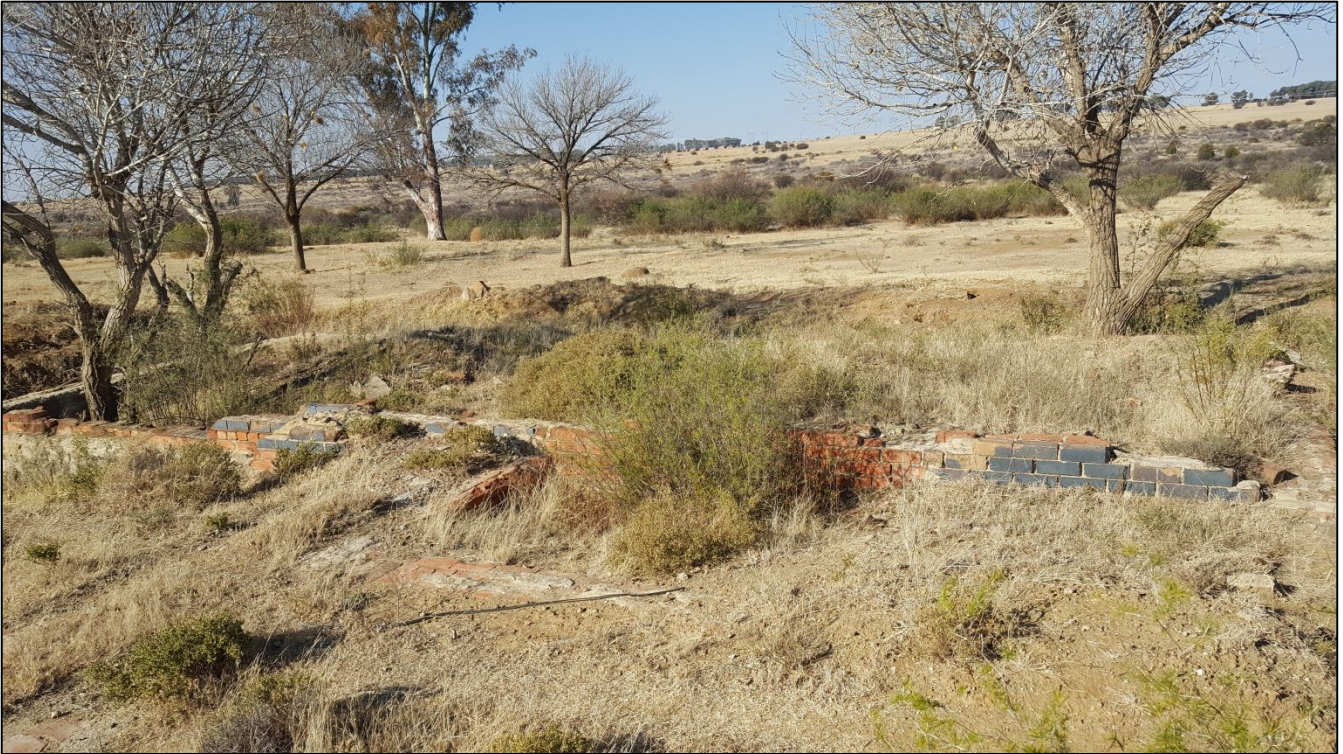
Figure 73 - The foundation remains of the outbuilding at site 023

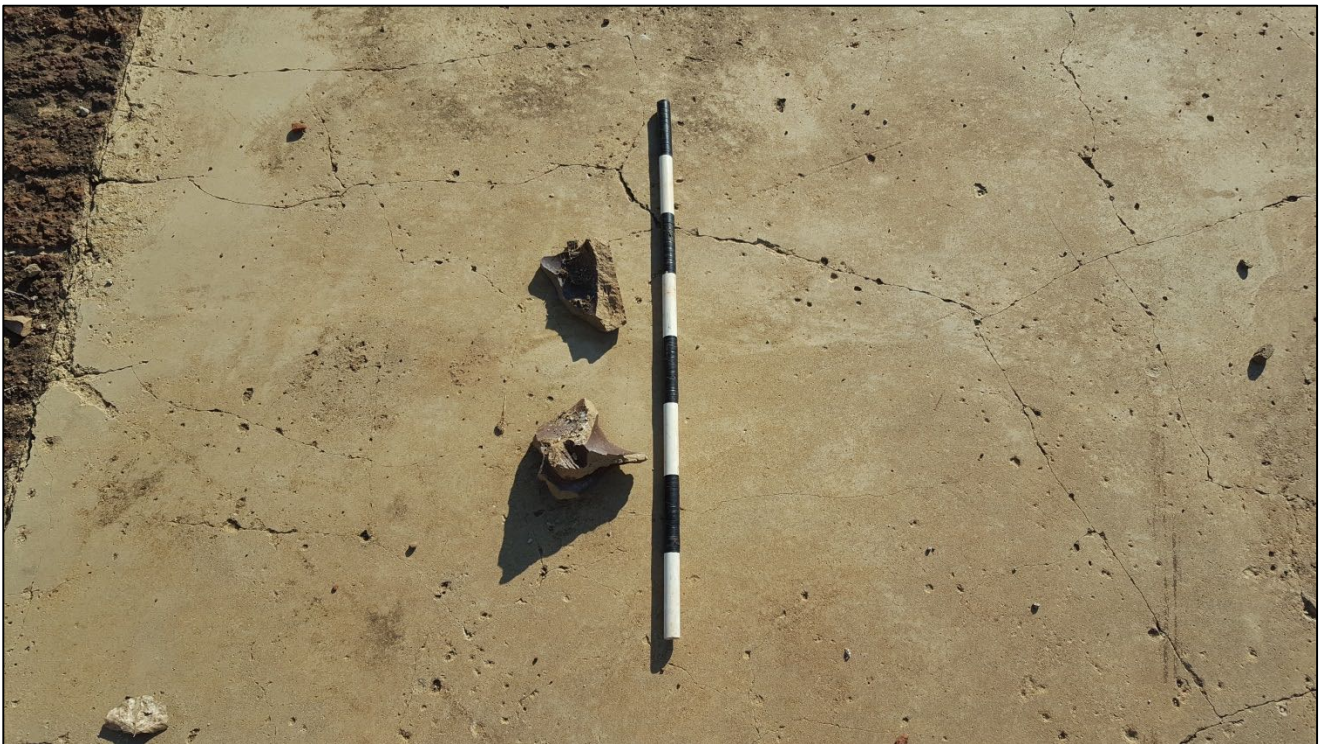
Figure 74 - Fragments of earthenware piping. Scale is in 10cm increments

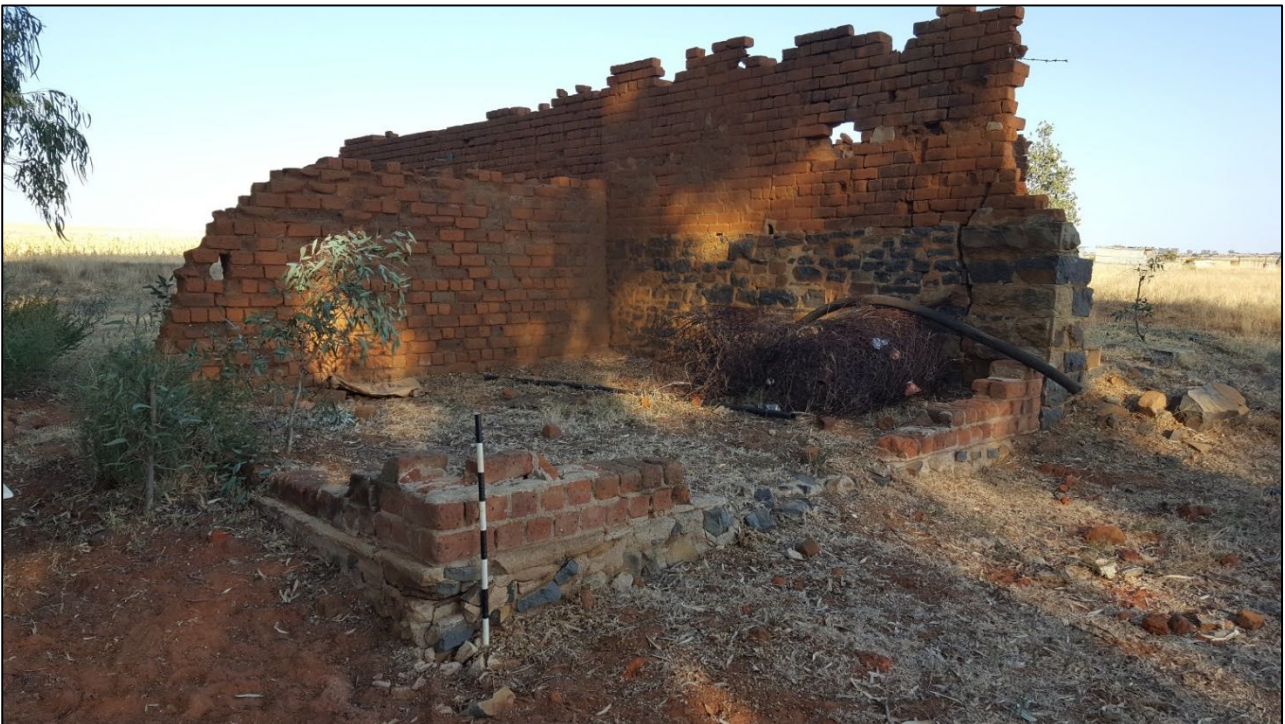
Figure 78 – View showing the brick foundation of the later extension to the wagon shed. Scale is in 10cm increments.

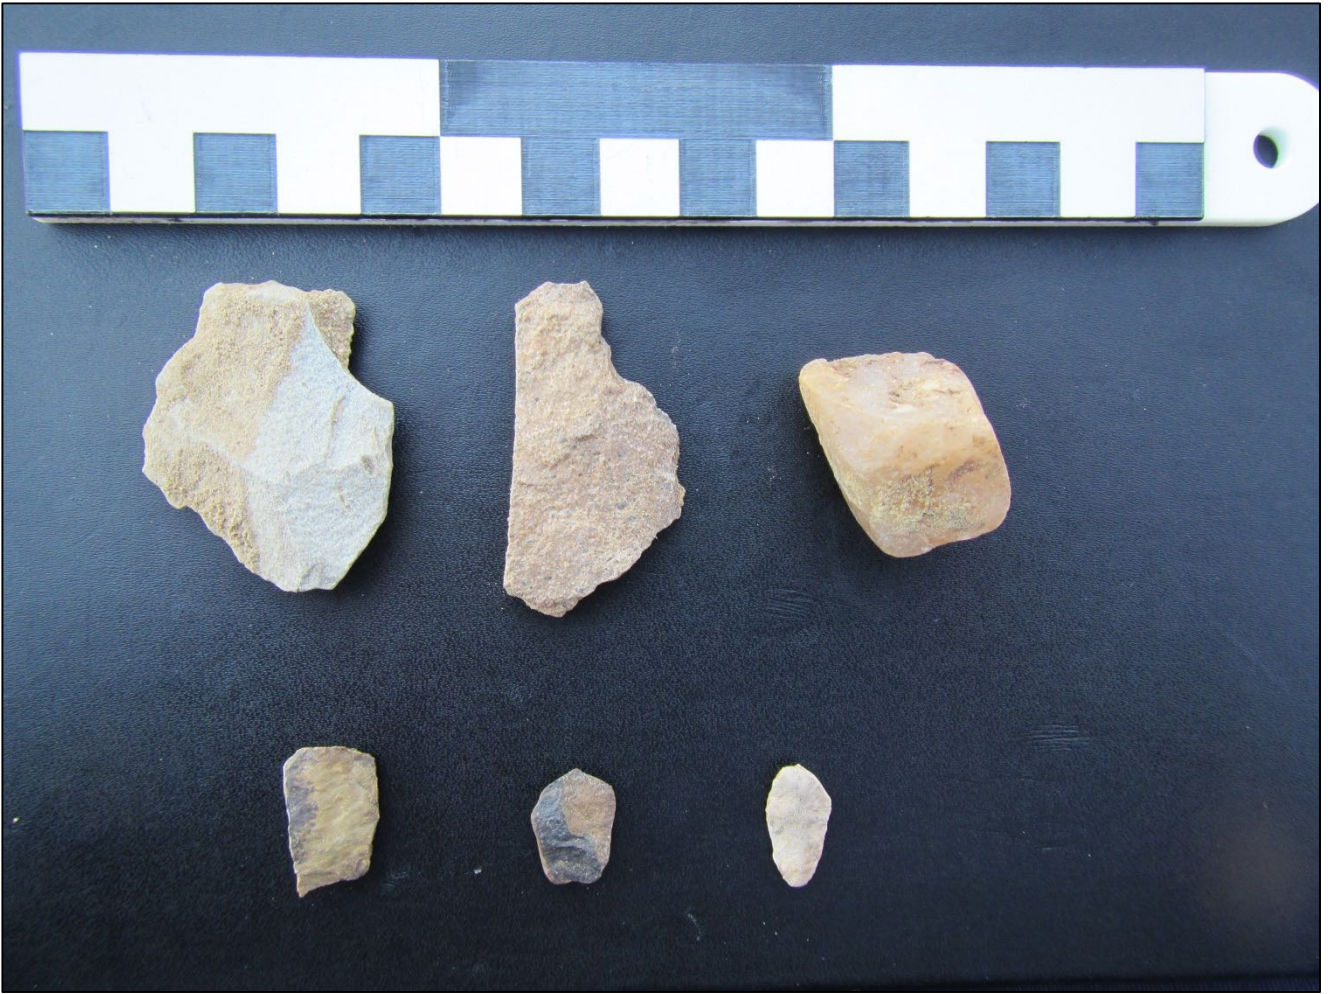
Figure 86 - MSA waste materials from Site 030. Scale is in increments of 1cm and 5cm.

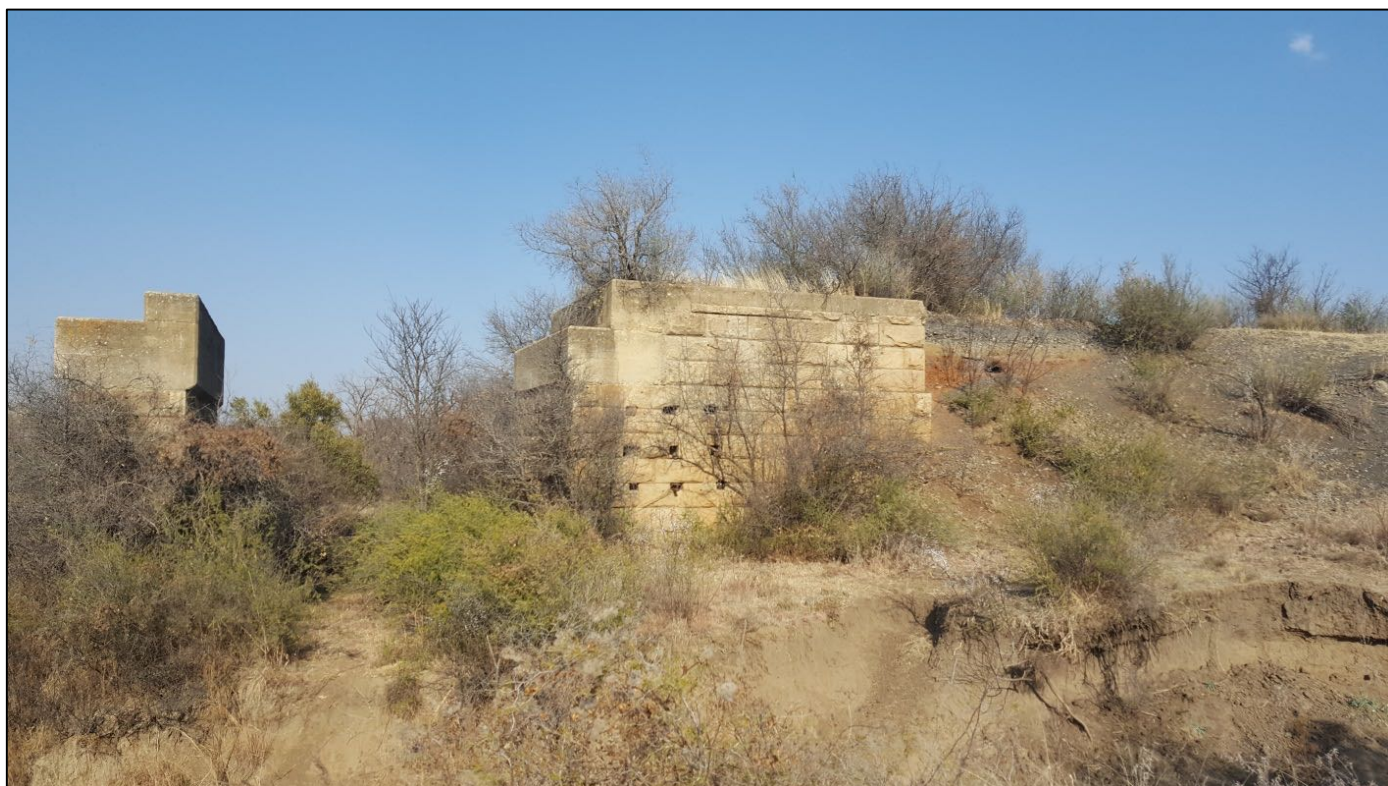
Figure 93 – General view of the railway bridge at Site 33a.
