**PROJECT NAME: BEATRIX MINING AREAS OF SIBANYE GOLD, BETWEEN WELKOM AND THEUNISSEN,
LEJWELEPUTSWA DISTRICT, ORANGE FREE STATE PROVINCE**

HERITAGE STUDY: HERITAGE AUDIT REPORT

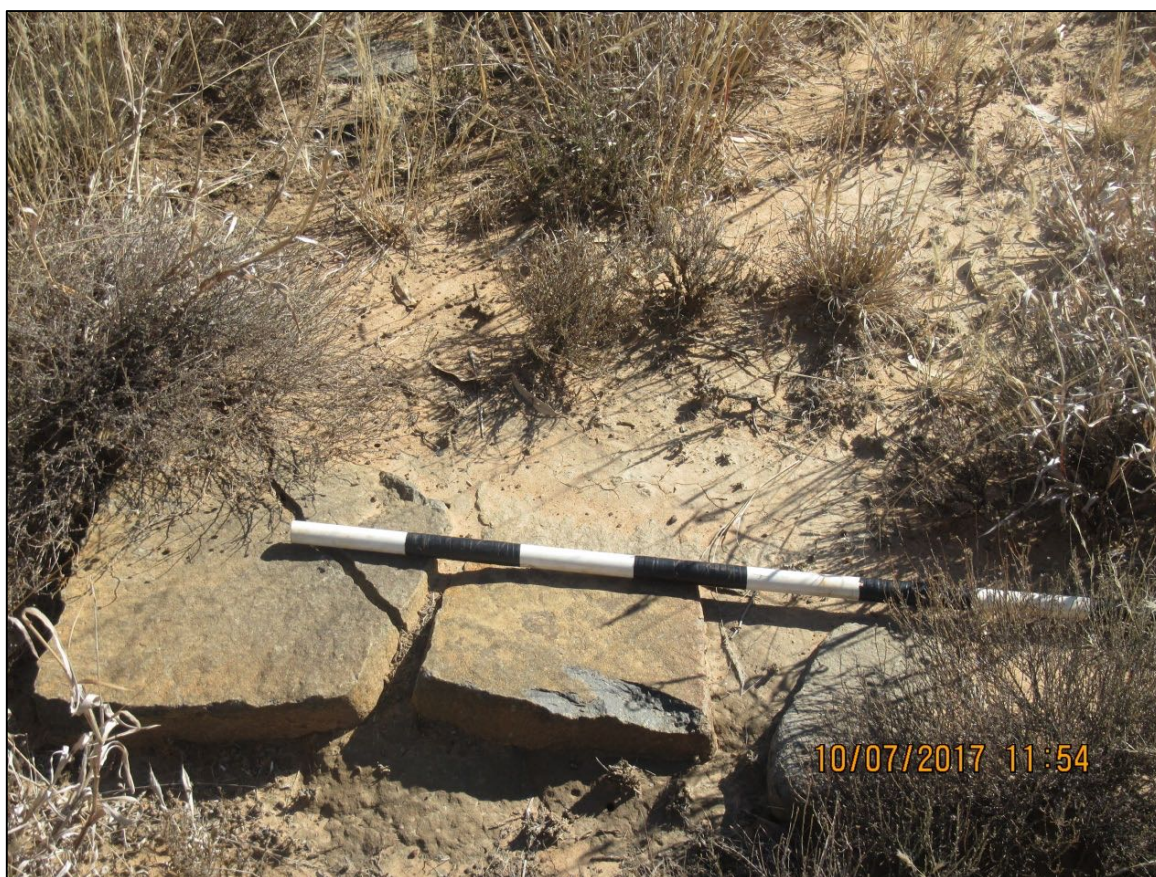
Figure 101 - Visible remains of stone foundation of the 8x3m structure. Scale is in increments of 10cm.

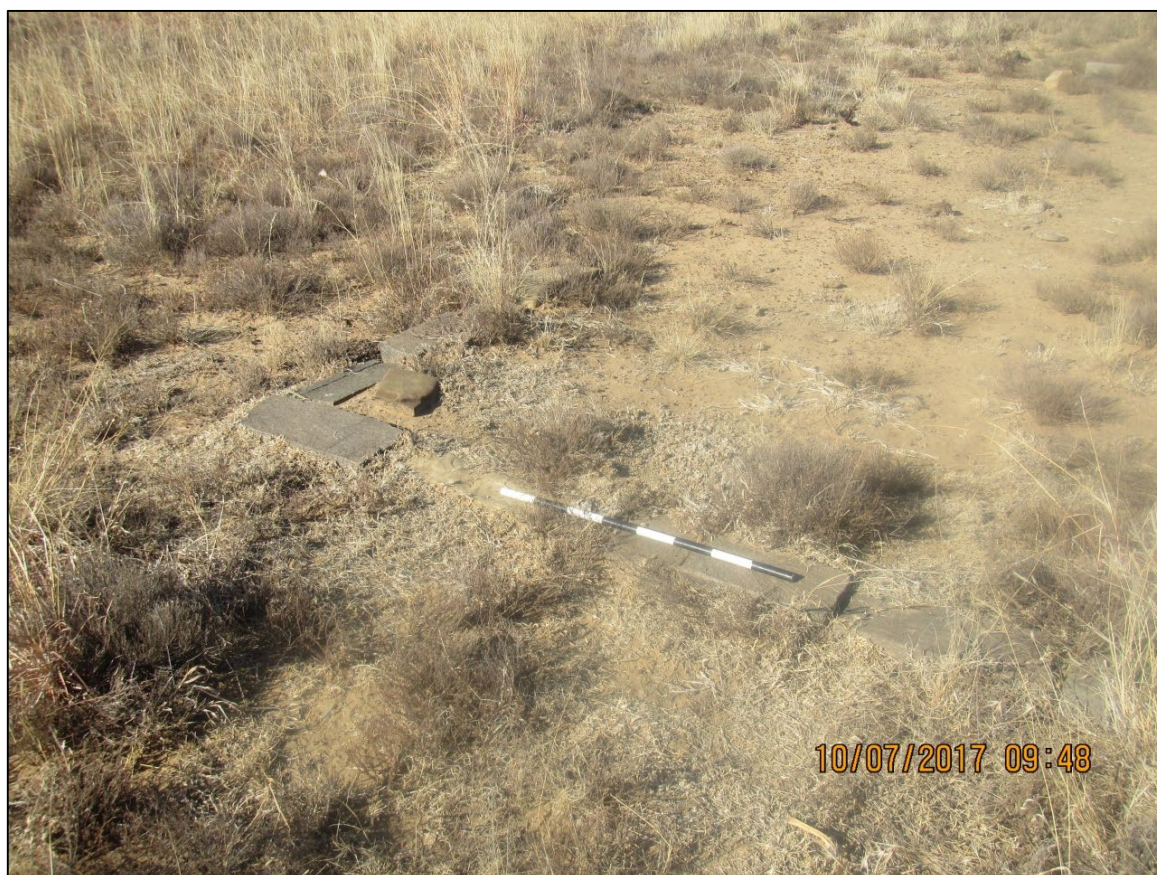
Figure 103 - Visible remains of structure foundation. Scale is in increments of 10cm.

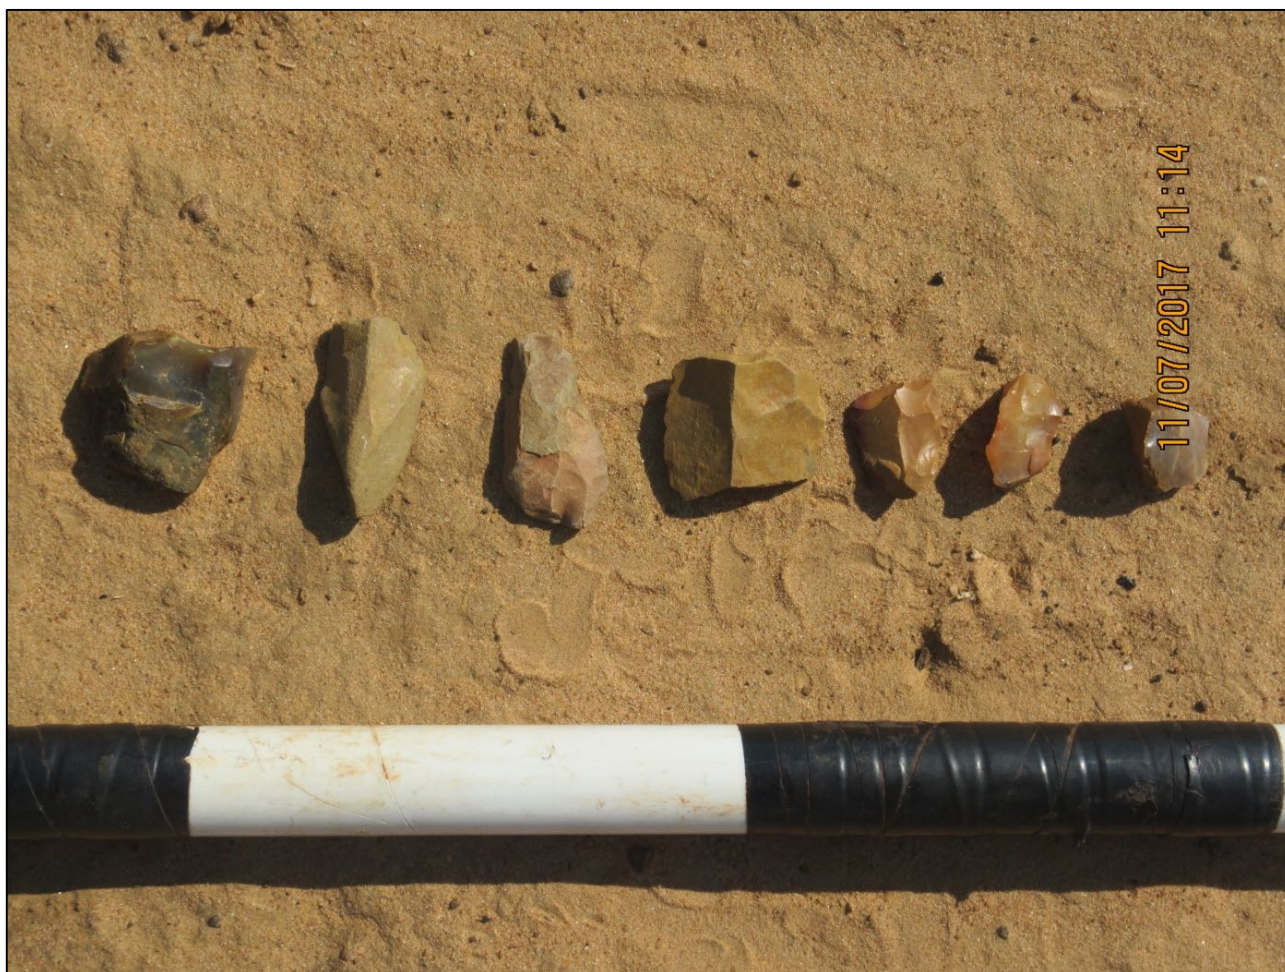
Figure 105 - LSA lithics observed at Site 038. Scale is in 10cm increments.

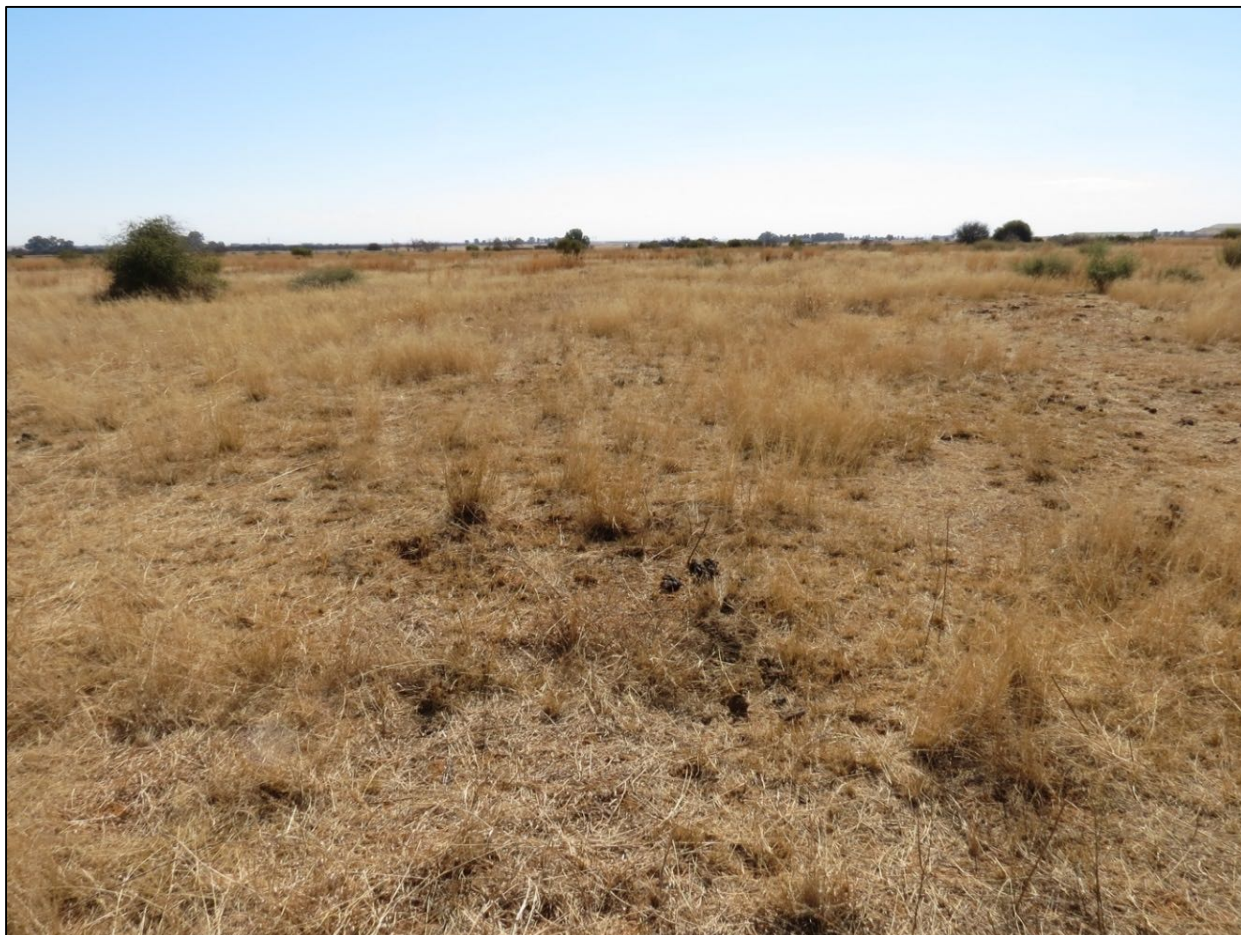
Figure 109 - General view of the area at Site 040 where the cluster of huts is depicted on the topographic sheet. As can be seen from this image, no evidence for these huts could be found.

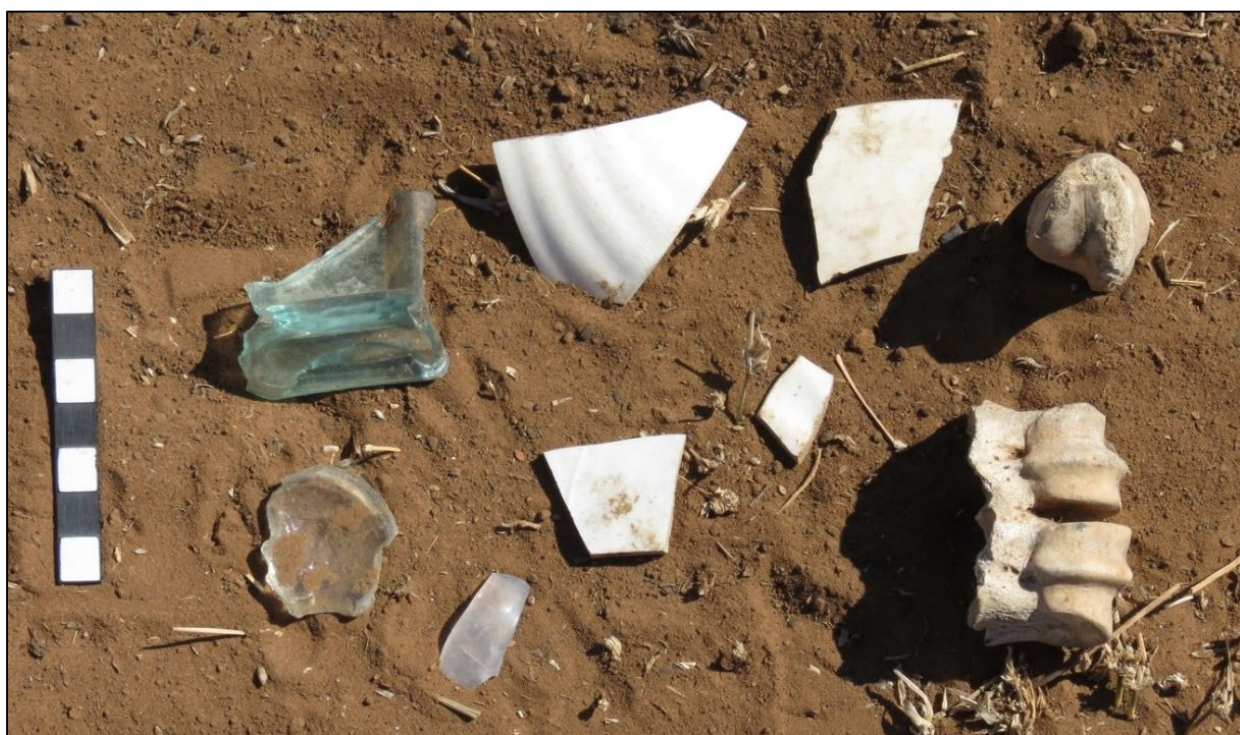
Figure 110 - Sample of artefacts and bones observed at the historic midden. Scale in 1cm increments

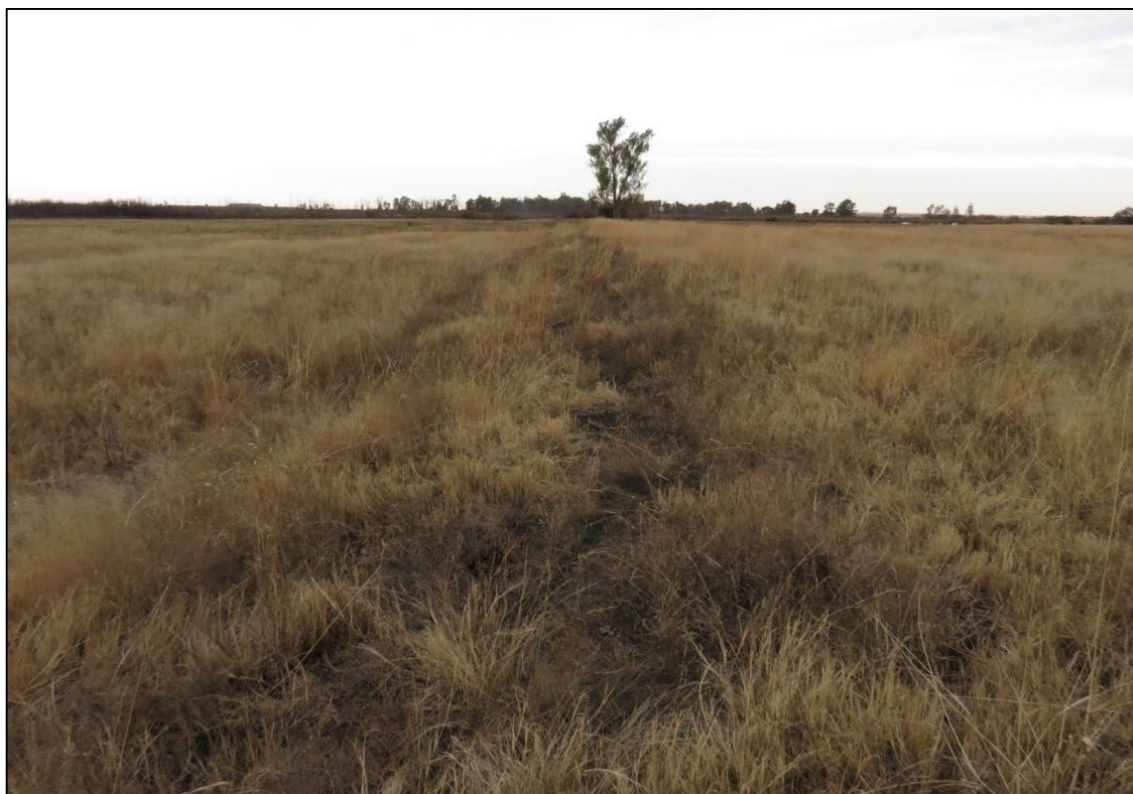
Figure 112 - General view of all that remains of the railway line that passes Moosig Siding. The railway line comprises a foundation of ballast stones, with no evidence of the railway tracks or sleepers. On this image the railway line runs from the immediate foreground in the direction of the tree on the horizon.

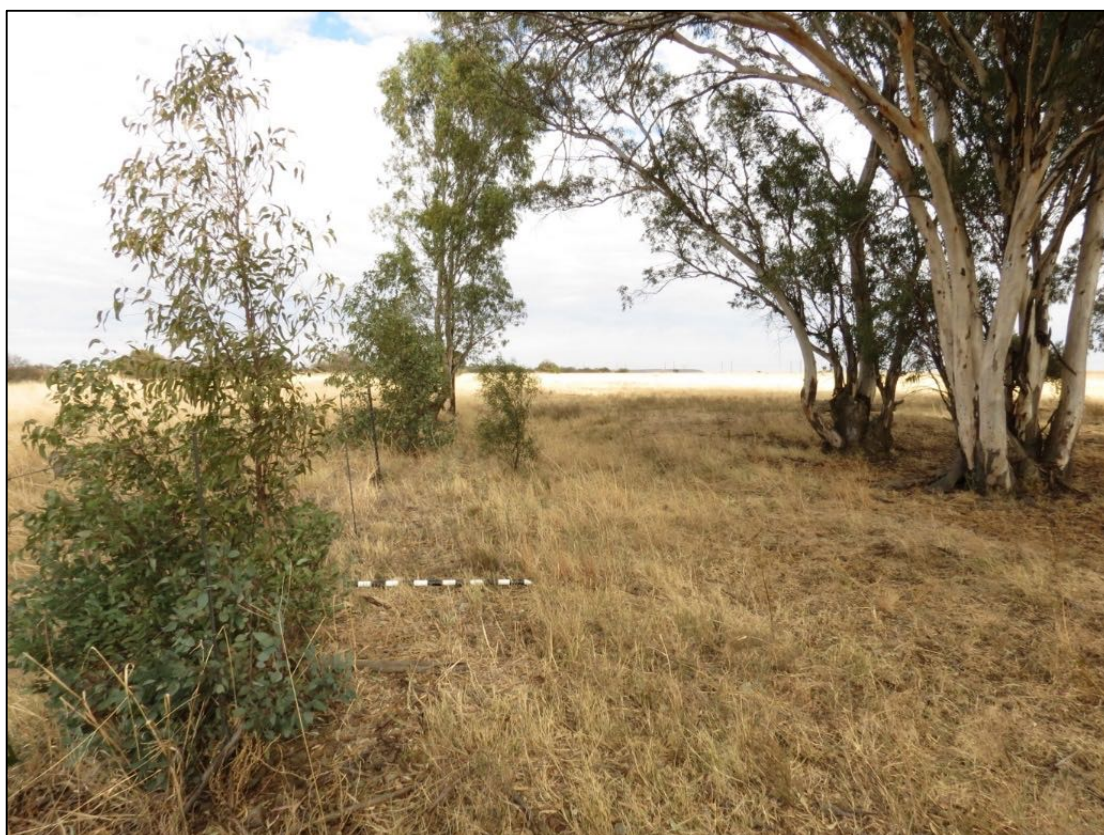
Figure 127 - This photograph was taken in proximity to Site 045 and shows the remains of the railway line under the fence visible to the left. All that presently remains of the entire historic railway line within the present study area is the railway ballast foundation.

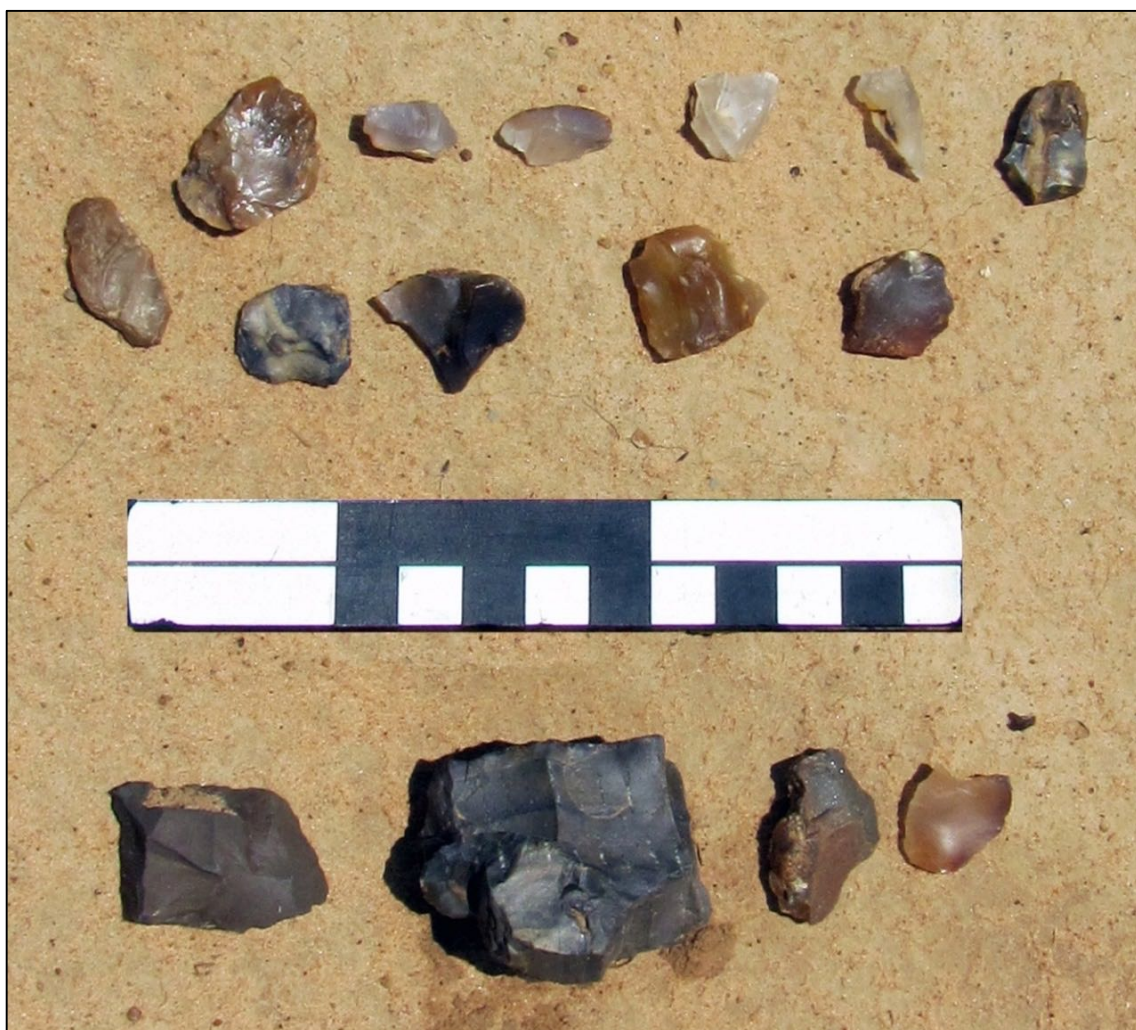
Figure 133 - Sample of lithics observed on the surface of the site. Scale is in 1cm and 5cm increments.

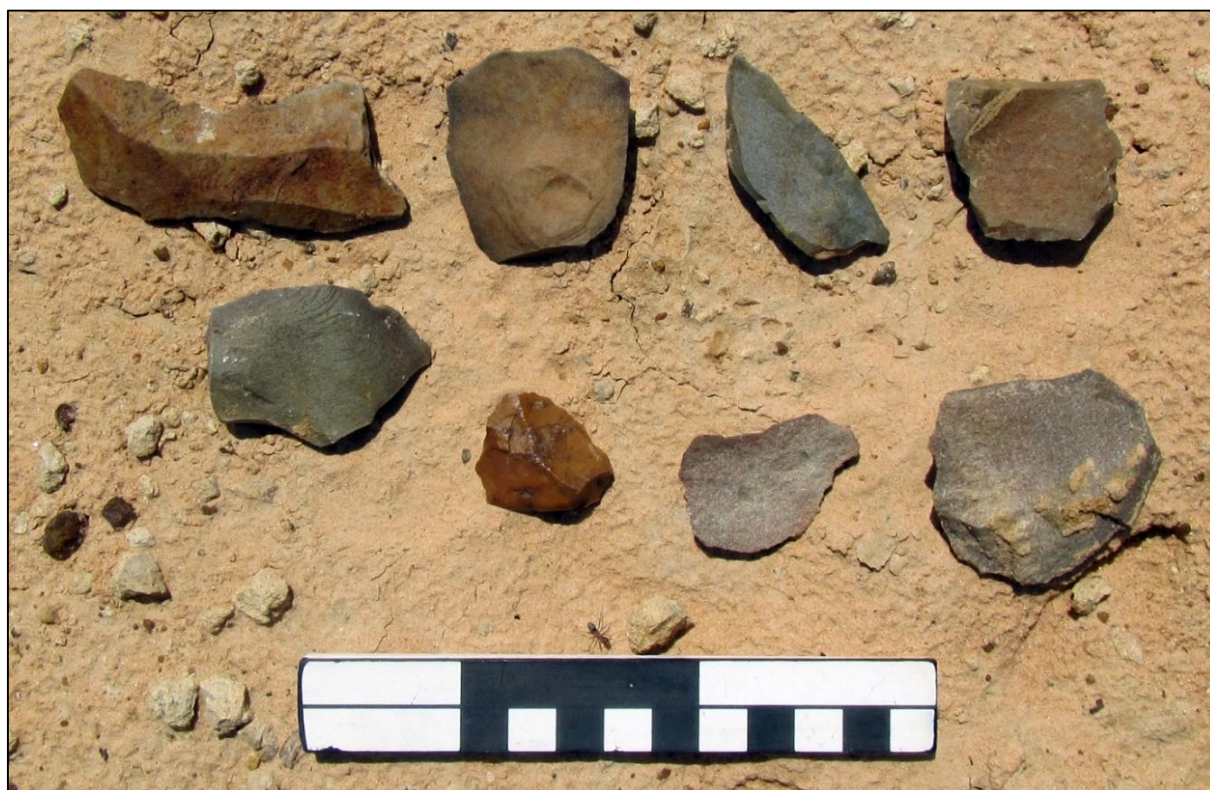
Figure 135 - Sample of lithics observed on the surface of the site. Scale is in 1cm and 5cm increments.

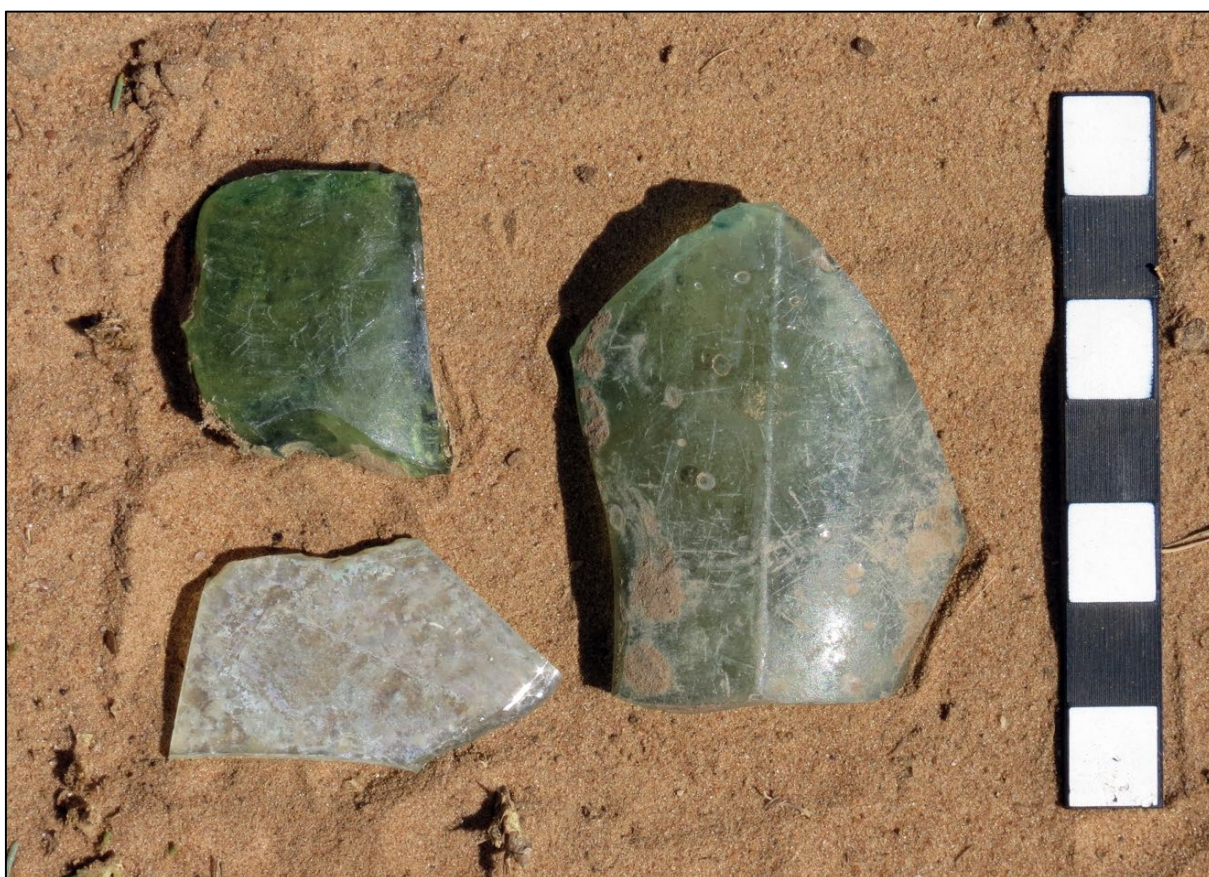
Figure 137 - Three of the glass fragments observed in proximity to Site 050a. Scale is in 1cm increments.

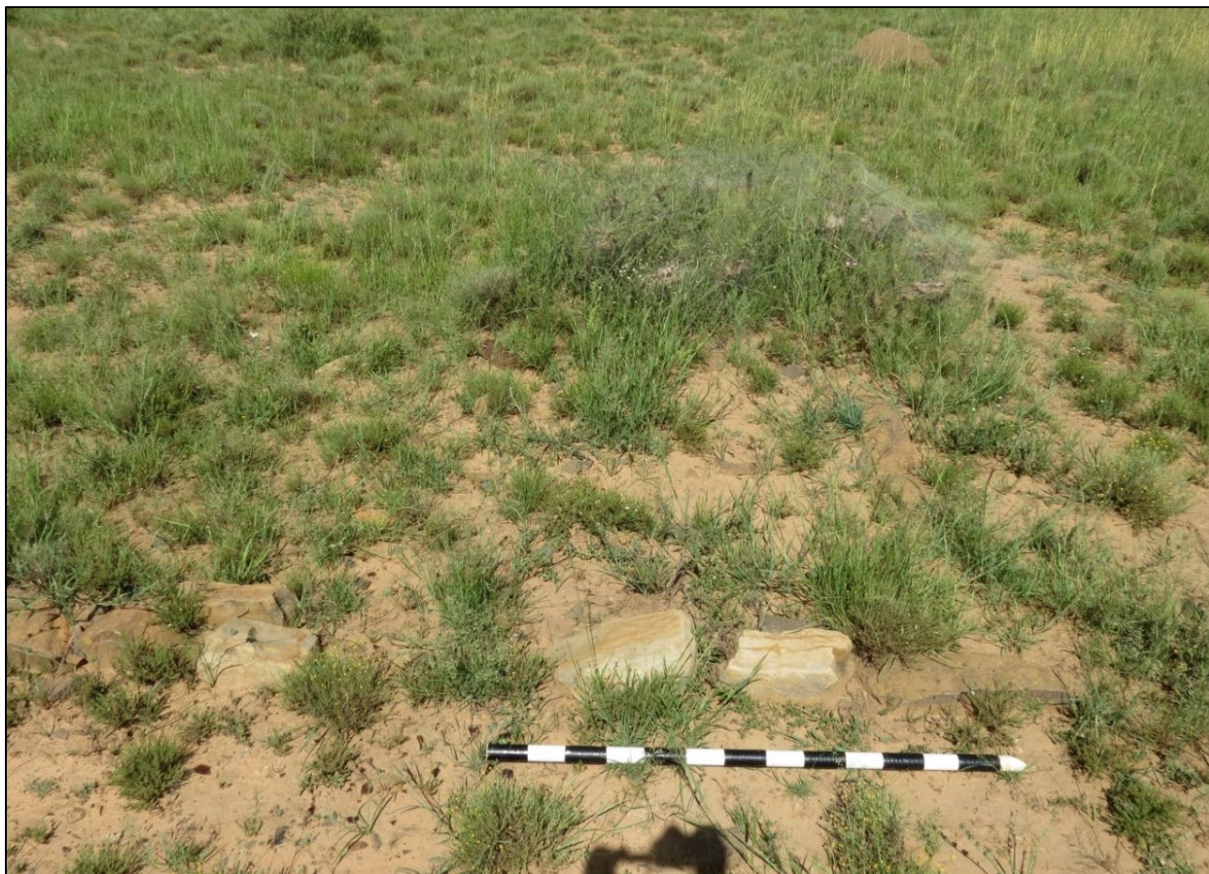
Figure 138 - General view of the structure at Site 050b. Scale is in 10cm increments

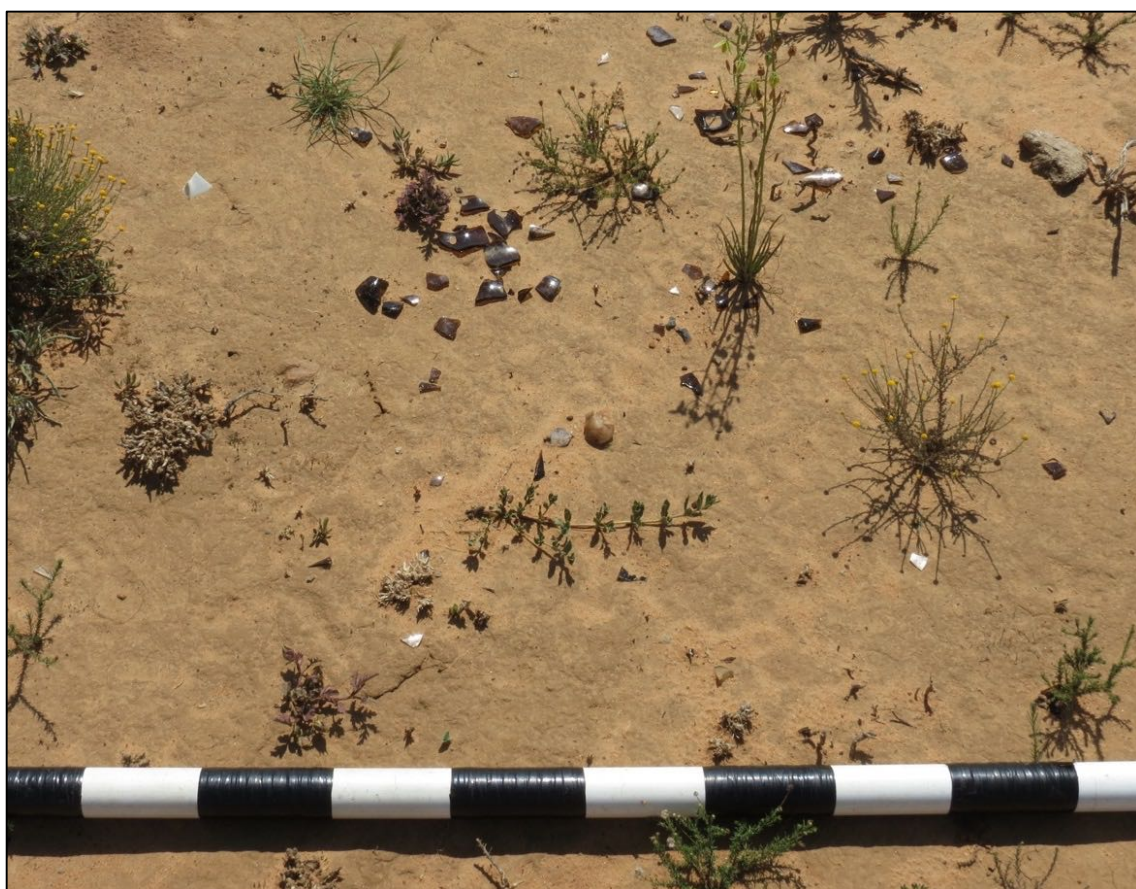
Figure 143 - Cultural material in the form of glass and metal fragments is found across the surface of the site. Scale is in 10cm increments.
