**GN 704 COMPLIANCE AUDIT REPORT FOR EXXARO COAL
GROOTEGELUK MINE**

MARCH 2021

GN 704 Grootegeluk March 2021

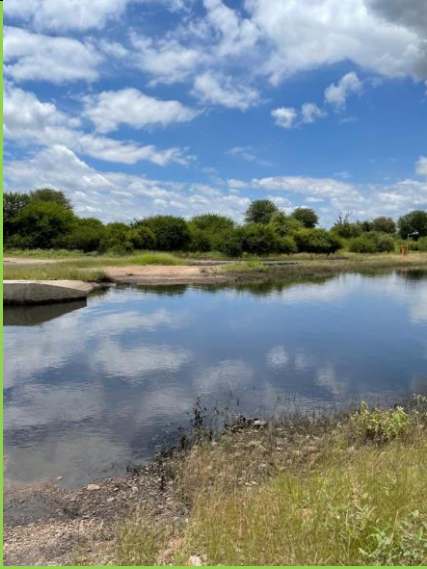
<p data-bbox="999 895 1263 922">Bosbok dam overflow.</p>

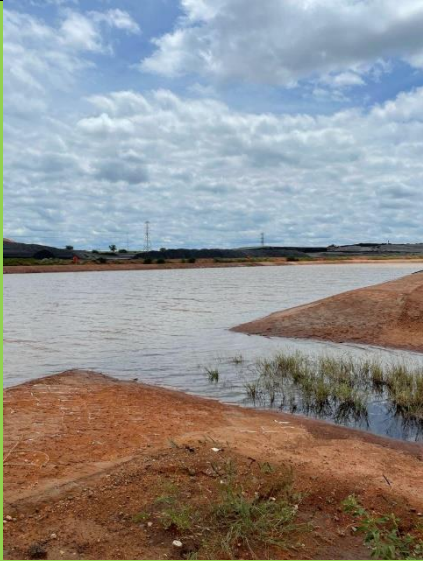
<p data-bbox="999 890 1328 919">Phase 2 Attenuation Dam 4</p>		
	(i) the date and time of the incident;	Did the holder notify the Department of the date and time of the incident?	Compliant		
	(ii) a description of the incident;	Did the holder provide a description of the incident?	Compliant		
	(iii) the source of the pollution or potential pollution;	Did the holder provide the source of the	Compliant

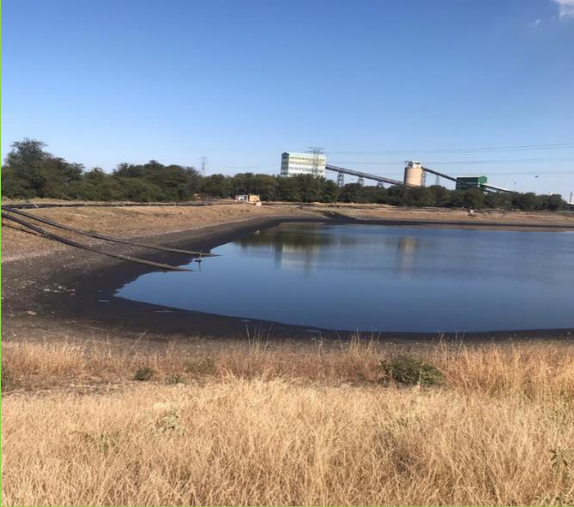
<p data-bbox="1001 834 1155 863">Bosbok Dam</p>

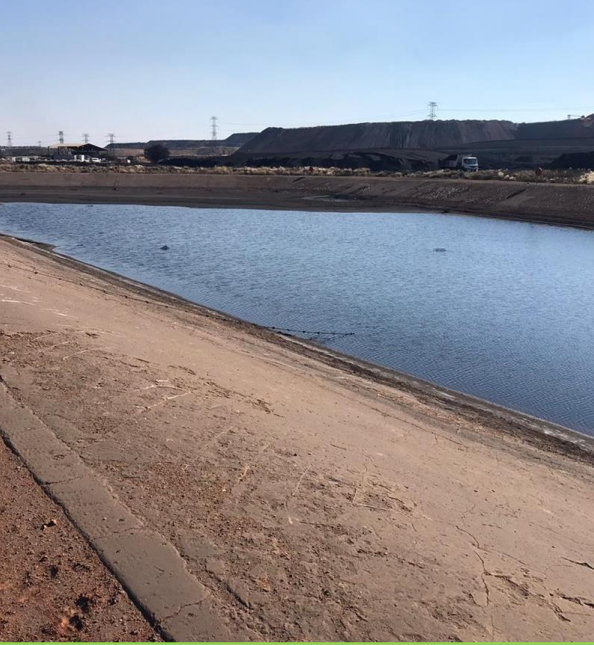
<p data-bbox="1003 975 1328 1007">Phase 2 Attenuation Dam 4</p>		
3. Exemption from requirements of regulations					
	The Minister may in writing authorise an exemption from the requirements of regulations 4, 5, 6, 7, 8, 10 or 11 on his or her own initiative or on application,	Exxaro to note.	Noted

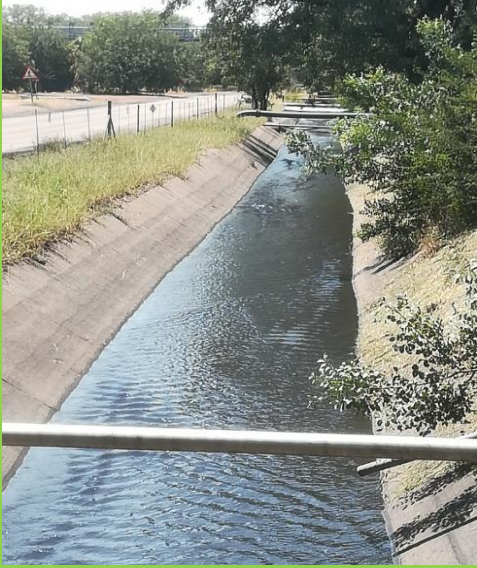
<p>(b) design, construct, maintain and operate any clean water system at the mine or activity so that it is not likely to spill into any dirty water system more than once in 50 years;</p>	<p>Has the holder designed, constructed, maintained and operated more than once in 50 years any clean water system at the mine or activity so that it was not likely to spill into any dirty water system?</p>	<p>Compliant, during the site visit it was observed that all storm-water infrastructure was designed adequately to prevent spillage. Cleaning contractors are continuously cleaning the channels.</p>

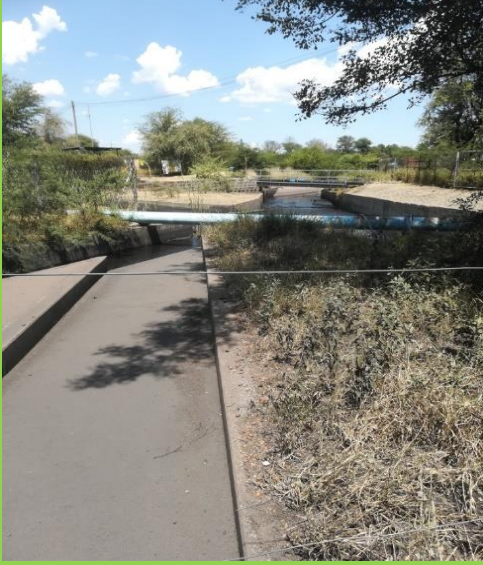
<p>(c) collect the water arising within any dirty area, including water seeping from mining operations, outcrops or any other activity, into a dirty water system;</p>	<p>Did the holder collect the water arising within any dirty area, including water seeping from mining operations, outcrops or any other activity, into a dirty water system?</p>	<p>Compliant, dirty is contained on site. During the site visit it was observed that the dirty water channels reporting to the pit is effective. Abstraction boreholes are in place to recover and contain the seepage water inside basalt aquifer.</p>

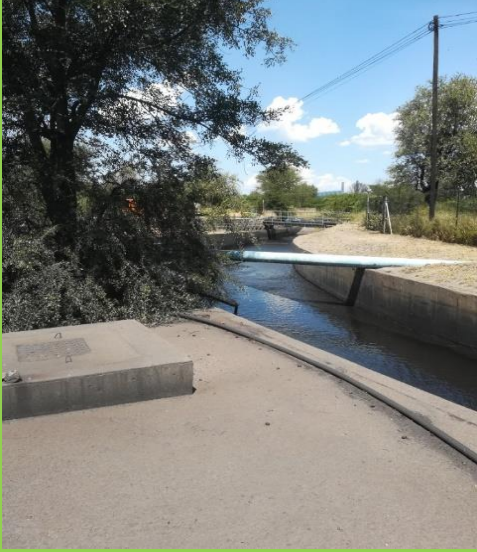
<p>(d) design, construct, maintain and operate any dirty water system at the mine or activity so that it is not likely to spill into any clean water system more than once in 50 years; and</p>	<p>Has the holder designed, constructed, maintained and operated more than once in 50 years any dirty water system at the mine or activity so that it is not likely to spill into any clean water system?</p>	<p>Compliant, during the site visit it was observed that all storm-water infrastructure was designed adequately to prevent spillage.</p> <p>Cleaning contractors are continuously cleaning the channels.</p>

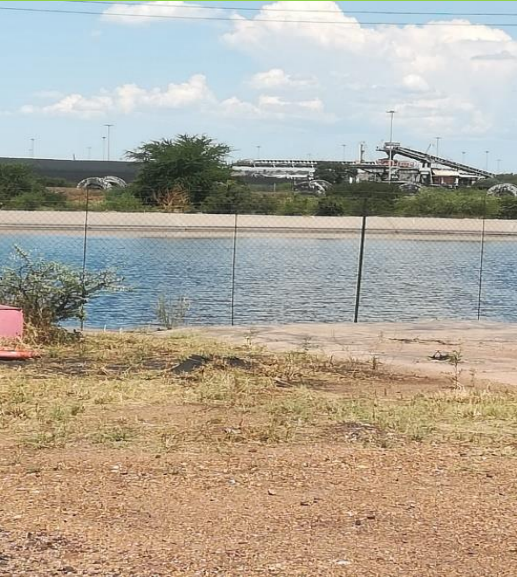
Ref #	Condition	Audit Question	Compliant/Non-Compliant	Responsible Person	Date
	(e) design, construct, maintain and operate any dam or tailings dam that forms part of a dirty water system to have a minimum freeboard of 0.8 metres above full supply level, unless otherwise specified in terms of Chapter 12 of the Act.	Has the holder designed, constructed, maintained and operated any dam or tailings dam that forms part of a dirty water system to have a minimum freeboard of 0.8 metres above full supply level, unless otherwise specified in terms of Chapter 12 of the Act?	<p>Compliant. The freeboard is maintained in all the PCD's visited.</p>

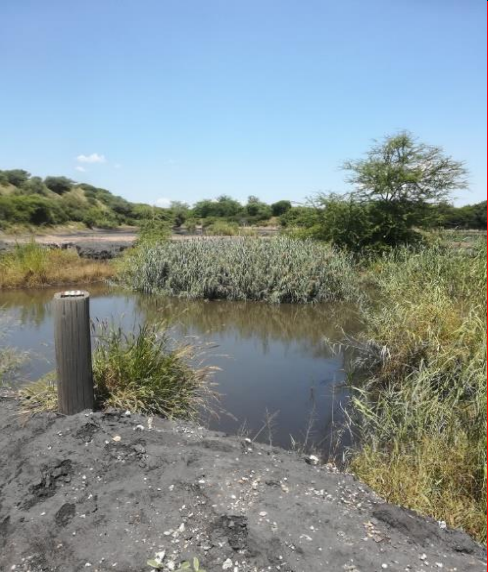
<p>The Reductant Product and Feed Stockpile expansions at the Reductant facility also still needs to be lined according to the WUL requirements. These is currently a Capital project that is aimed doing so. If this is not implemented the areas needs to be cleaned.</p>	<p>Armand Bezuidenhout</p>	<p>31 Aug 2021</p>
	<p>(b) design, modify, locate, construct and maintain all water systems, including</p>	<p>Has the holder taken reasonable measures to design, modify, locate, construct and maintain</p>	<p>Compliant No instream Infrastructure. Storm Water systems are however maintained to prevent pollution of water resources.</p>

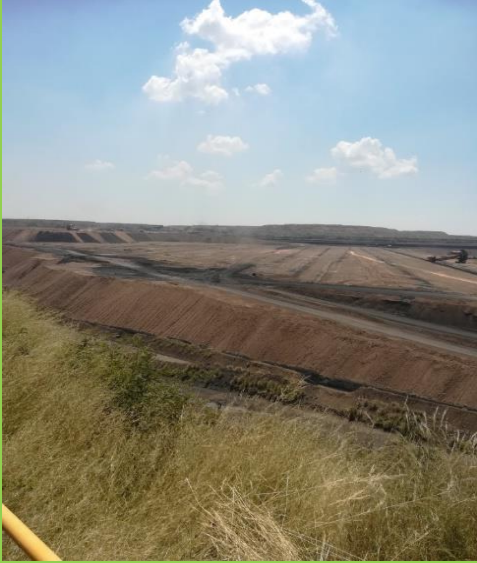
<p>d) design, modify, construct, maintain and use any dam or any residue deposit or stockpile used for the disposal or storage of mineral tailings, slimes, ash or other hydraulic transported</p>	<p>Has the holder taken reasonable measures to design, modify, construct, maintain and use any dam or any residue deposit or stockpile used for the disposal or storage of mineral tailings, slimes, ash or other hydraulic</p>	<p>Compliant.</p> <p>Quarterly Stability Audits are conducted for the Slimes dam facility.</p> <p>The approved As-built designs are available for the Cyclic ponds.</p>

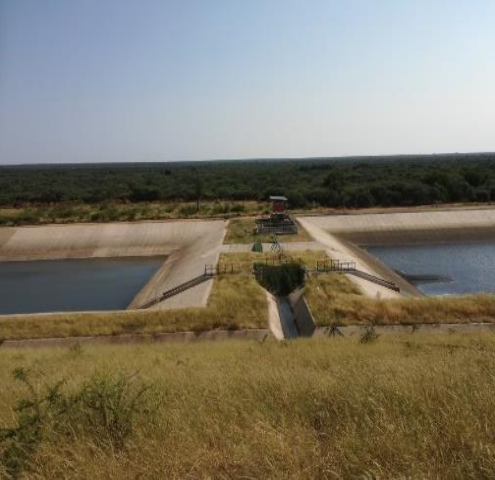
<p>Has the holder taken reasonable measures to prevent the erosion or leaching of materials from any residue deposit or stockpile from any area and contain material or substances so eroded or leached in such area by providing suitable barrier dams, evaporation dams or</p>	<p>Compliant, Erosion Control Plan is in place. Areas of concern were identified in the 2020 Audit and there is an action plan that needs to be implemented in the Dry season on 2021. Erosion is managed accordingly.</p>

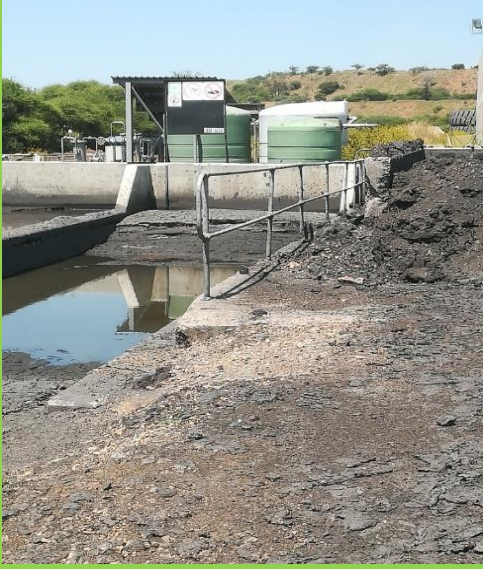
g) at all times keep any water system free from any matter or obstruction which may affect the efficiency thereof; and	Did the holder take reasonable measures to keep any water system free from any matter or obstruction which may affect the efficiency thereof at all times?	Partially compliant, some channels observed are silted up, even with vegetation growing. There is a contract in place to clean the channels.	A Molauzi	Ongoing

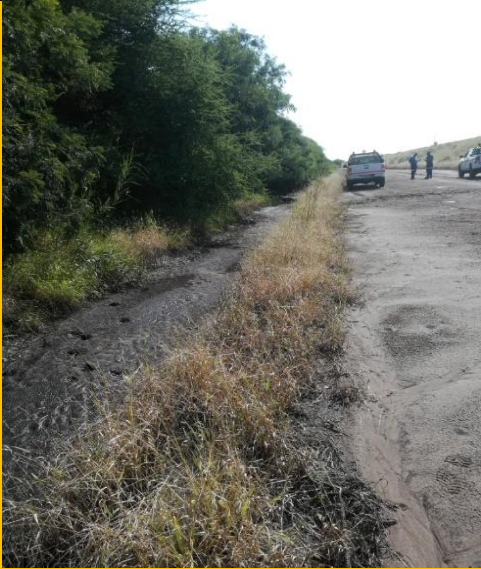
<p data-bbox="1010 898 1608 975">Storm water drainage Channel at the slimes dam facility</p>		
	(h) cause all domestic waste, including wash-water, which cannot be disposed of in a municipal sewage system, to be disposed of in terms	Did the holder take reasonable measures to cause all domestic waste, including wash water, which cannot be disposed of in a municipal sewage system, to be disposed	<p data-bbox="1010 991 1137 1023">Compliant</p> <p data-bbox="1010 1038 1608 1118">Domestic waste water is disposed at the mins SWWTP. All process water is recovered for reuse.</p>

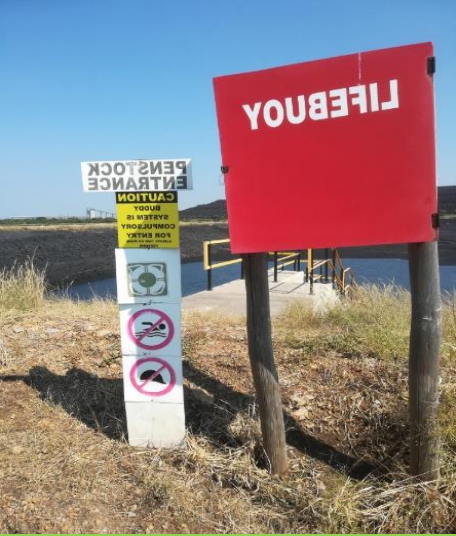
8. Security and additional measures					
	Every person in control of a mine or activity must-				
	a) cause any impoundment or dam containing any poisonous, toxic or injurious substance to be effectively fenced-off so as to restrict access thereto, and must erect warning notice boards at prominent locations so as to warn persons of the hazardous contents thereof;	<p>Has the holder caused any impoundment or dam containing any poisonous, toxic or injurious substance to be effectively fenced off so as to restrict access thereto?</p> <p>Has the holder erected warning notice boards at prominent locations so as to warn persons of the hazardous contents thereof?</p>	<p>Compliant</p> <p>Project in place to upgrade fencing and signage.</p>

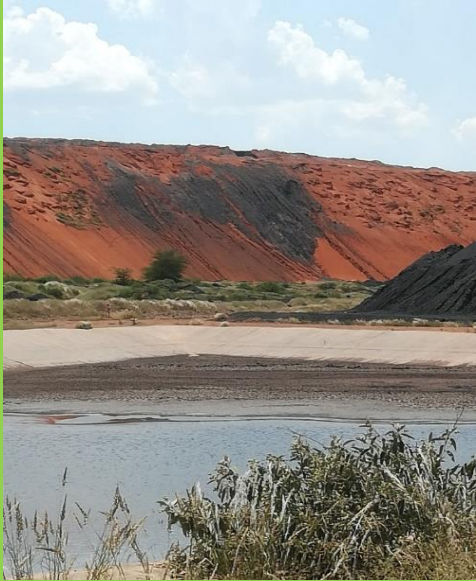
Ref #	Condition	Audit Question	Compliant/Non-Compliant	Responsible Person	Date
	such residue deposits so that-				
	(a) all residue deposits are compacted to prevent spontaneous combustion and minimise the infiltration of water; and	Did the holder ensure that all residue deposits were compacted to prevent spontaneous combustion and minimise the infiltration of water?	<p>Compliant</p> <p>The placing of the Residue Material results in sufficient compaction and is approved in the EMPR.</p> <p>During the site visit there was no Spontaneous combustion evident. Red sand is used to control any Spontaneous Combustion that does occur.</p>
